Project	North Sound Behavioral Health Treatment Center
Created	2020-08-24 09:54:54 PDT by Adam Johnson
Updated	2020-08-24 15:02:09 PDT by Adam Johnson

Project Name and Number	North Sound Behavioral Health Treatment Center - R16-180068.01
Location	902 Pine St., Everett, WA 98201
Observation Report No.:	15
Report Author	Adam Johnson
Date of Visit	2020-08-24
Time of Visit	09:54
Weather Conditions	Mostly Sunny
Temperature (F)	64
GC/CM	BN Builders
Site Walk By	Jeff Hencz & Steve Slawson (SnoCo), Adam Johnson (OAC), Danny O'Brien (BNB)

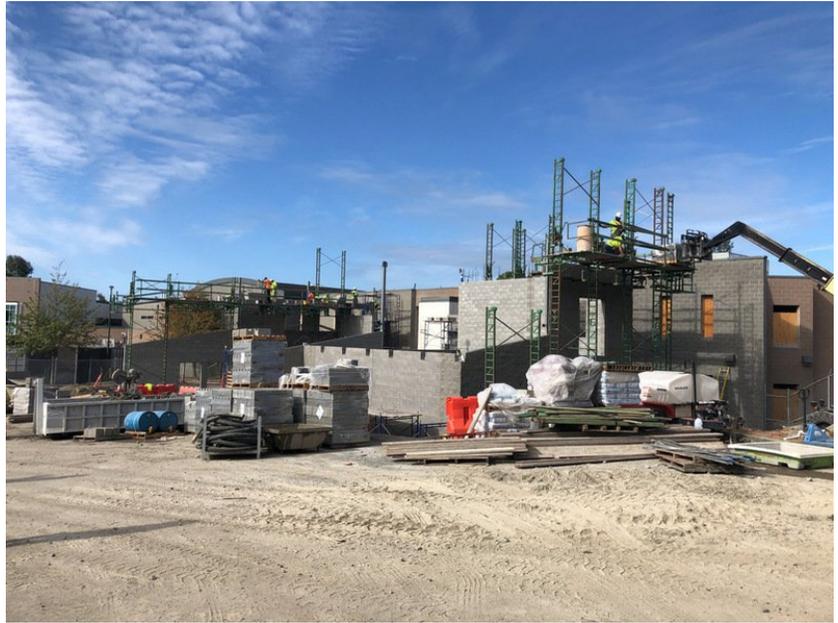
Masonry progress in the admin area. Photo facing (plan) southeast.

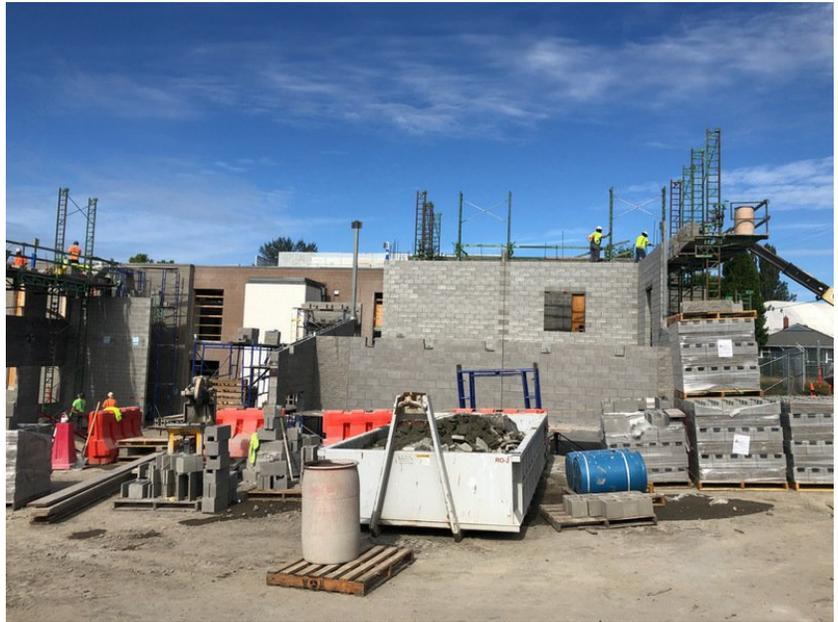
Masonry progress in the admin area. Photo facing (plan) south.

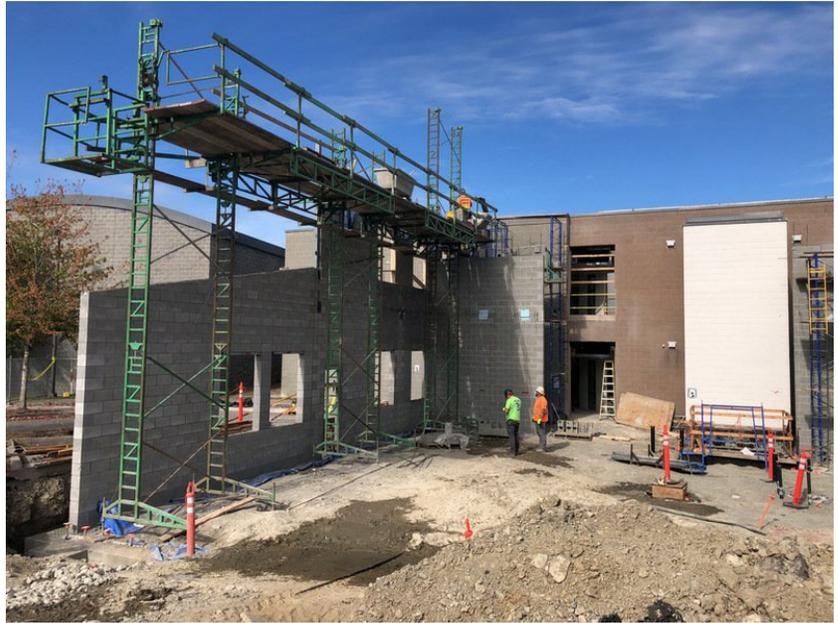
Masonry progress along the 34 line. Photo facing (plan) southeast.

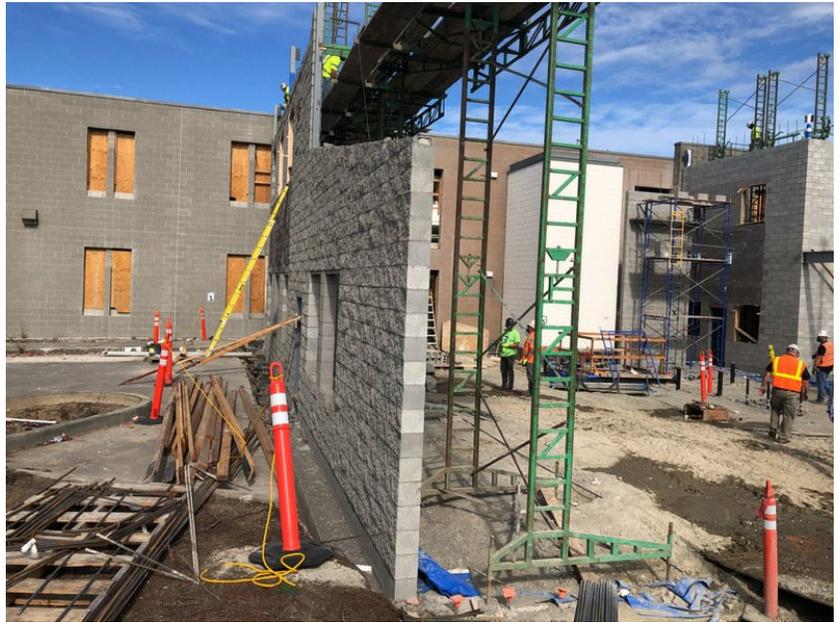
Masonry progress along the 34 line. Photo facing (plan) south.

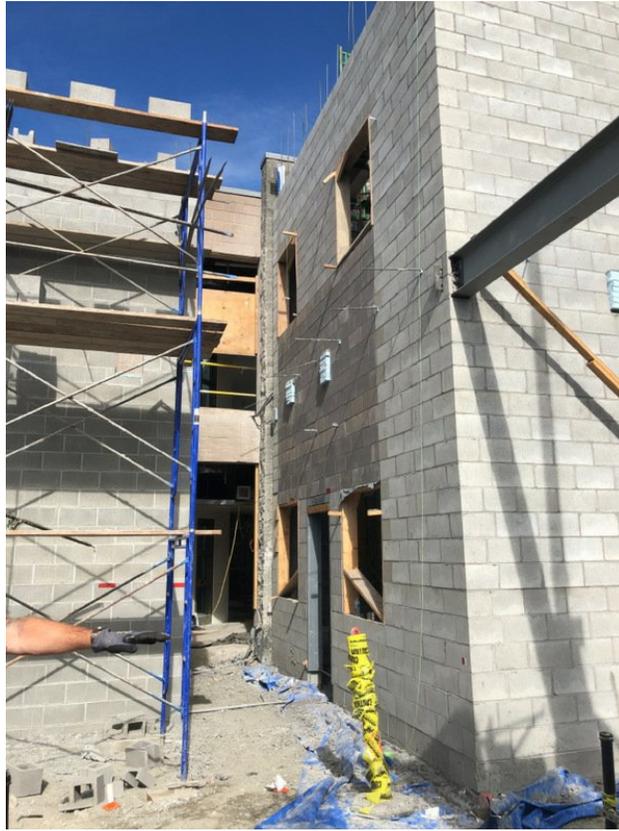
Masonry in progress. Photo facing (plan) south towards corridor 135/235.

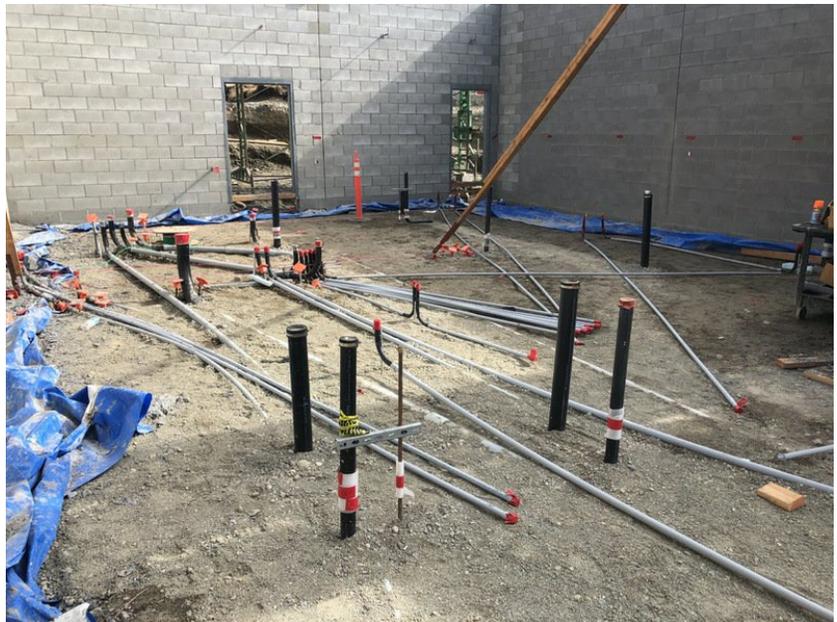
Underground MEP at the (plan) northeast corner of the admin area. Photo facing (plan) northwest.

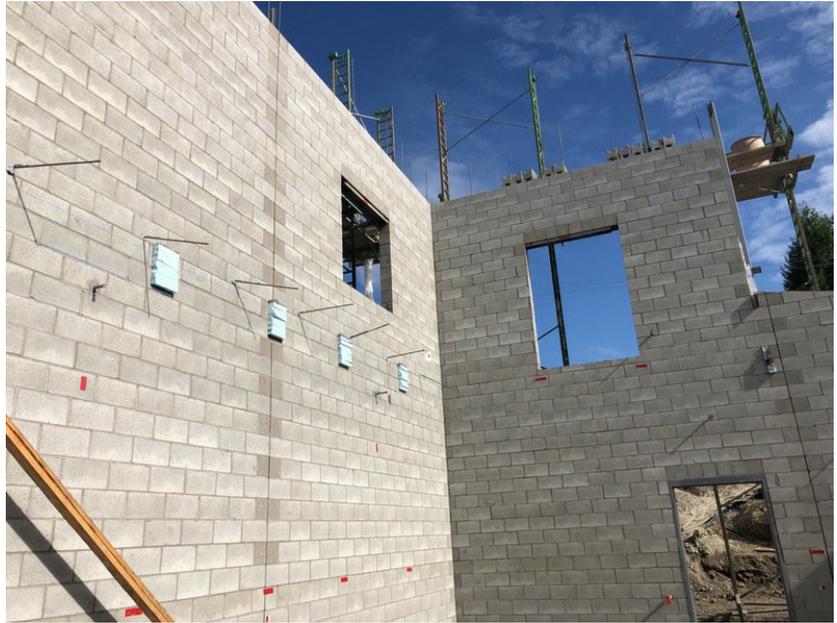
2nd floor rough openings for Mechanical Room 246. Rough opening on the right is sized larger than the plans call for to allow for material delivery to the 2nd floor. Photo facing (plan) west.

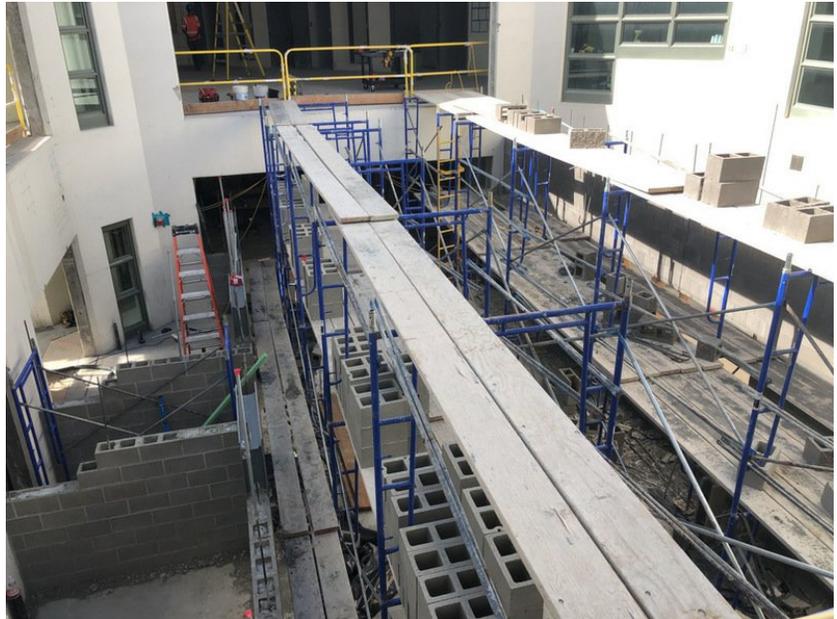
Light court and nurse station area as viewed from the 2nd floor men's housing area photo facing (plan) east.

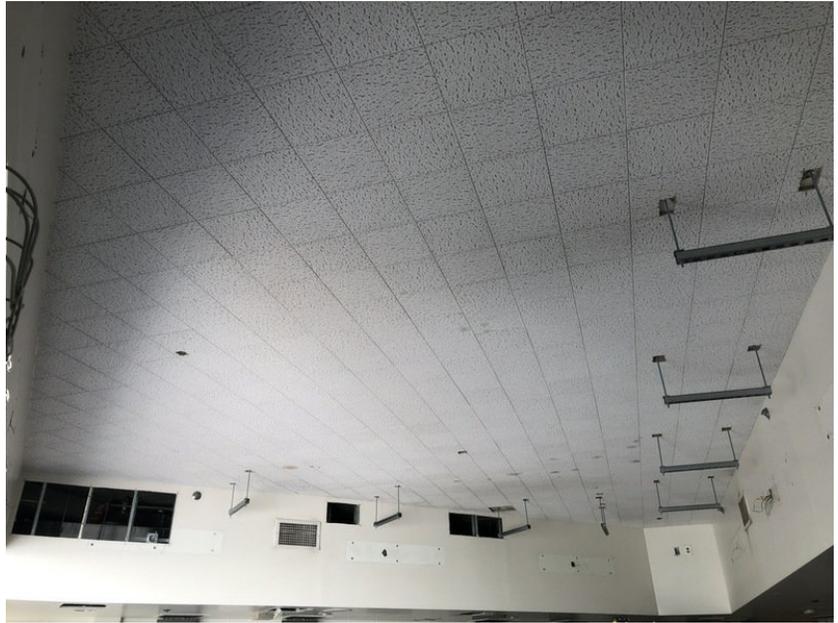
2nd floor women's housing area. MEP rough-in and hangers in progress.

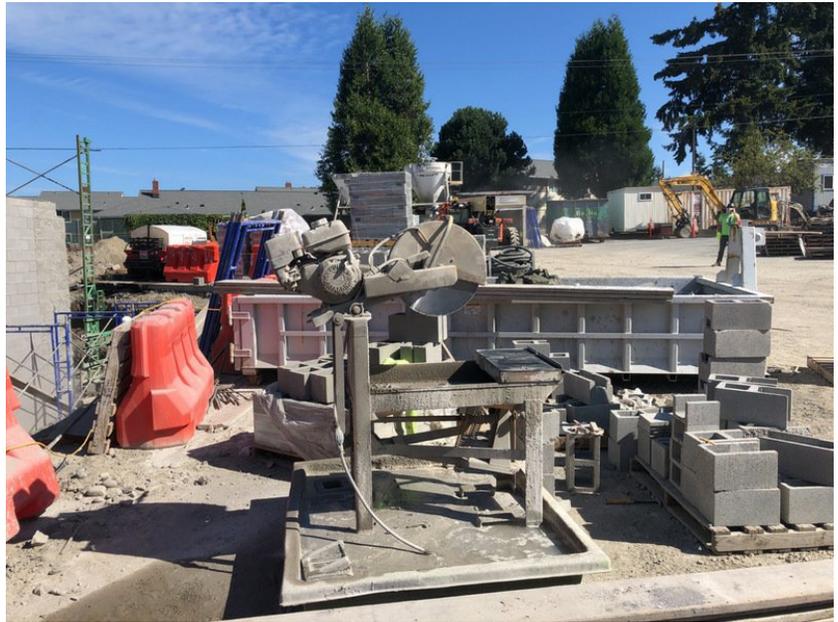
Masonry equipment and materials on site.

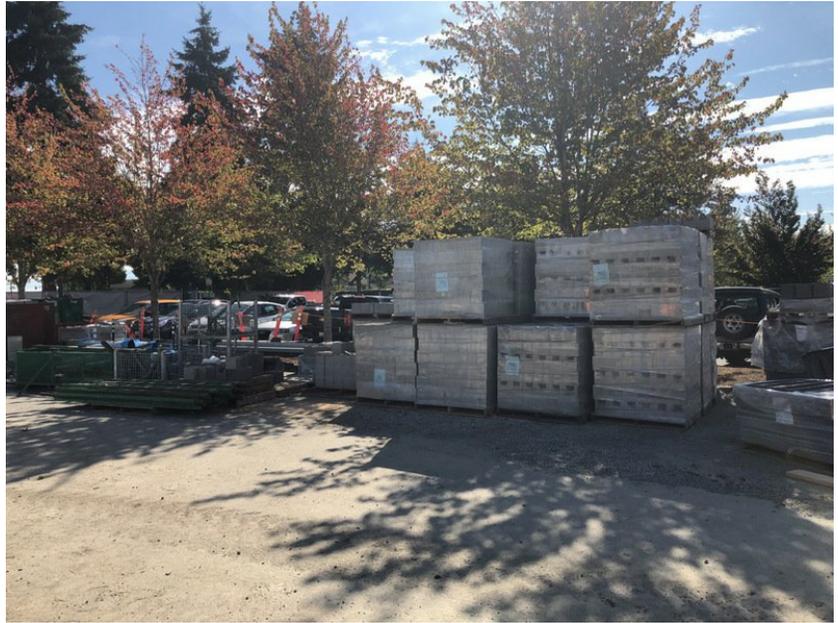
Masonry and other materials stored on site.

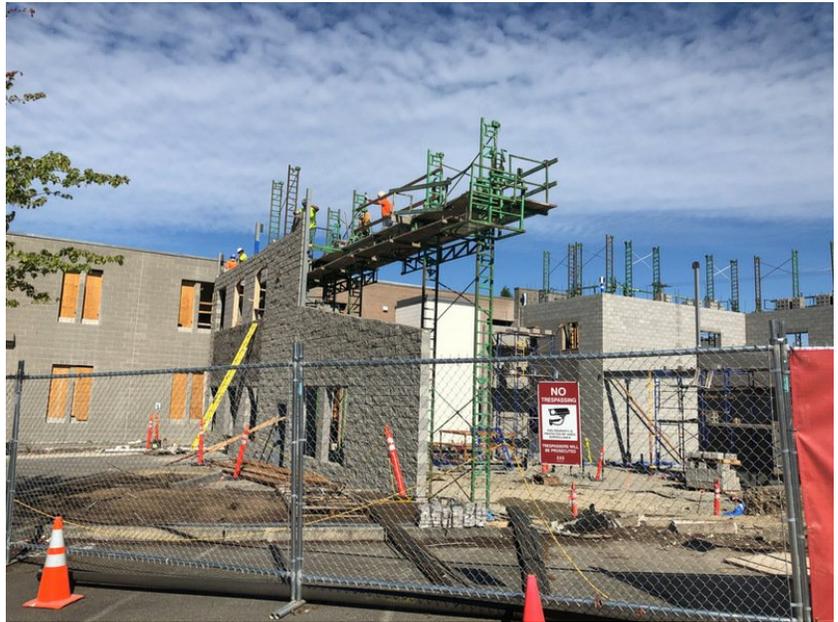
Masonry in progress . Photo facing (plan) southwest.

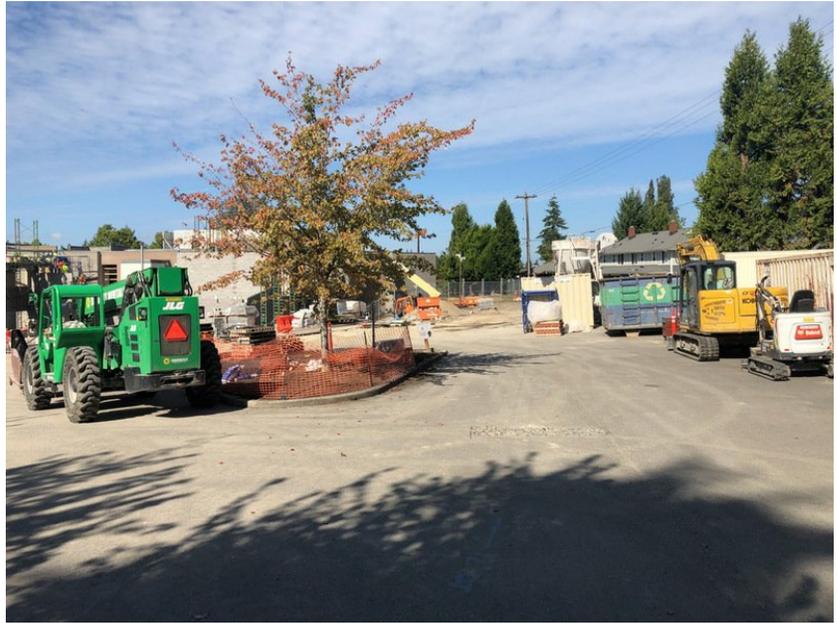
Equipment and materials stored on site.

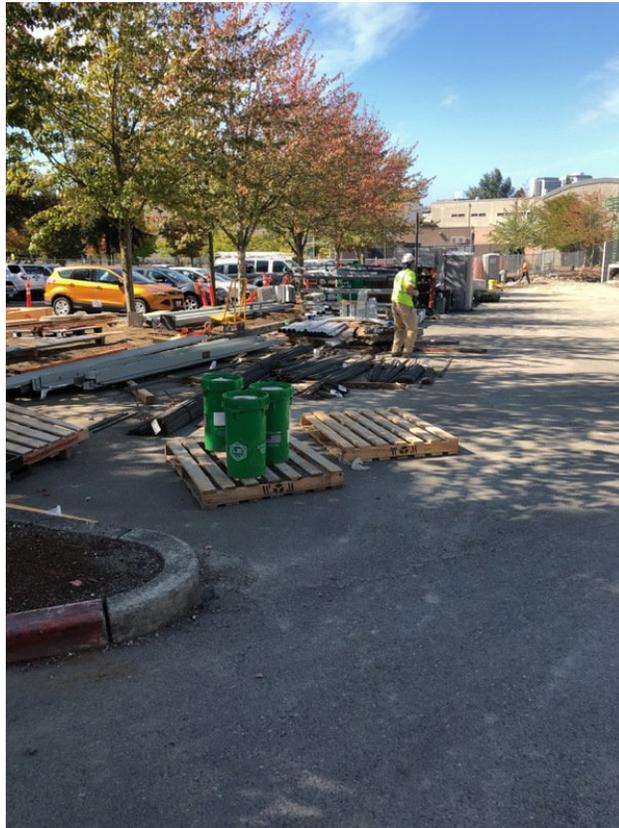
Materials stored on site.
