Project	North Sound Behavioral Health Treatment Center
Created	2020-09-21 10:27:29 PDT by Adam Johnson
Updated	2020-09-21 13:43:38 PDT by Adam Johnson

Project Name and Number	North Sound Behavioral Health Treatment Center - R16-180068.01
Location	902 Pine St., Everett, WA 98201
Observation Report No.:	17
Report Author	Adam johnson
Date of Visit	2020-09-21
Time of Visit	10:27
Weather Conditions	Cloudy
Temperature (F)	58
GC/CM	BN Builders
Site Walk By	Jeff Hencz, Steve Slawson (SnoCo); Kevin Fromm, Adam Johnson (OAC); Danny O'Brien (BNB)

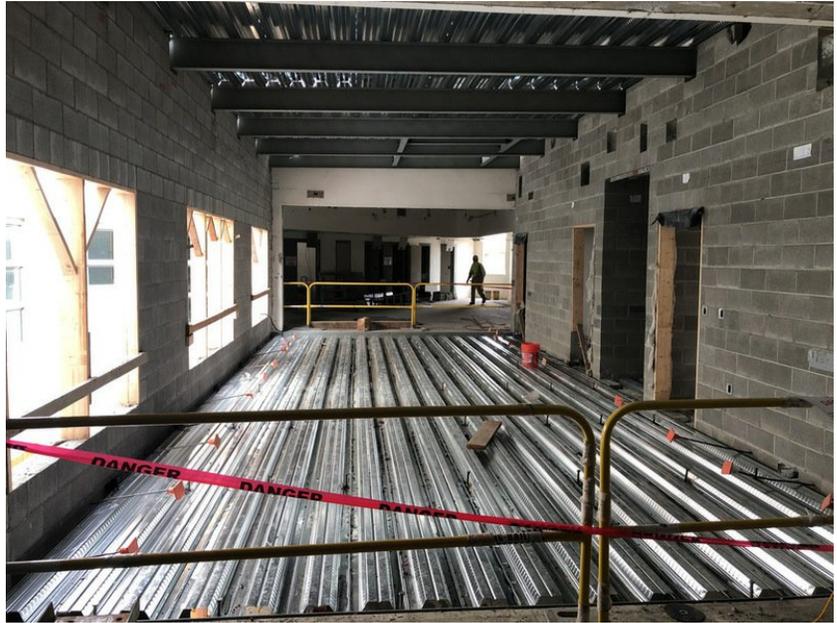
2nd floor light court area infill is in progress. Photo from the women's housing area facing (plan) west.

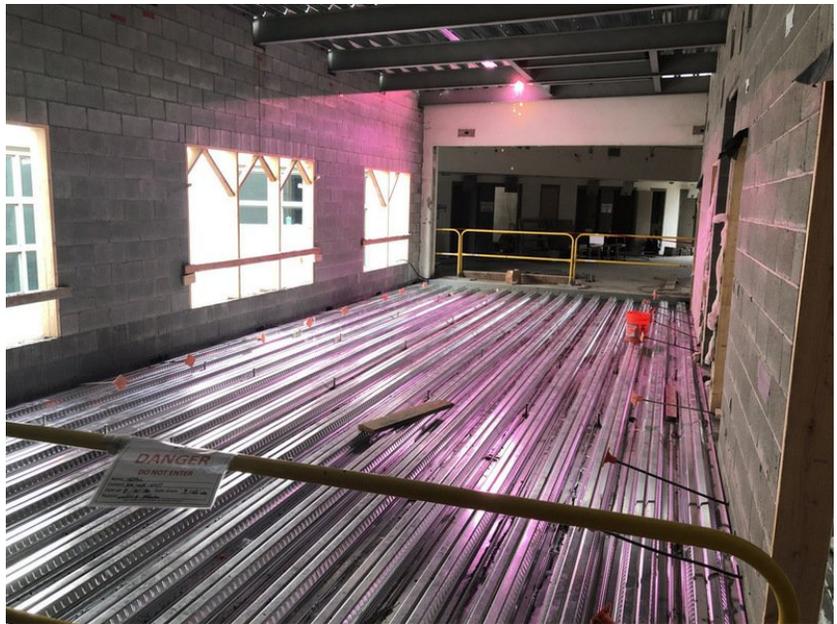
2nd floor light court area infill is in progress. Photo from the women's housing area facing (plan) west.

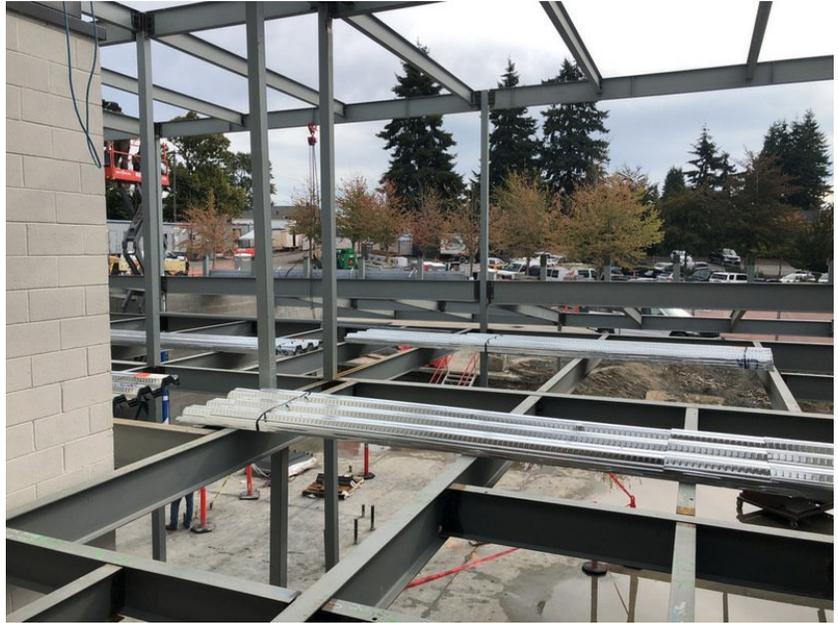
Steel erection and decking in progress in the admin area. Photo taken from the women's housing area facing (plan) north.

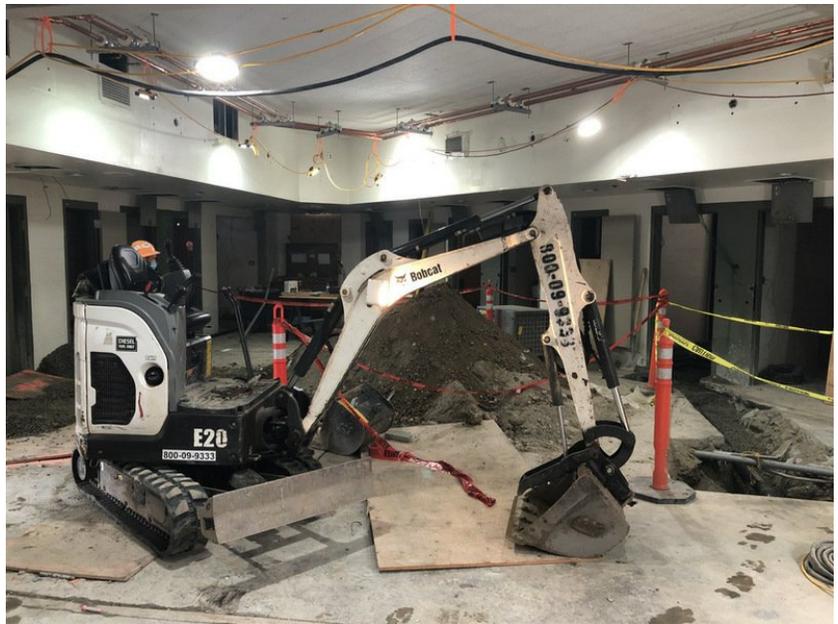
MEP rough-in in progress in the 1st floor women's housing area. Photo facing (plan) southeast.

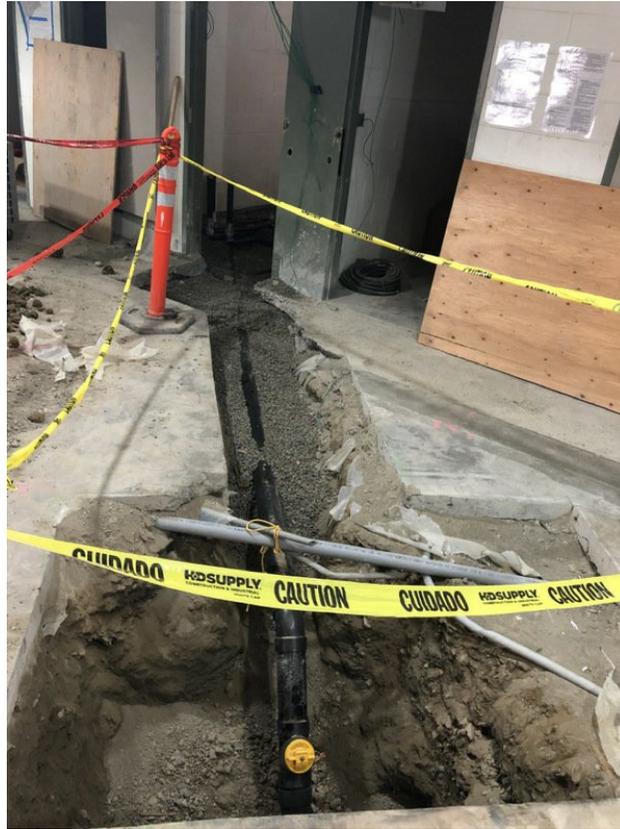
MEP rough-in in progress in the 1st floor women's housing area. Photo facing (plan) south.

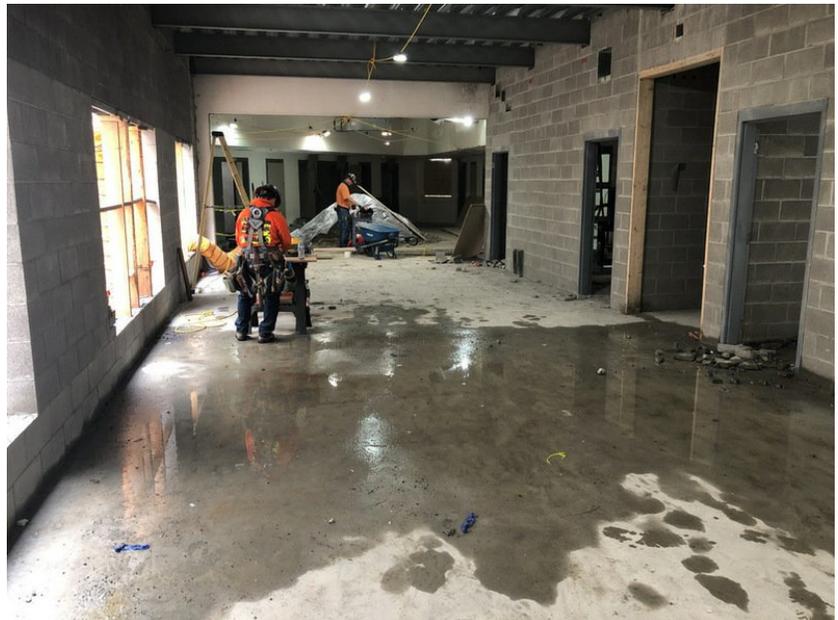
Slab-on-grade has been poured in the lightcourt in fill area. Photo taken from the women's housing side facing (plan) west.

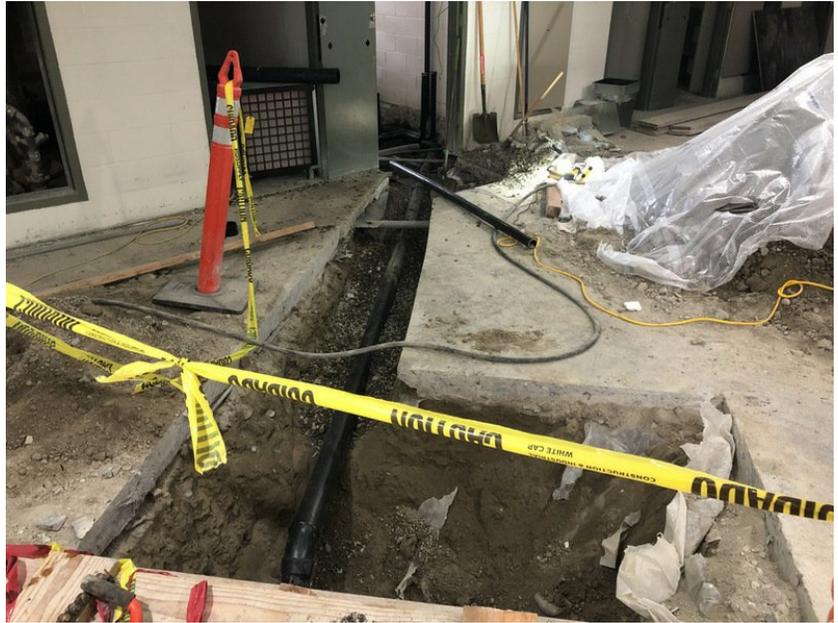
MEP rough-in in progress in the 1st floor men's housing area. Photo facing (plan) southwest.

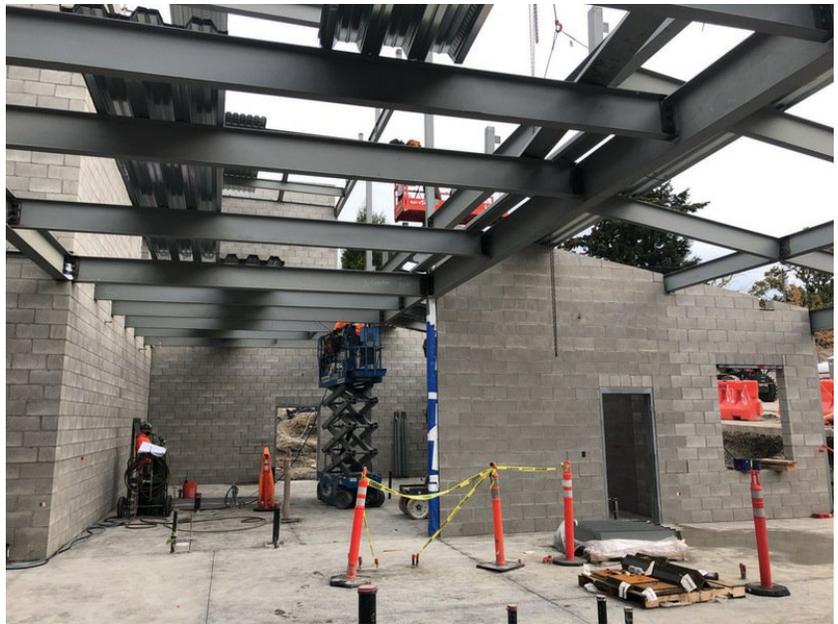
Steel decking installation in progress in the admin area. Photo facing (plan) west.

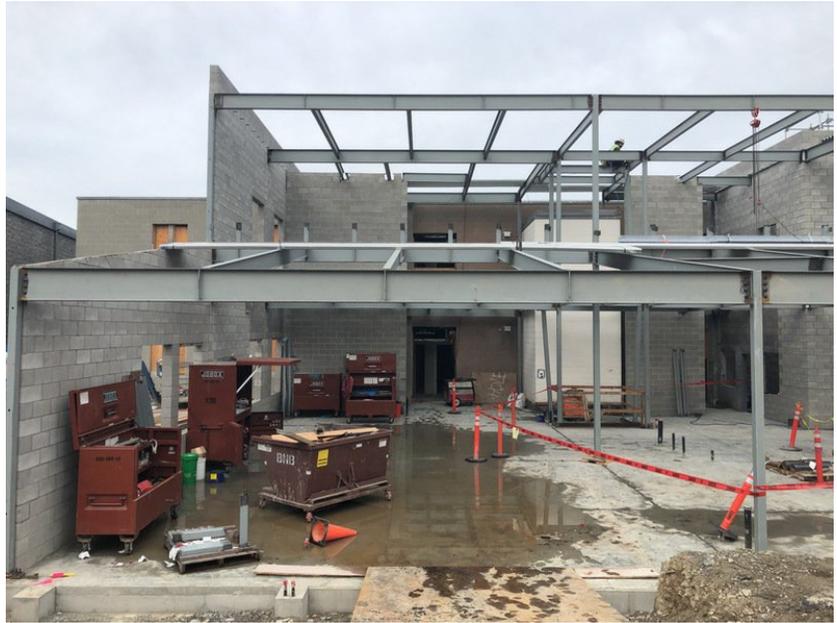
Steel decking installation in progress in the admin area. Photo of the (plan) east side, facing (plan) south.

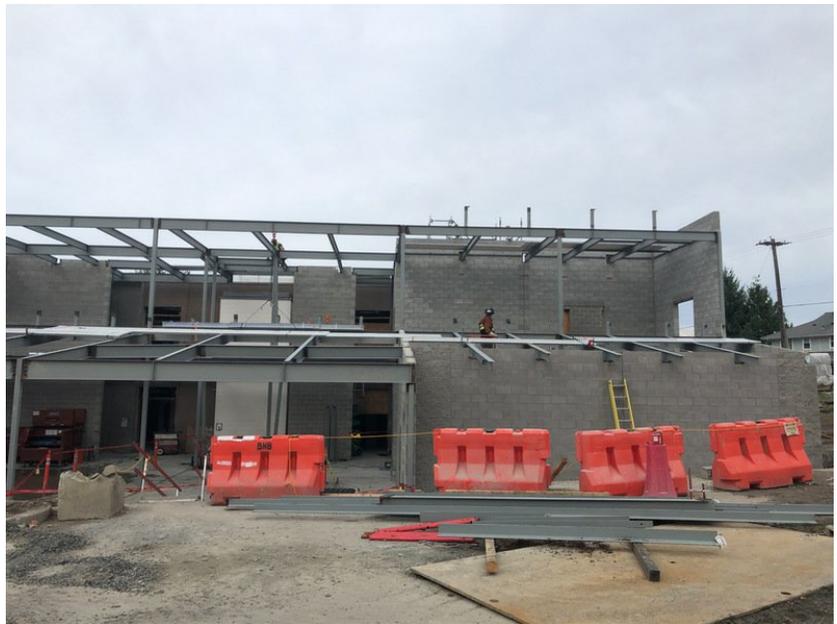
Steel decking installation in progress in the admin area. Photo of the (plan) west side, facing (plan) south.

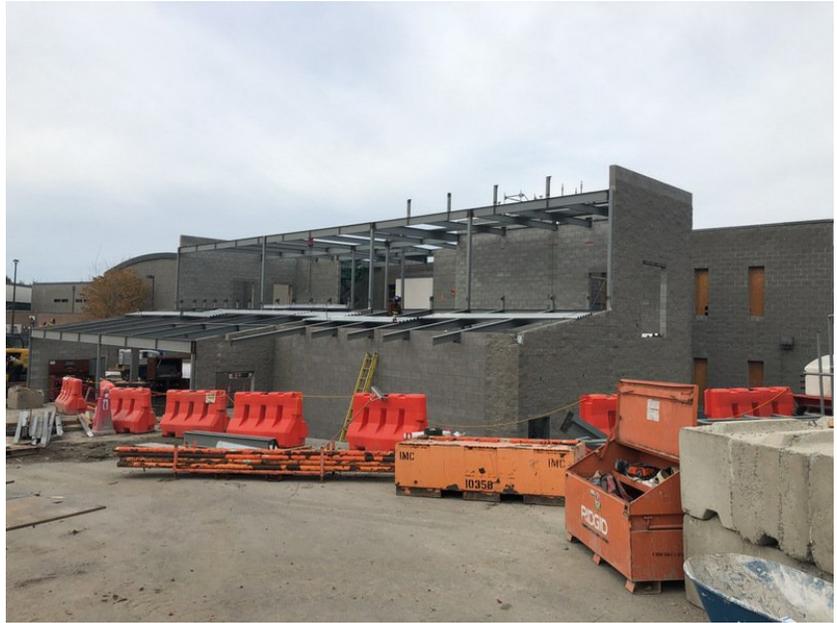
Steel erection and decking progress shown on the (plan) north elevations.

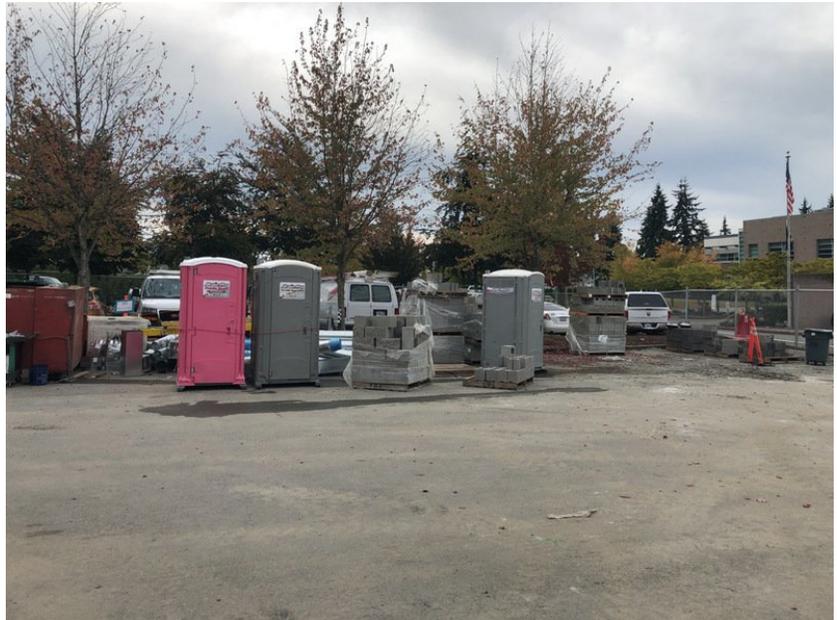
Material and equipment on site. 2 extra sanicans are staged for the water shutdown that was scheduled for 9/24 but has been moved to 10/3.

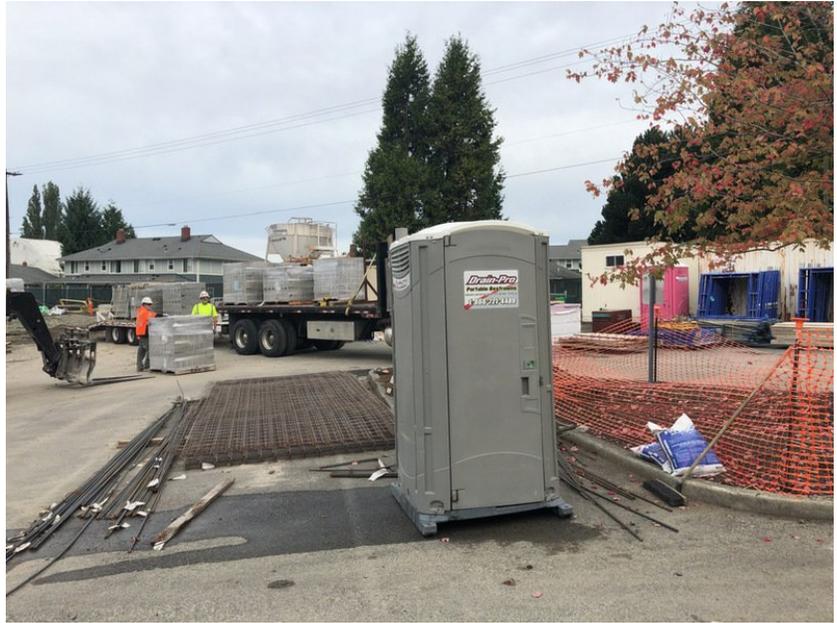
Materials on site. CMU was being taken off site during the site visit.
