Snohomish County Public Works Department
Surface Water Management Division

2009 Project Effectiveness Monitoring Program Report

Twin Creeks Recovery Project, North Creek, 5-year Monitoring Results

Twin Creeks Project – 5-year Engineering and Habitat Summary & Recommendations

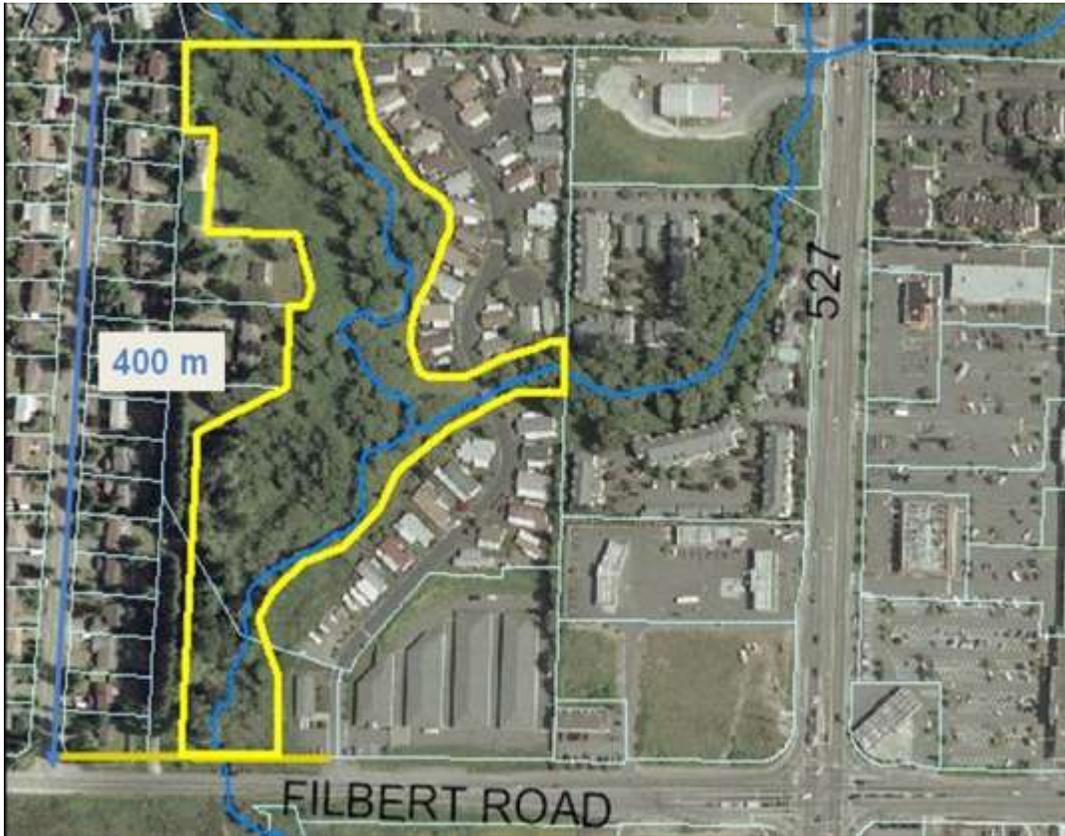
Figure 1. Twin Creeks project site. The yellow boundary shows the approximate conservation easement that includes Silver Creek (from the east) and North Creek (flow direction is top-bottom in figure). Photo is from 2003.

The Twin Creeks project is located (Figure 1) in North Creek in a low gradient (<1.0% slope) and generally unconfined stream reach, immediately upstream from 208th St SE (aka Filbert Rd.), at the confluence with Silver Creek. This location is cited as a critical stream reach for salmon habitat restoration in the WRIA 8 Chinook Salmon Recovery Plan (adopted by NOAA in 2007), in part, because this reach was ranked highly for its protection and restoration value based on Ecosystem Diagnosis and Treatment (EDT) modeling implemented for the WRIA 8 Technical Advisory Group (Mobrand Biometrics 2003). Within the project vicinity there is low to medium density residential land use. Between here and the City of Mill Creek (upstream) is the least developed area along the mainstem within unincorporated Snohomish County and retains the widest stream buffer

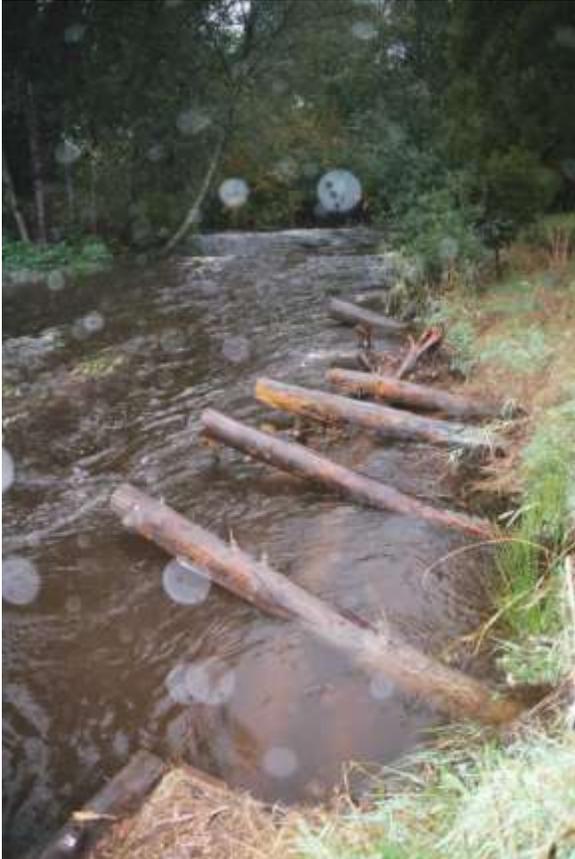
Figure 2. LWD pieces impaled into streambank as part of larger LWD debris jam (27 pieces).

- Impaling LWD into streambanks may have destabilized some banks at this site directly or indirectly due to wood buoyancy/vibration during flooding.
- Don’t anchor wood that is large enough to form pools based on minimum functional diameter and if length is greater or equal to bankfull width.

At the erosion hazard mentioned above, 27 pieces LWD were placed and anchored together along the streambank. Several pieces were impaled higher than others (e.g., Figure 2). No new erosion has occurred at this location since project implementation. We observed flooding in 2003 produced no erosive flows at the streambank margin. In fact,

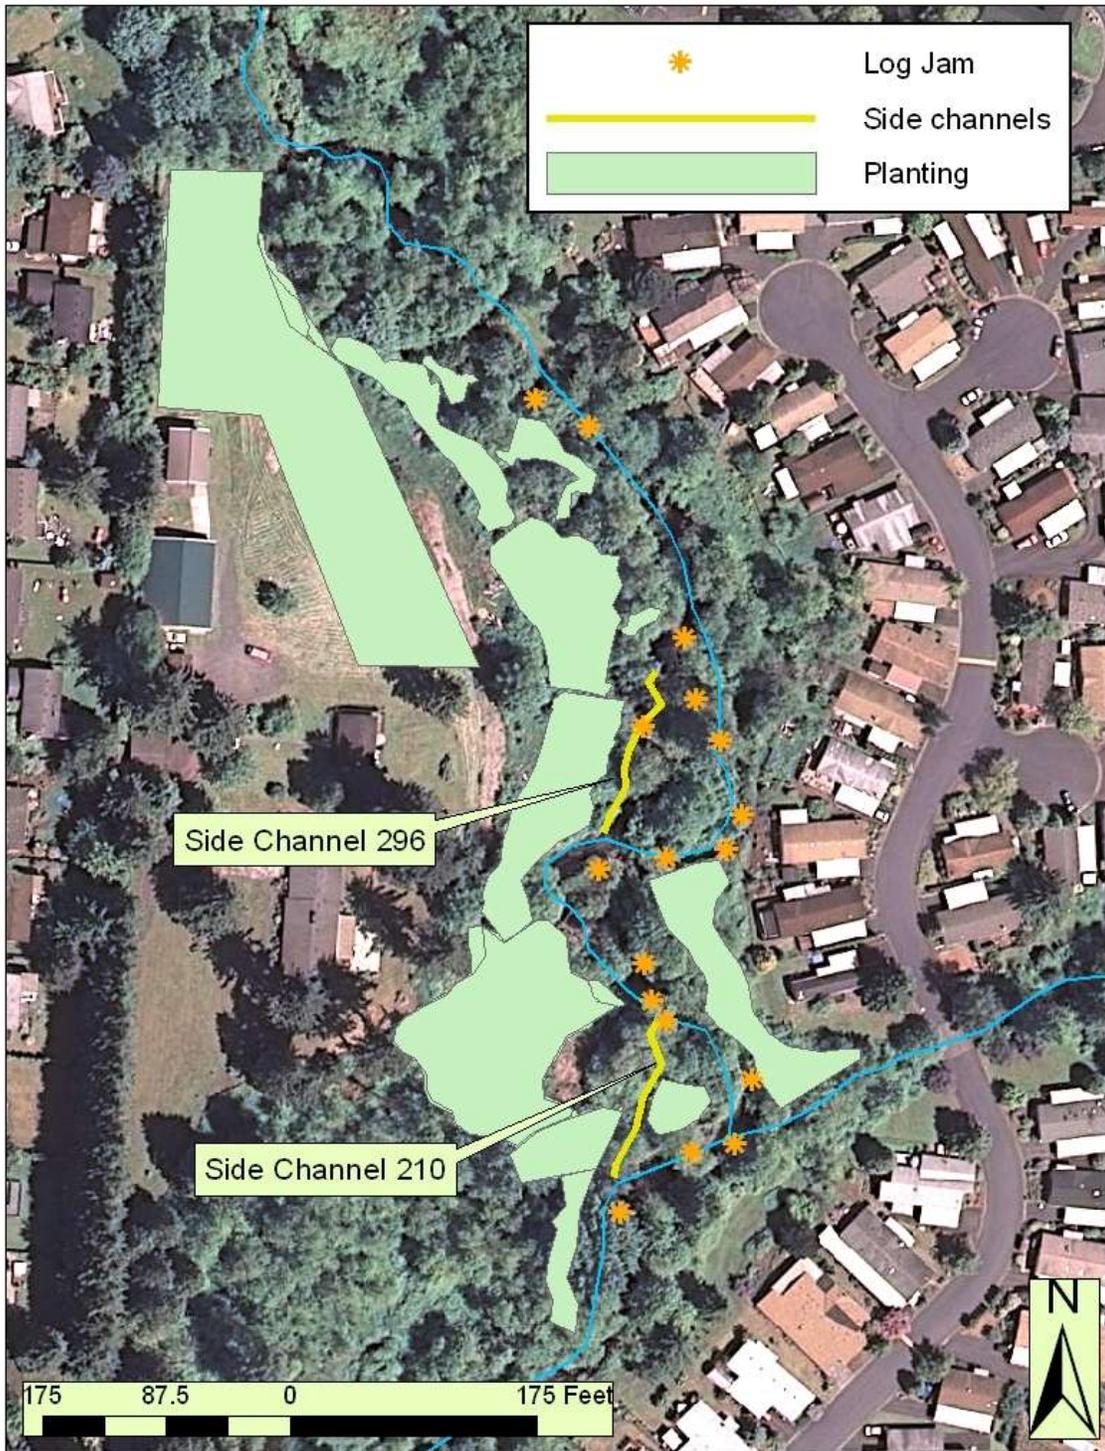
Figure 3. Twin Creeks treatment area.

Overall, LWD was placed in 17 locations (Figure 3), mostly in 12 LWD jam formations. In total, 124 of 170 pieces (73%) were placed in LWD jams, where at least 6 pieces touched together. Of these, 82 pieces were anchored and 42 were not anchored, but were set into the streambanks as described above. Individually, jams contained 6-27 pieces.

6740 plants, 1240 of which were conifer trees, were planted among 3.7 acres of the approximately 8-acre conservation easement over a span of five years (2003-2008, Figure 3). Prior to planting, extensive fields of mostly Himalayan blackberry were cleared from the 3.7 acres. Other knotweed species were also removed by hand and treated with aerial foliar spray approved by Washington State Department of Ecology for aquatic applications.

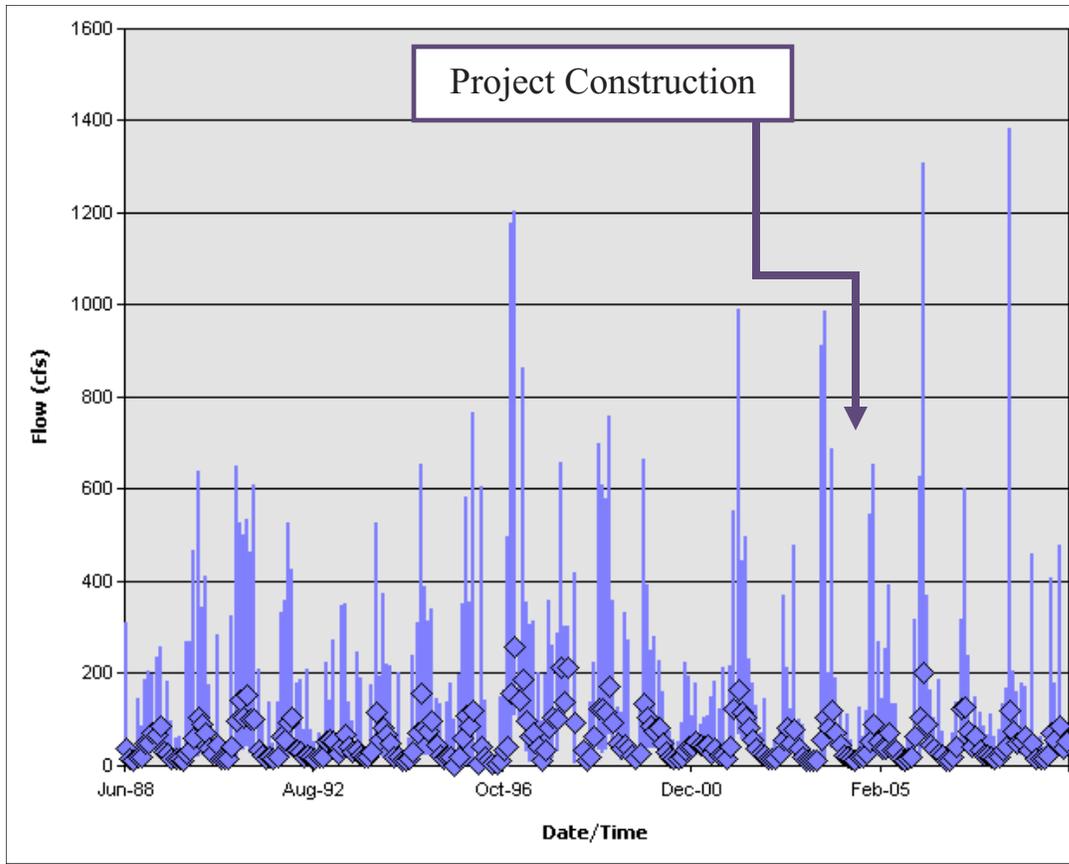
Figure 4. North Creek monthly mean flow discharge recorded at 240th Street SE, 2.5 miles downstream from Twin Creeks.

Since the project was constructed in August 2003, several significant flood events have occurred in 2003 (October and November), 2006 (January) and 2007 (December) (Figure 4 of flows at 240th St SE). The estimated daily peak flows associated with these 4 floods were, respectively, 387 cfs, 536 cfs, 702 cfs and 1415 cfs. These flows ranged in approximate recurrence from 25-100-year intervals (based on tables from Draft North Creek Flood Hazard Reduction Plan, CH2MHill, 1995) and appear to be larger than most recent floods since stream gaging began in 1988 (Figure 4).

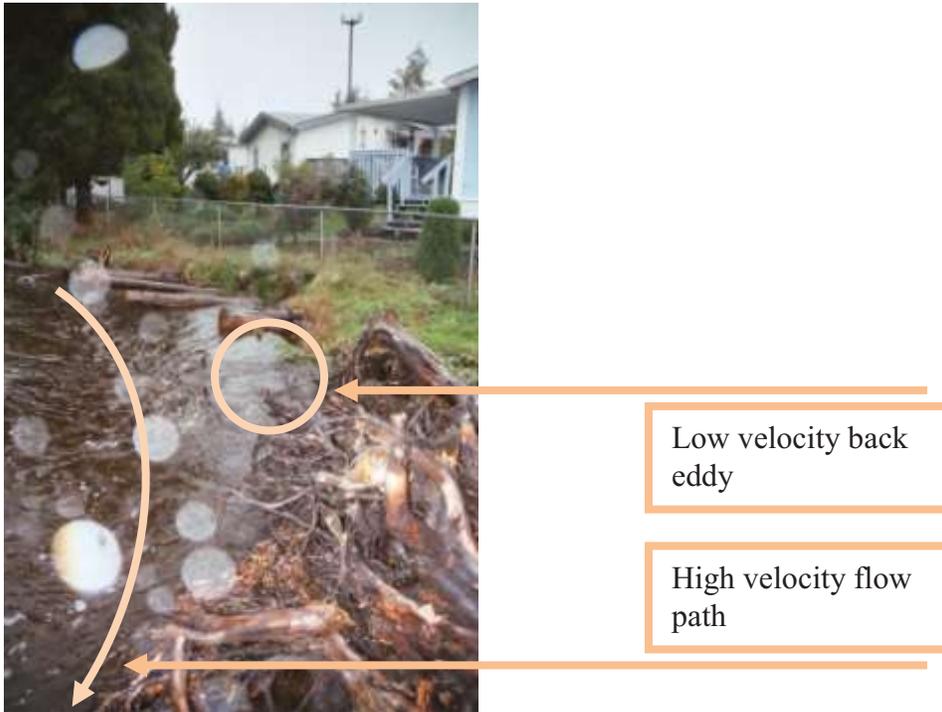
Figure 5a. Mobile home bank stabilization site during October 2003 high flow event.

wood placed at this location appeared to create low velocity eddies (Figure 5a). In five years, no additional woody debris has recruited to this location, potentially due to the channel shift described below. This location is now part of a side channel that has narrowed from vegetation encroachment, but nevertheless still supports summer base flow (Figure 5b).

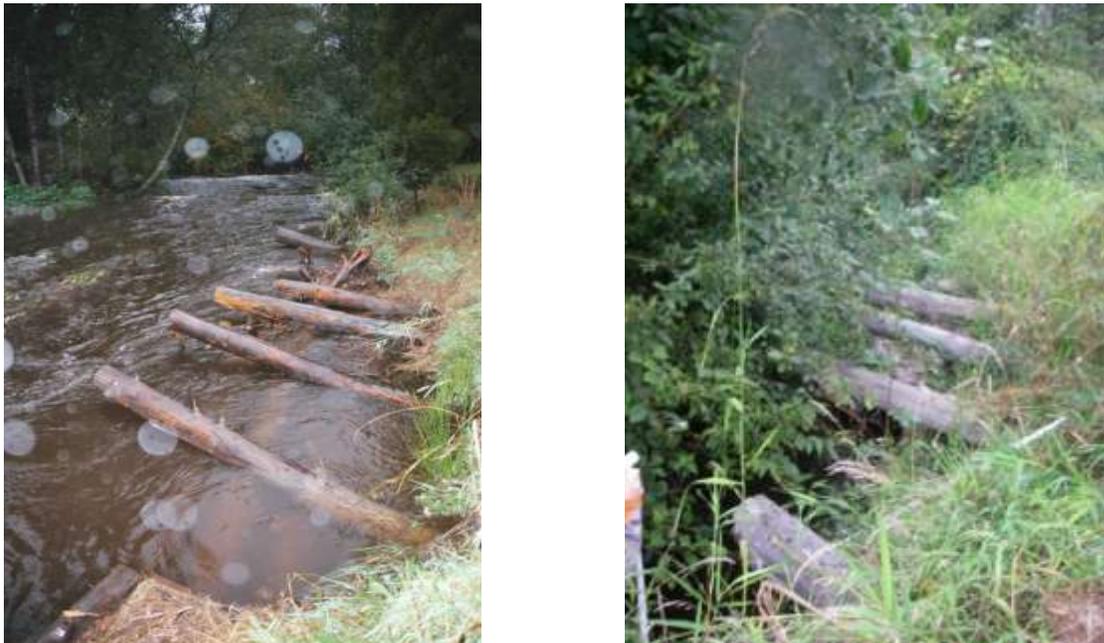
Figure 5b. Mobile home bank stabilization treatment in 2003 (left) and 2008 (right).

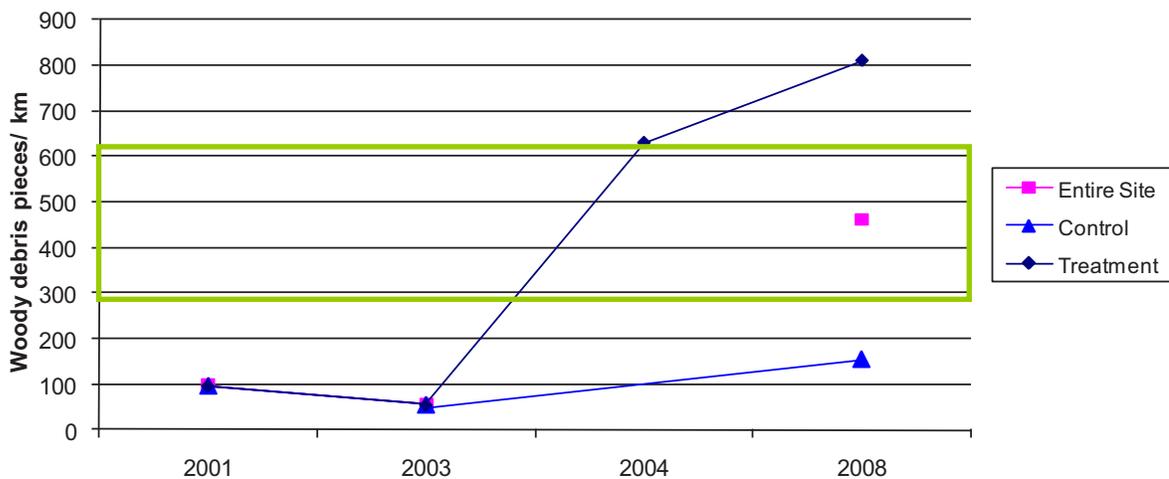
Figure 6. Changes in woody debris frequency among years in the control and treatment areas. Boxed area represents 25th-75th percentile suitable condition range in Fox (2001).

consideration as LWD (>7.6 m/>30 cm). The complement of restored LWD, in addition to existing smaller wood exceeded most woody debris abundance thresholds in 2004 (Table 4). In particular, woody debris frequency exceeded 350 pieces per kilometer in the entire project area (Figure 6), with an even higher abundance in the LWD treatment area. This increase is all the more evident based on 5th-year monitoring in 2008. In the treatment area, woody debris frequency was estimated to exceed 800 pieces/km. LWD frequency in natural forested areas in western Washington ranges from 241-643 pieces/km (Ralph et al. 1994), 225-1,087 pieces/km (Beechie and Sibley 1997) or 292-634 pieces/km (Fox 2001), as reported in these studies. Thus, for the time being, there is a robust wood load.

Whereas all wood debris abundance and frequency estimates appear to meet or exceed suitable habitat criteria, Table 4 shows that the largest class of LWD that would be considered a "key" piece is not present at Twin Creeks based on definitions of such pieces (i.e.; NOAA 1996; WFBP 1997). It is believed that many pieces placed at Twin Creeks act as key pieces for pool formation, sediment storage, future debris entrainment, and channel planform control because numerous pieces are longer than the average bankfull width of 9.4 meters (30 of 170 pieces placed are >9.4 m), many have root wads >1 m diameter (15 out of 30), and most large pieces are anchored (26 out of 30), thereby attaining a greater effective mass contributing to flow resistance.

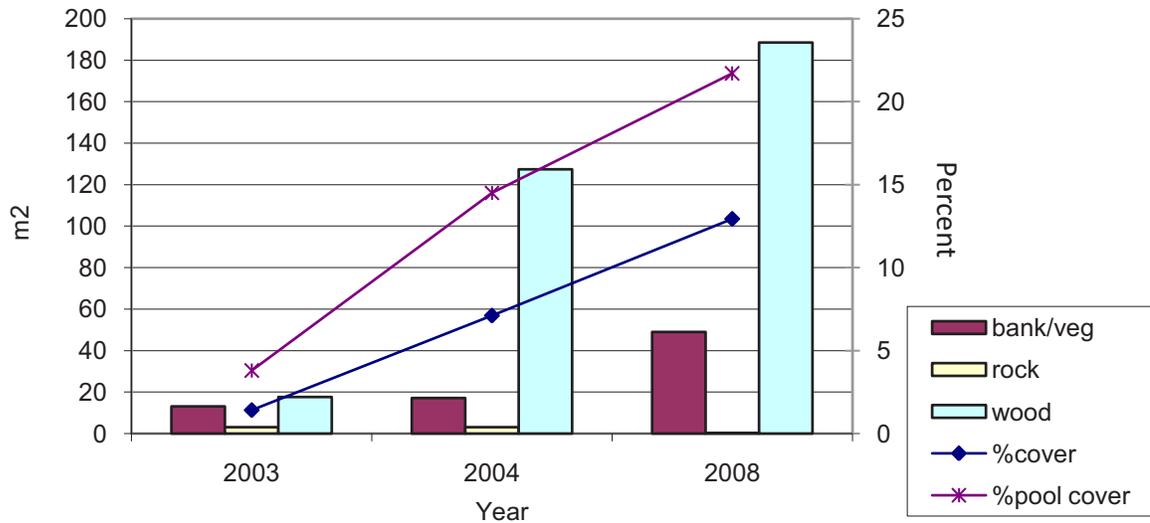
Figure 7. Total fish concealment cover by cover type, as a percent of total wetted area and as a percent of cover over pools.

We observed a 10-fold increase in the amount of wood-formed cover between 2003 and 2008 (Figure 7), due to both an increase from placed wood and from newly recruited wood in 2008 (Figure 8). In 2004, 90% of wood cover was attributed to wood placement. In 2008, 50% of wood cover was attributable to natural wood cover. The decrease in total amount of cover from placed wood reflects the reduction in number of wood formed pools (from placed wood) and apparent channel adjustment away from anchored wood locations as discussed earlier.

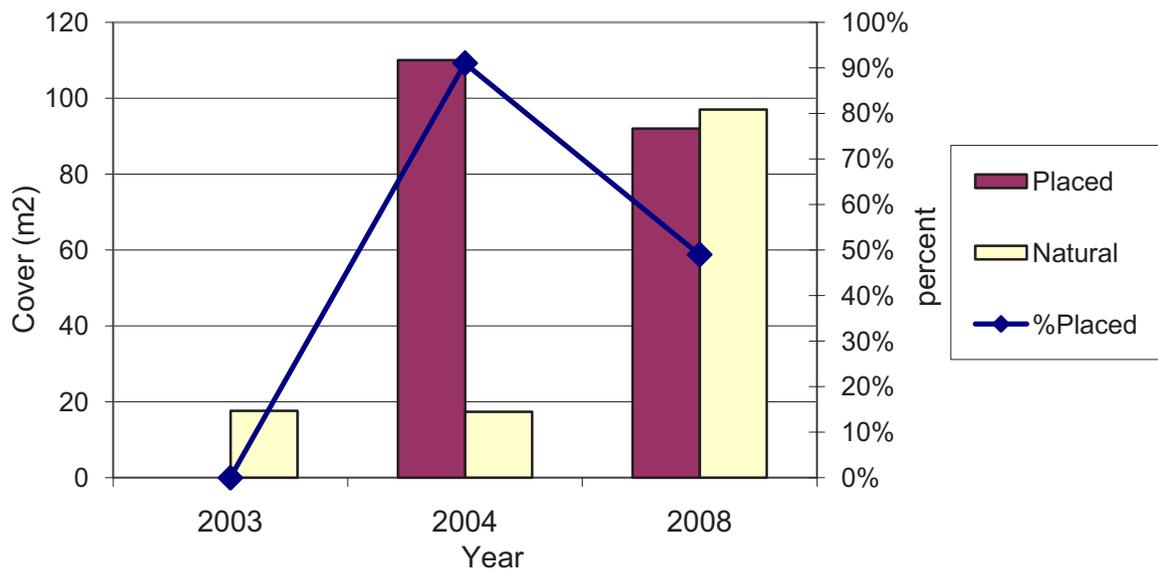
Figure 8. Total cover (m²) and percent cover by woody debris between placed and natural wood categories among monitoring years.

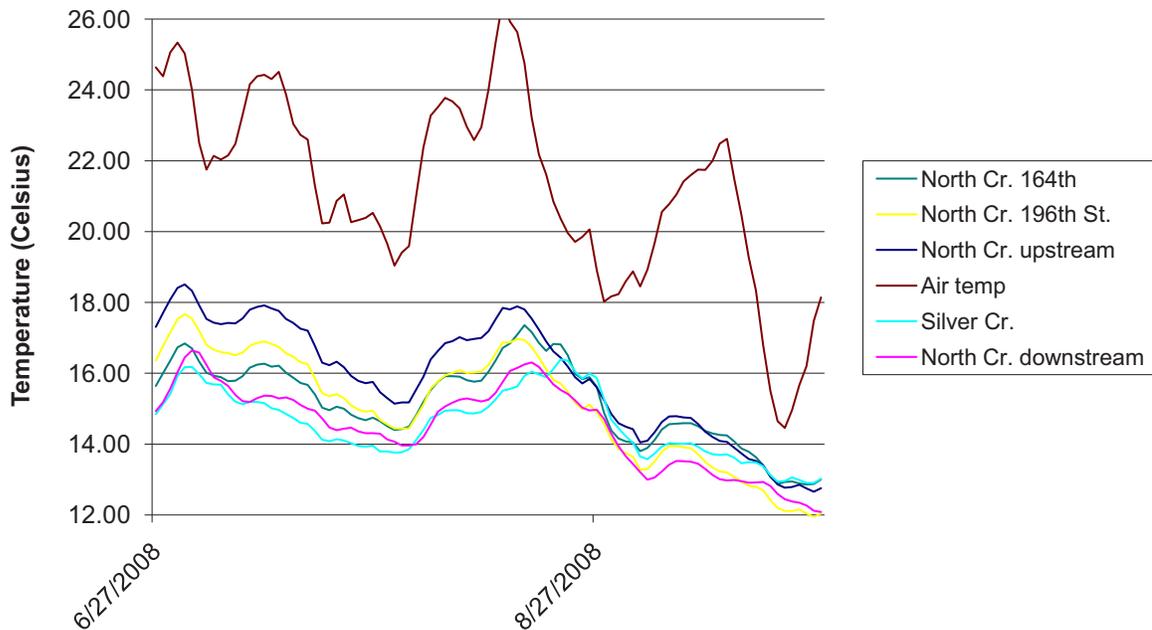
Figure 9. North Creek water temperatures among several sites over three months. Legend site labels correspond with upstream-to-downstream sample locations separated over three miles.

In 2008, temperature data were also available from other North Creek locations upstream from our project site, including at 164th St. and 196th St (Figure 9). The temperatures at these locations are cooler than at Twin Creeks. In general, water temperature appears to increase in a downstream direction over the course of several miles. At the 196th St stream gage, temperature exceeded the temperature standard 3.2% of the time (3 days) in 2008. Between 196th St. and the Twin Creeks project site, downstream warming in this ¾ mile segment of North Creek led to three weeks additional water temperature exceedance in 2008, until becoming abruptly cooler at the confluence with Silver Creek.

Silver Creek appears to buffer water temperature the most in North Creek (at least downstream to our sample site) during the warmest days. We found the absolute difference in temperature ranged from 0.26-2.6° C and this absolute difference was strongly correlated with air temperature ($r^2=0.72$), presumably because stronger groundwater influence in Silver Creek (originating from Sulfur Springs Creek) kept Silver Creek temperatures comparatively low no matter the air temperature. That is; temperature variability in Silver Creek was low relative to daily air temperature fluctuations and as compared to the upstream North Creek location.

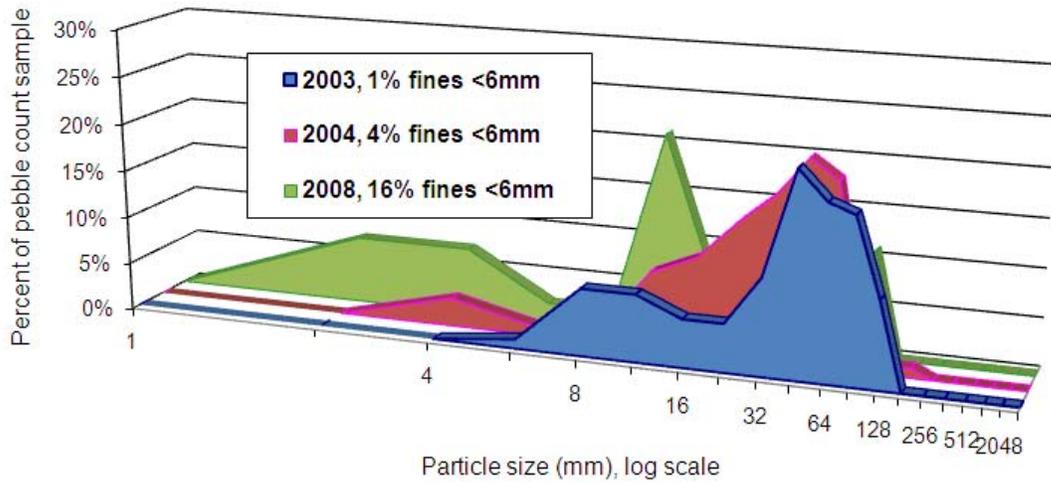
Figure 10. Twin Creeks, pebble count site #3, substrate particle size distribution among sample years and percent fine sediment <6mm, as measured by pebble count methods.

Although sampling among sites in 2008 was incomplete, the abundance of more fine sediment is visually apparent. At site # 3, in particular, the substrate size composition among years demonstrably becomes finer as more of the total substrate sample falls into finer size class categories (Figure 10). The change in abundance of fine sediment may be widespread in North Creek, but also may be localized to the project site. As indicated, new erosion of banks and side channel expansion would have supplied fine sediment to North Creek at this project. A 40% channel expansion in Silver Creek, as measured, also could have delivered fine sediment to North Creek. Other field surveys of North Creek (and tributaries) proposed for 2009 will allow us to estimate whether fine sediment at Twin Creeks is locally elevated, reflecting major project changes, or is more widespread, reflecting wider watershed disturbance.

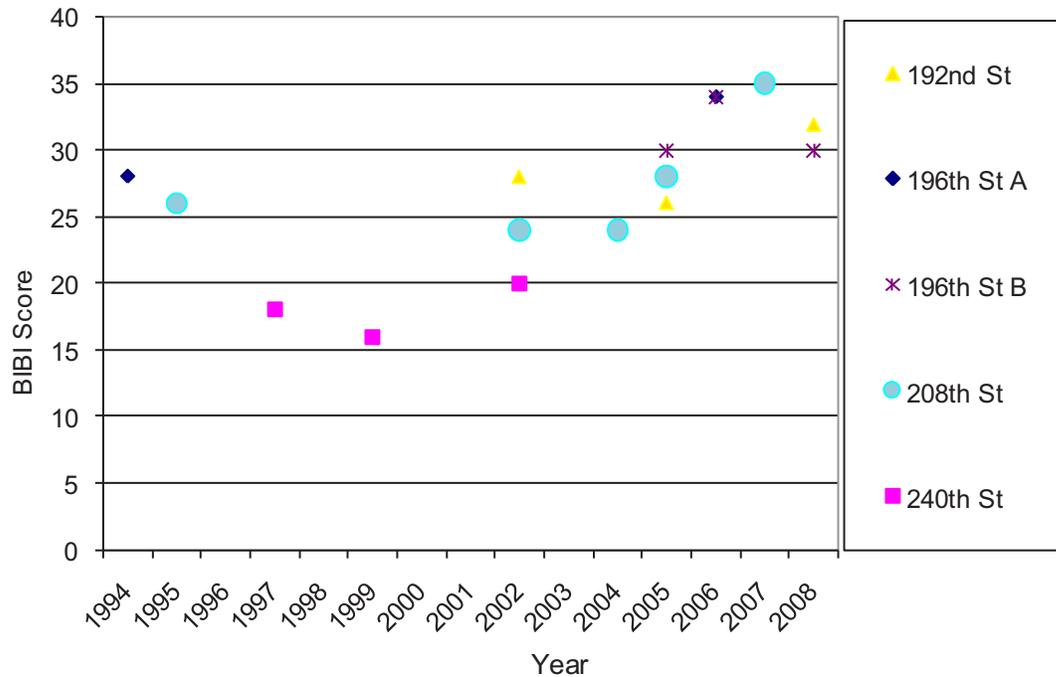
Figure 11. North Creek B-IBI values among several locations, including Twin Creeks (@208th St). Sample locations are denoted by nearest cross street and are ordered north to south, spanning 3.6 stream miles (192nd-240th). Sampling occurred in 2 years prior to project implementation in 2003 and three years post-project implementation.

The biotic integrity at Twin Creeks as measured by 10 metrics of the stream benthic invertebrate community was first estimated in 1995. Other locations in North Creek have also been monitored for biotic integrity in the last 15 years. Biotic integrity index values for Twin Creeks are shown in Figure 11. Whereas there appears to be an increase in biotic integrity scores after project implementation in 2003, other North Creek locations also appear to increase during this time, limiting interpretation of restoration effectiveness relative to wider improvement (or upward variance) in B-IBI scores. After sampling in 2008, the B-IBI score at Twin Creeks appears to be the highest in all of North Creek, suggesting additional improvement is not likely. Future sampling at Twin Creeks and elsewhere among urban(izing) subbasins will help us to interpret existing status and future changes in B-IBI at Twin Creeks.
