**Centennial Clean Water Fund
Integrating Stormwater Water Quality Management**

**Macs Blue Spruce
Native Growth Protection Area (NGPA)
Management Plan
2007 to 2009**

Section I: Restoration and Vegetation Management Plan, 2009

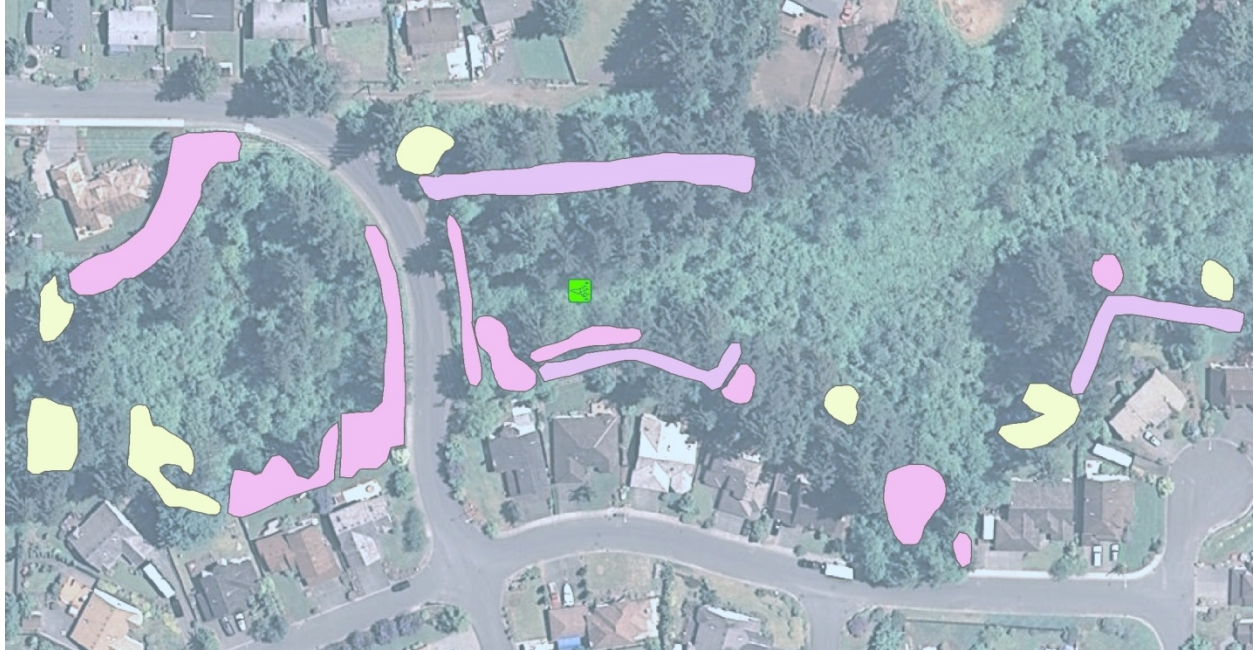
Primary invasive plant removal and planting areas at Mac's Blue Spruce by plant community type

Approximately 52,000 square feet.

Weed removal and treatment areas were replanted with native plants. Planting areas were delineated as three different community types: Deciduous edge, Mixed Conifer interior, and Wetland Edge. Deciduous edge accounts for approximately 25,000 sq ft.; Conifer interior totals 13,000 sq ft; and Wetland edge represents 13,000 sq ft.

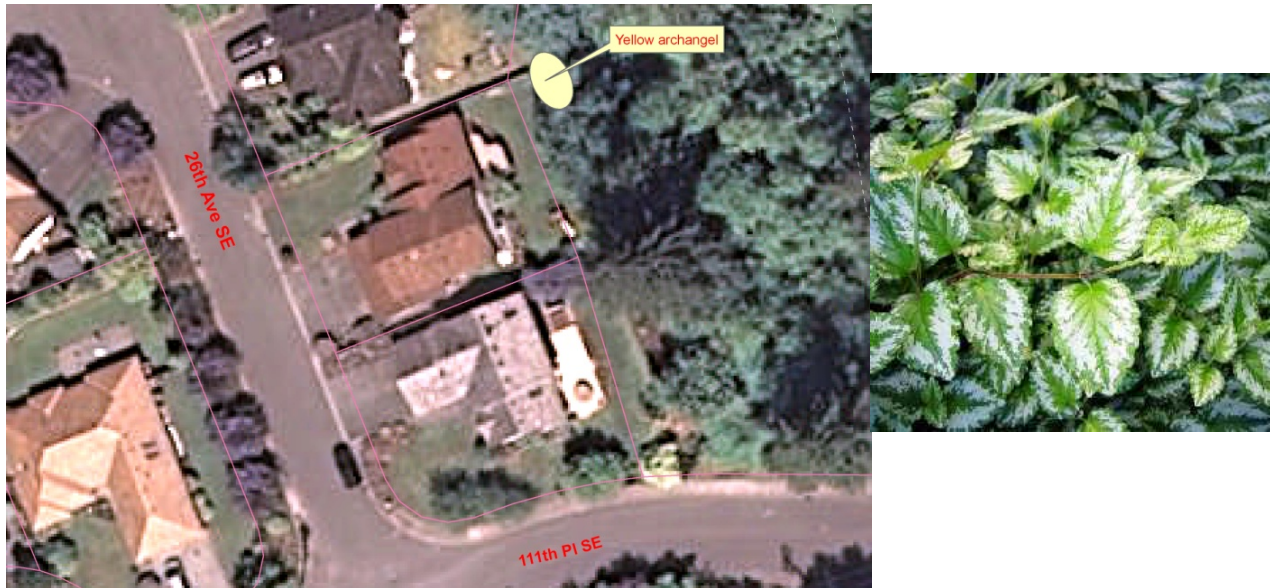
1. **Yellow archangel** (*Lamium galeobdolon*): is a highly invasive woody vine of shady forest floors that quickly forms dense blankets of leafy vines smothering any native ground covers. Rarely climbs. Once established it is difficult to eliminate this plant without a high amount of collateral damage to existing plants. Often starts with discarded house plant at the NGPA edge.

There is one known infestation in the NGPA located in the northwest corner behind two adjacent homes on 26th Ave SE. It is still a relatively small patch approximately 3 x 5 ft. The patch was treated with glyphosate during visits summer of 2009.

Treatment: behaves much like bindweed – resprouts from root fragments, roots are shallow but break easily. On small patches it may be possible to succeed with diligent digging and grubbing on a regular basis throughout the spring and summer. Small patches may respond to sheet mulching with cardboard and wood chips.
