Subsurface Conditions Report

Point Wells Redevelopment Snohomish County, Washington

Prepared for
BSRE Point Wells, LP

April 20, 2018
17203-54

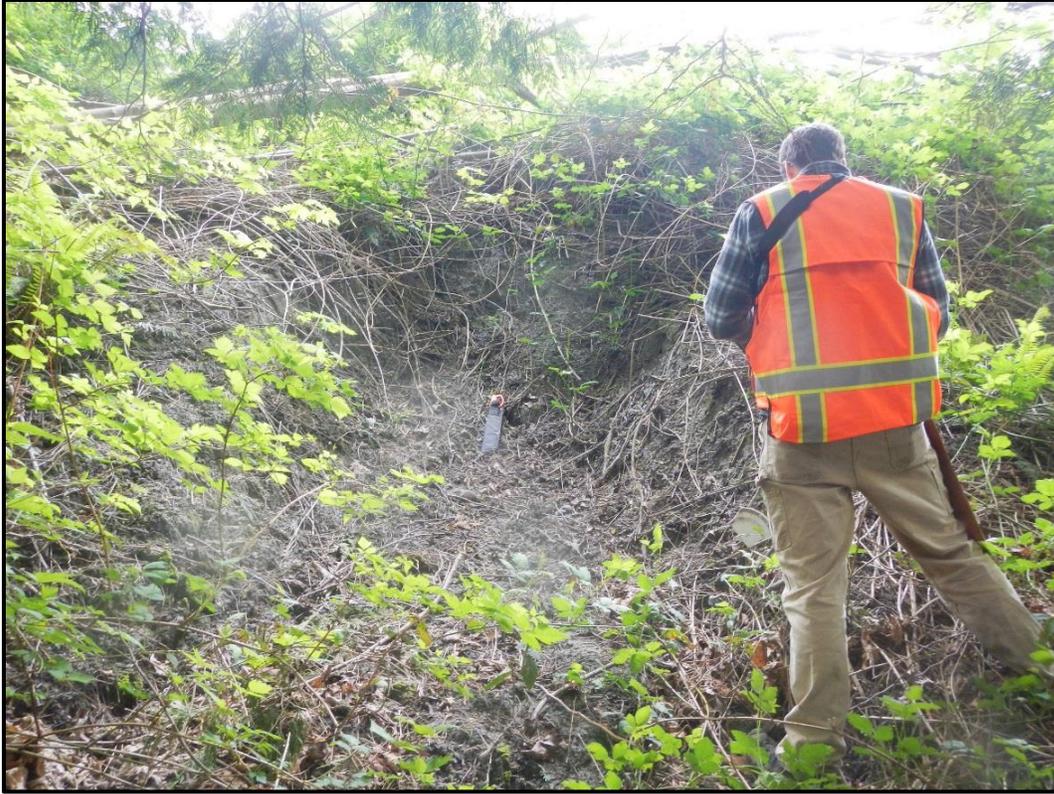
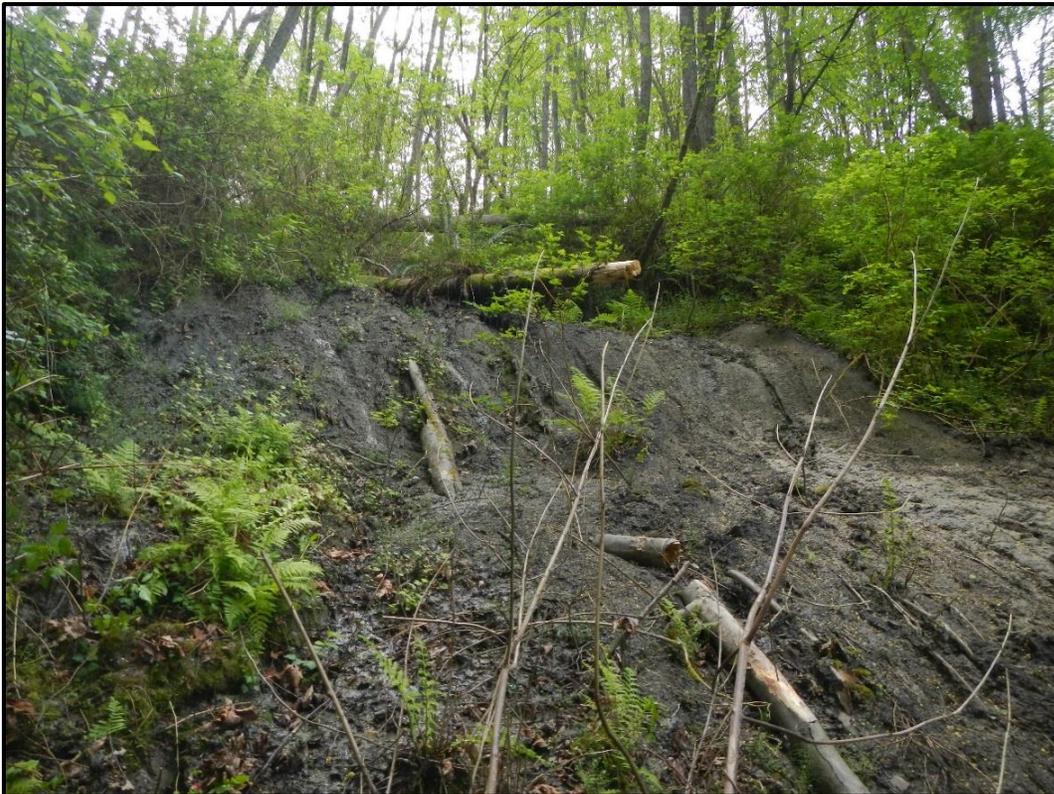
Photographs 1 (top) and 2 (bottom): Localized small landslides near Drainage 1.

Our observations found recent landslide activity to be primarily confined to the immediate vicinity of the drainages and likely the result of erosion at the toe of the slope and saturated soil conditions resulting from seeps and springs on the hillside. Examples of these slides are shown in Photographs 1 and 2.

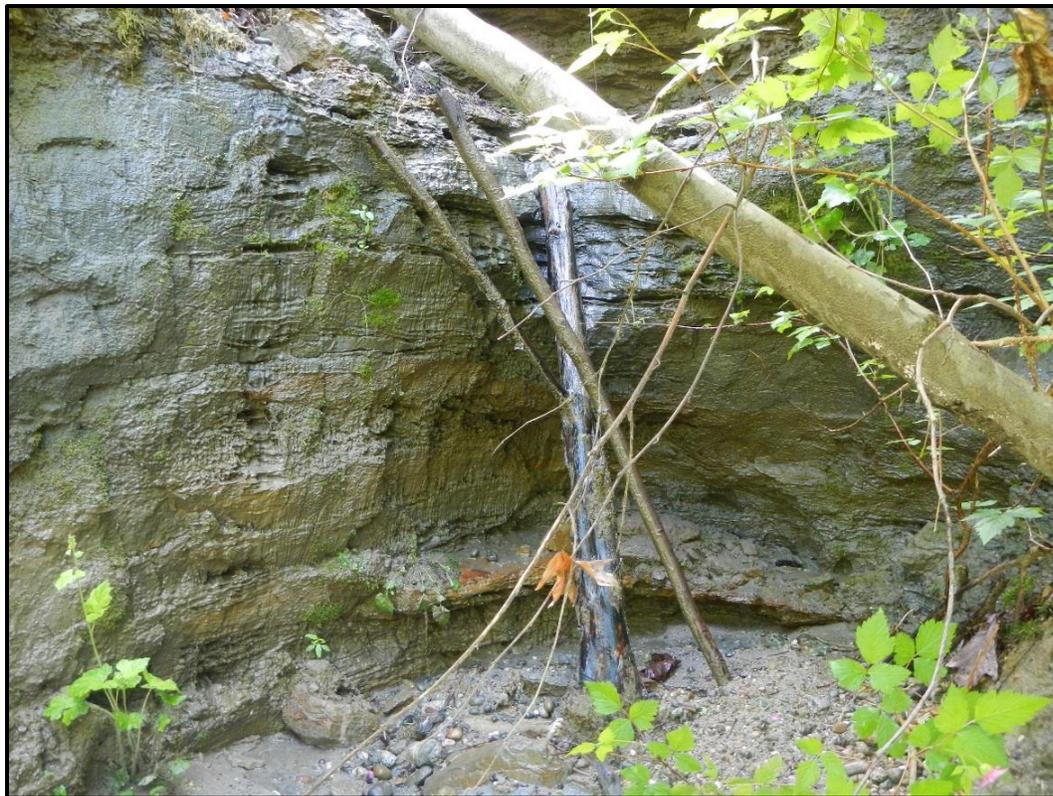
Photograph 3: Creek forming from seepage at the Advance Outwash-Lawton Clay contact.

Evidence of larger block slides and bluff erosion was observed along the northern portion of the upper bluff. At the base of the upper bluff, where the Advance Outwash-Lawton Clay contact could be observed, seeps within the Advance Outwash formed a small creek (Photograph 3).

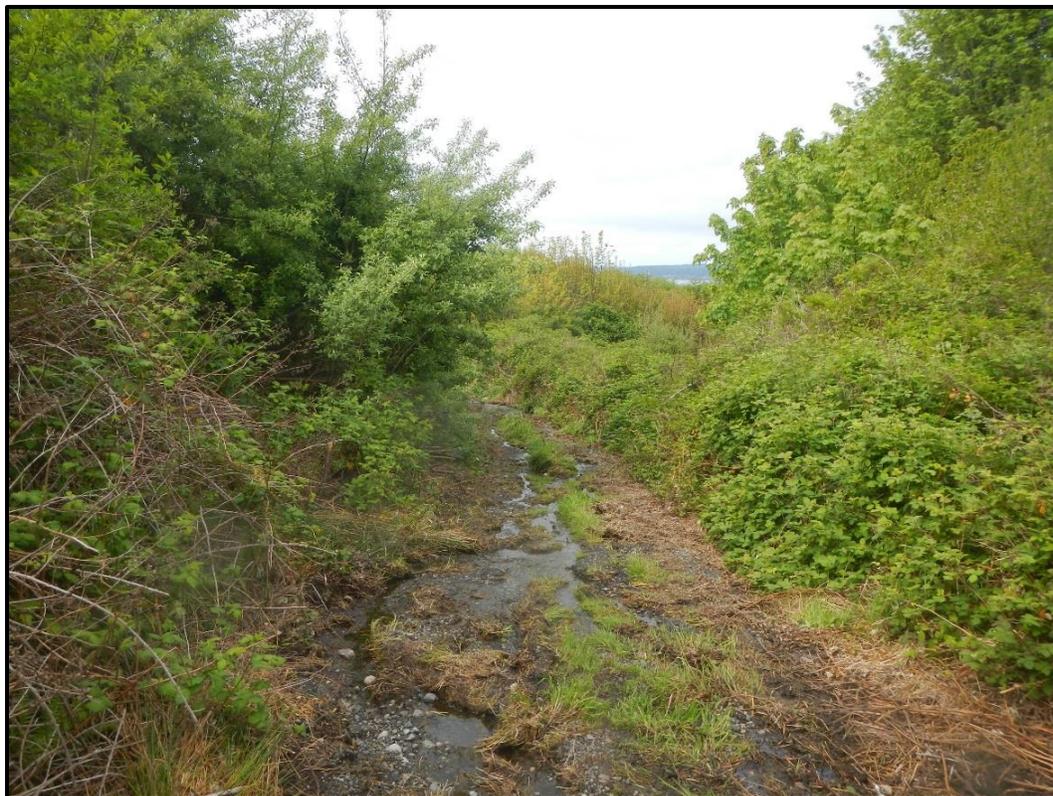
Photograph 4: Surface runoff at gate to the private property at the top of the slope, above Drainage 2.

Drainage 2 begins at approximately elevation 235 feet, where a storm drain discharges to the surface near the private property gate at the end of 238th Street Southeast, as shown in Photograph 4.

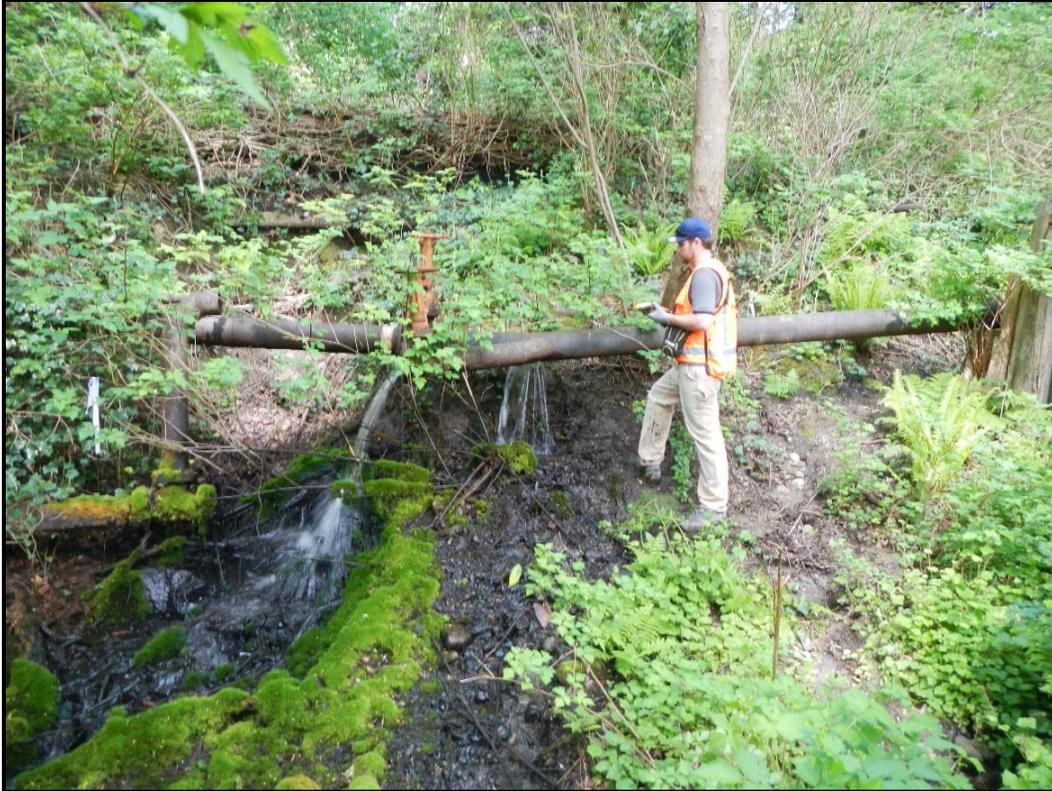
Photograph 5: Leaking pipes below retention pond in Drainage 1.

Numerous pipes that are mostly buried and likely related to historical Chevron activities at the top of the slope were observed near Drainage 1. As mentioned above, one of these was leaking near the upper retention pond, as shown in Photograph 5. It is unclear whether water is conveyed through the other pipes.

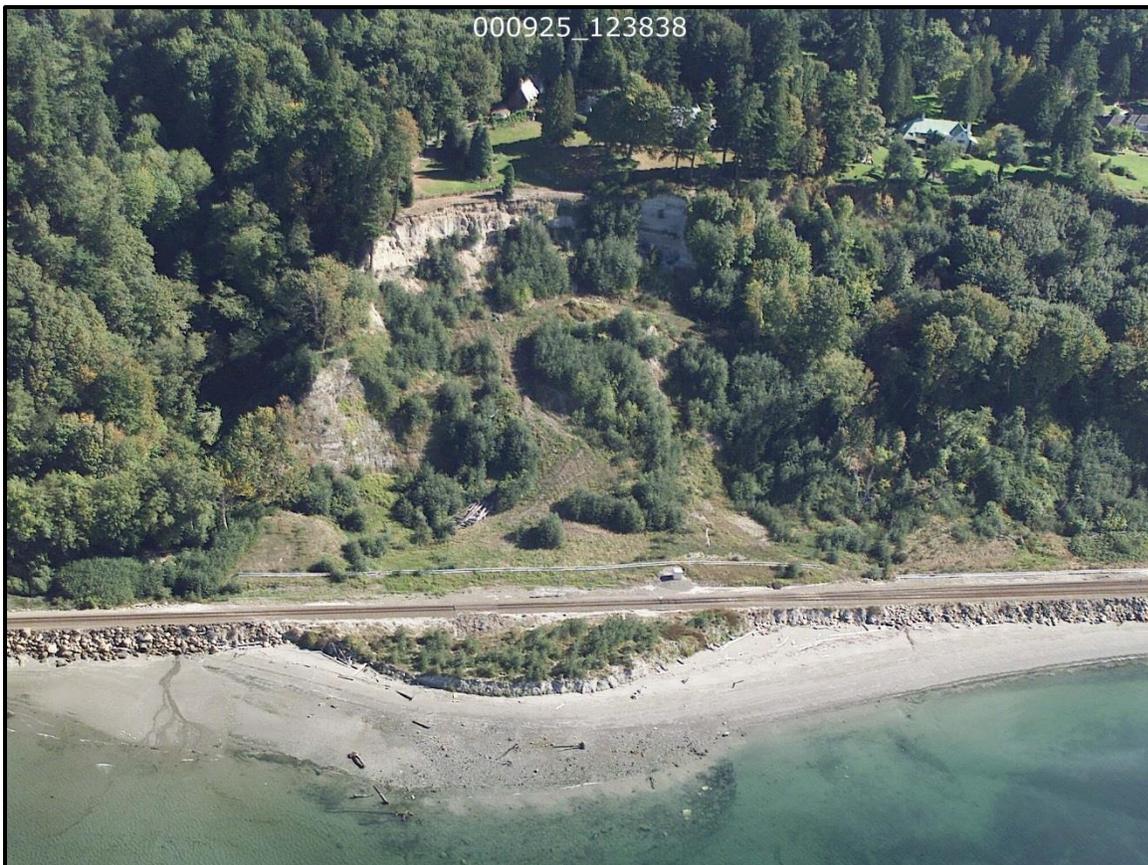
Photograph 6: 1997 Woodway Landslide in 2000 (Ecology 2002).

Large, deep-seated landslides have occurred in the vicinity of the site. The well-documented Woodway Landslide, approximately 1,500 feet north of the site and shown in Photograph 6, is an example of the type of large, deep-seated landslides that occur on Puget Sound coastal bluffs. The Woodway slide followed a prolonged period of heavy precipitation, which resulted in increased water infiltration into the subsurface, increased groundwater pore pressures, and reduced soil strength; these combined factors are believed to have triggered the landslide (Landau 1998 and Savage et al. 2000). Based on finite element slope stability modeling, Savage et al. estimated the slide was triggered when the accumulation of perched groundwater above the Lawton Clay increased to about 16.5 feet from its typical 8 feet measured over a period of 2.5 years after the slide occurred.

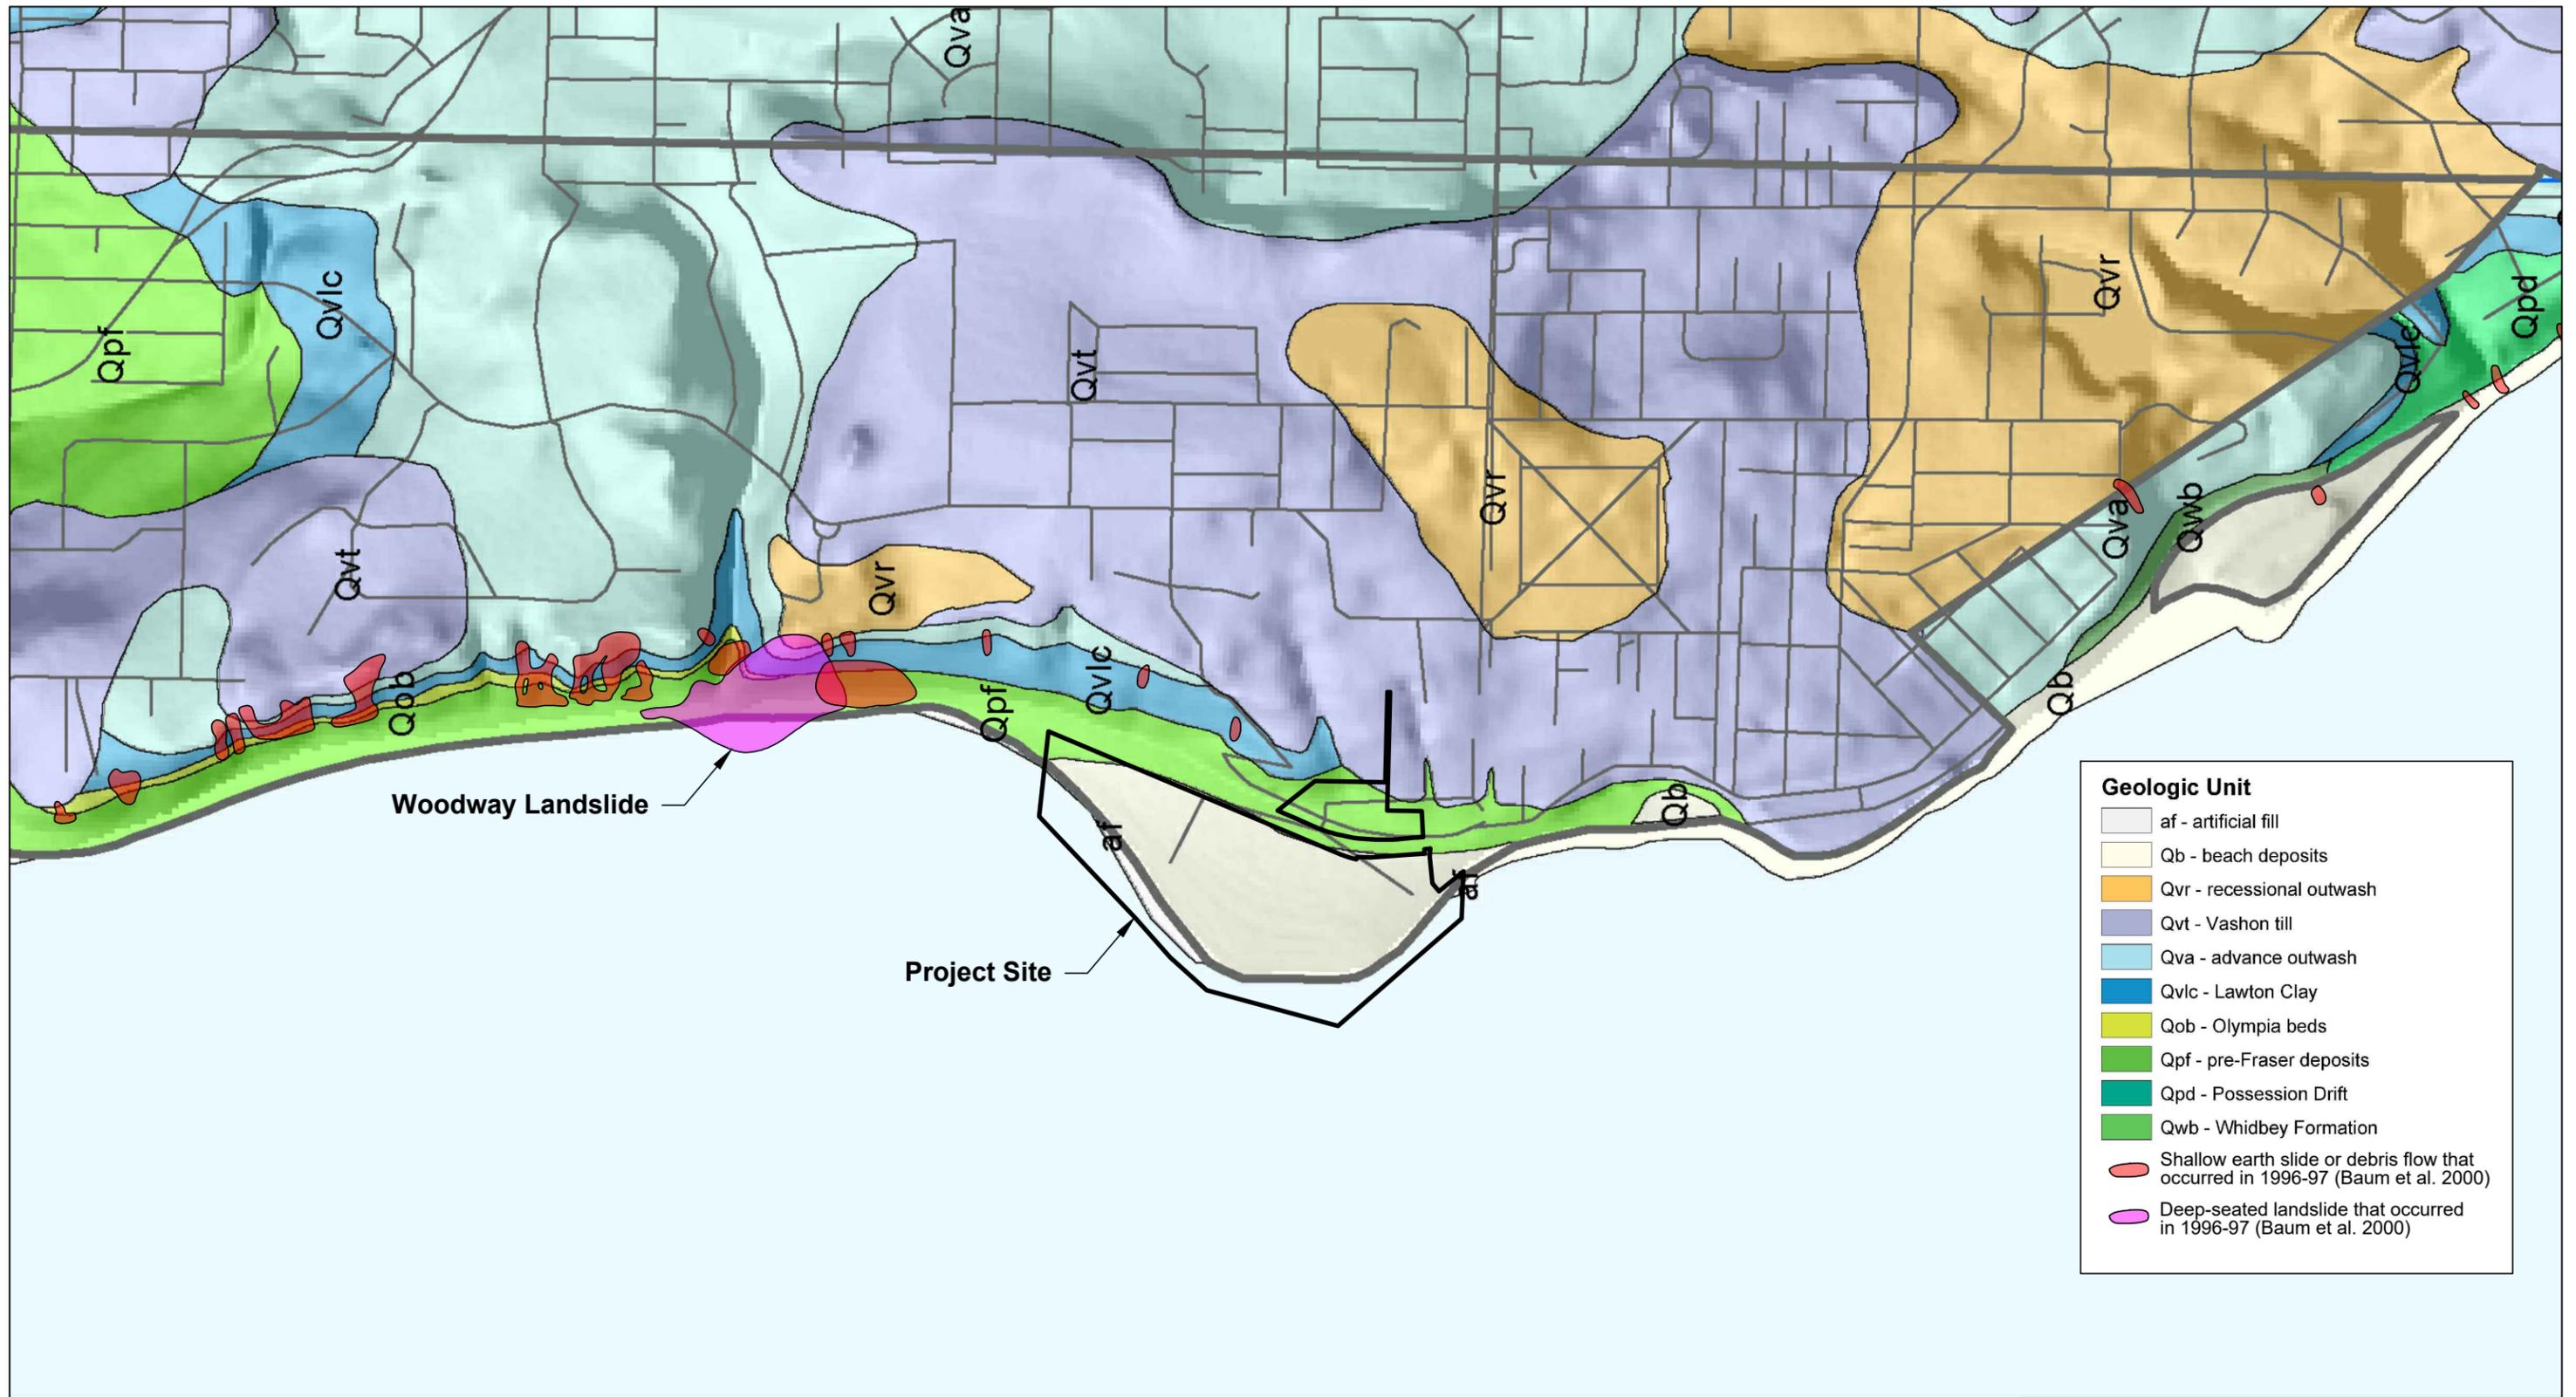
6

Source: "Composite Geologic Map of the Sno-King Area," Central Puget Lowland, Washington, by Derek Booth, Brett Cox, Kathy Troost, and Scott Shimel. Seattle-Area Geologic Mapping Project (SGMP), University of Washington, and the United States Geological Survey (USGS) January 5, 2004. Map scale 1:24,000.

A geologic map of the site and surrounding vicinity based on the work by Booth et al. (2004) is shown on Figure 6. The surficial soil of the Lower and Upper Benches consist of artificial fill (af) and pre-Fraser deposits (Qpf), respectively. The pre-Fraser deposits are sedimentary deposits typically consisting of poorly to well-sorted gravel, sand, silt, and clay. The original ground surface of the Lower Bench was modified and fill was placed to raise grade for construction of the existing facility. The artificial fill consists of loose to dense, trace to silty, gravelly sand.

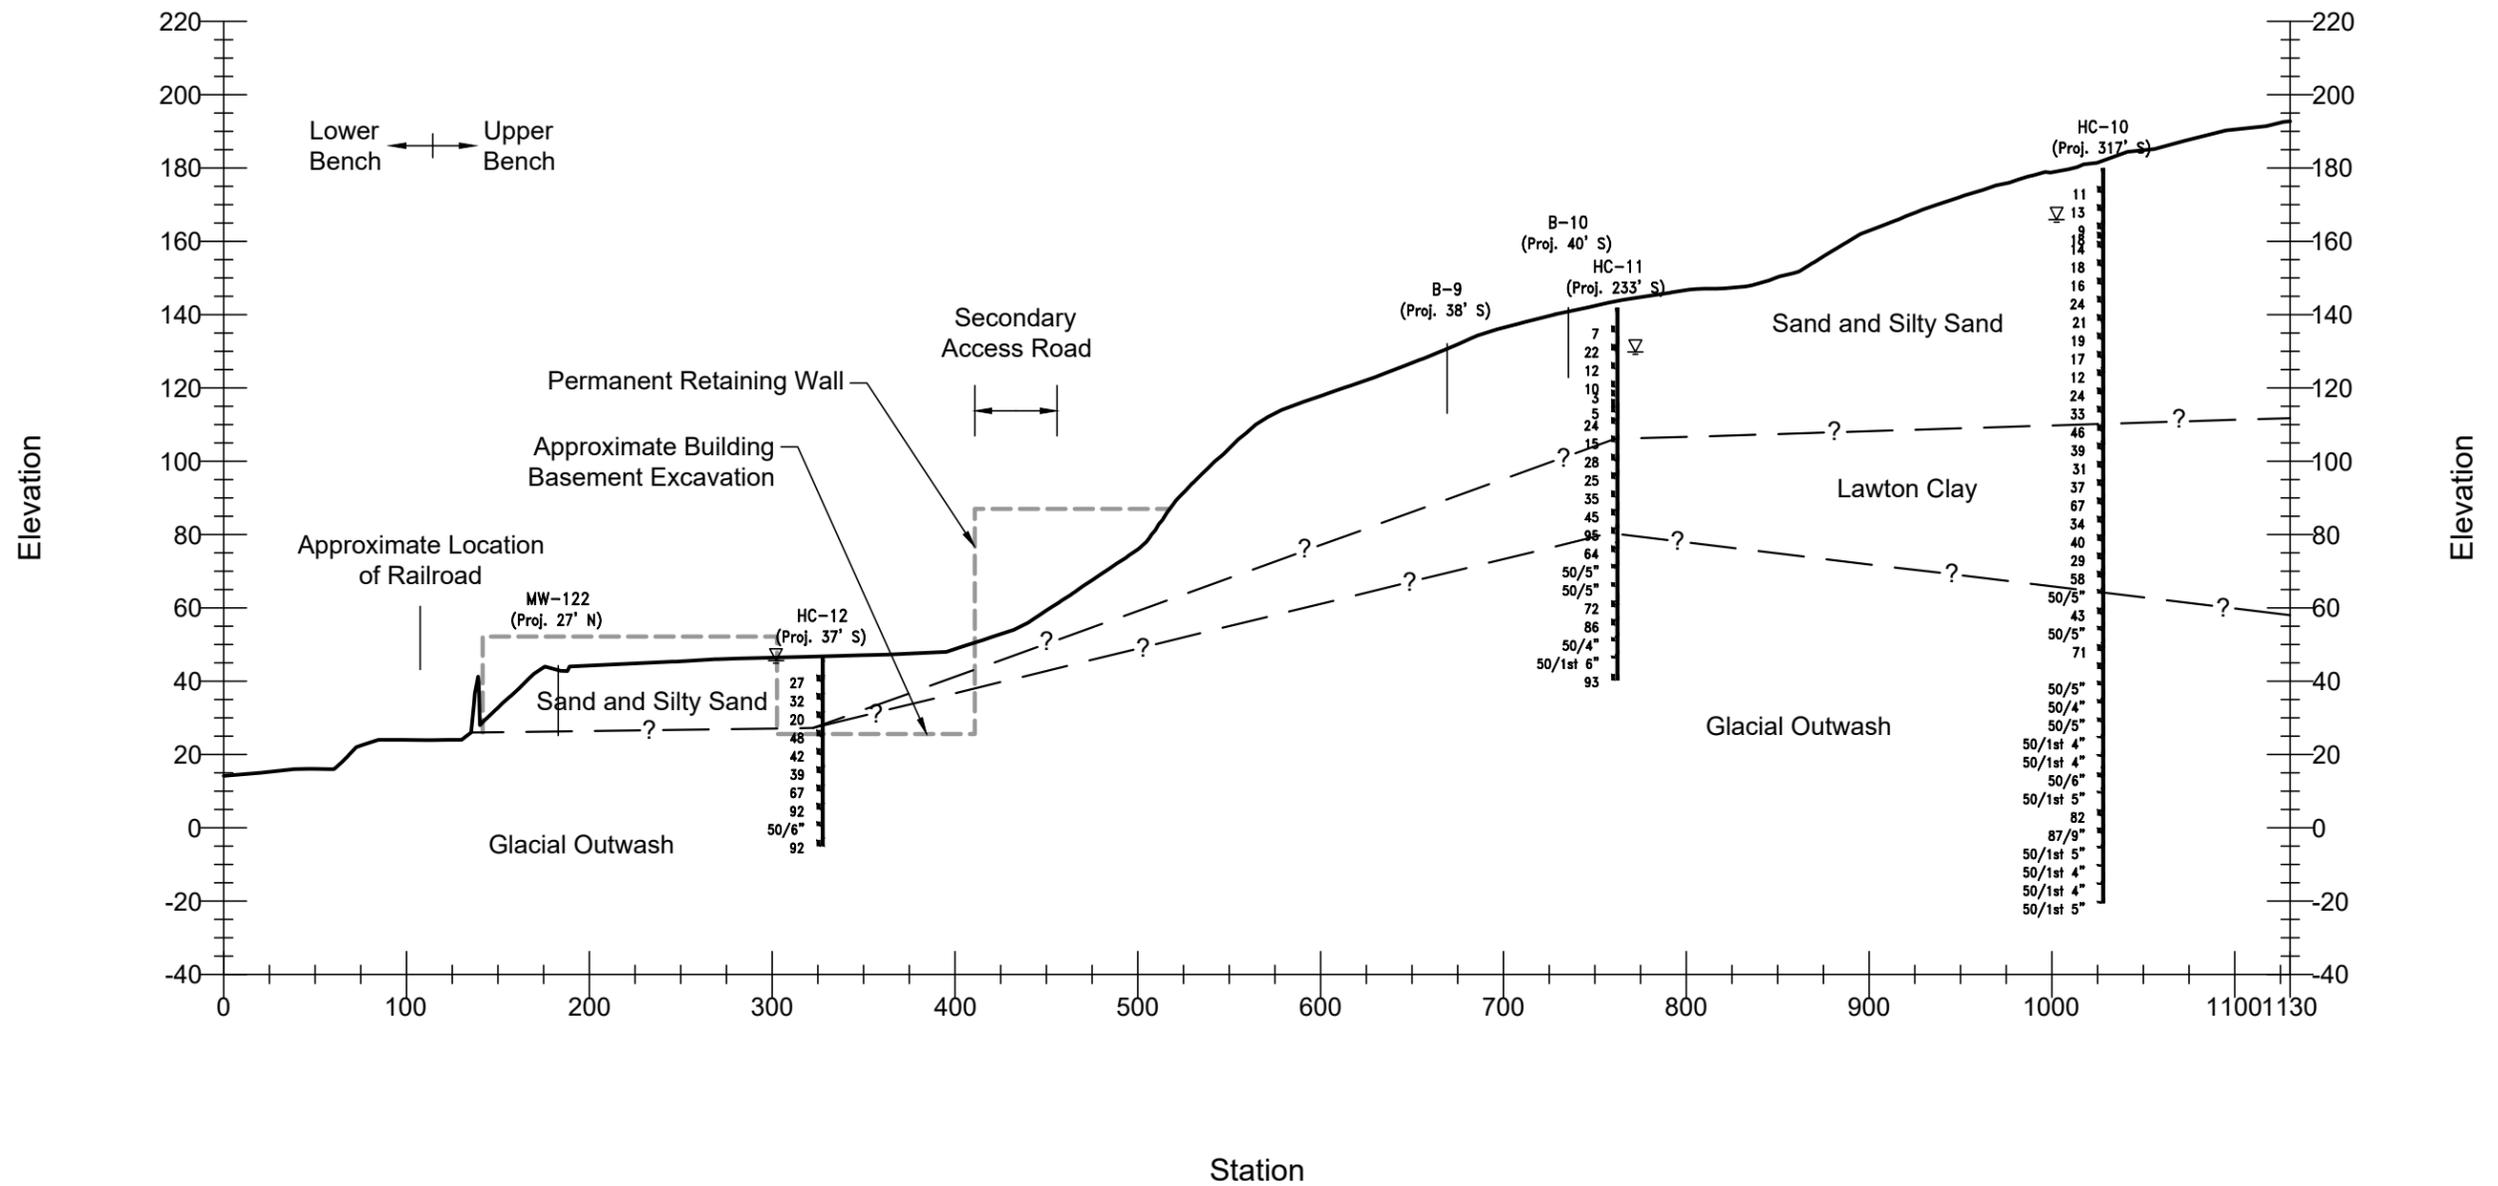
Point Wells Richmond Beach, Washington	
Generalized Subsurface Cross Section G-G'	
17203-54	4/18
	Figure 9

Note:
 1. Contacts between soil units are based upon interpolation between borings and represent our interpretation of subsurface conditions based on currently available data.
 2. Slopes appear steeper than they actually are because of vertical exaggeration used for figure clarity. See Figure 4 for slope profile without vertical exaggeration.

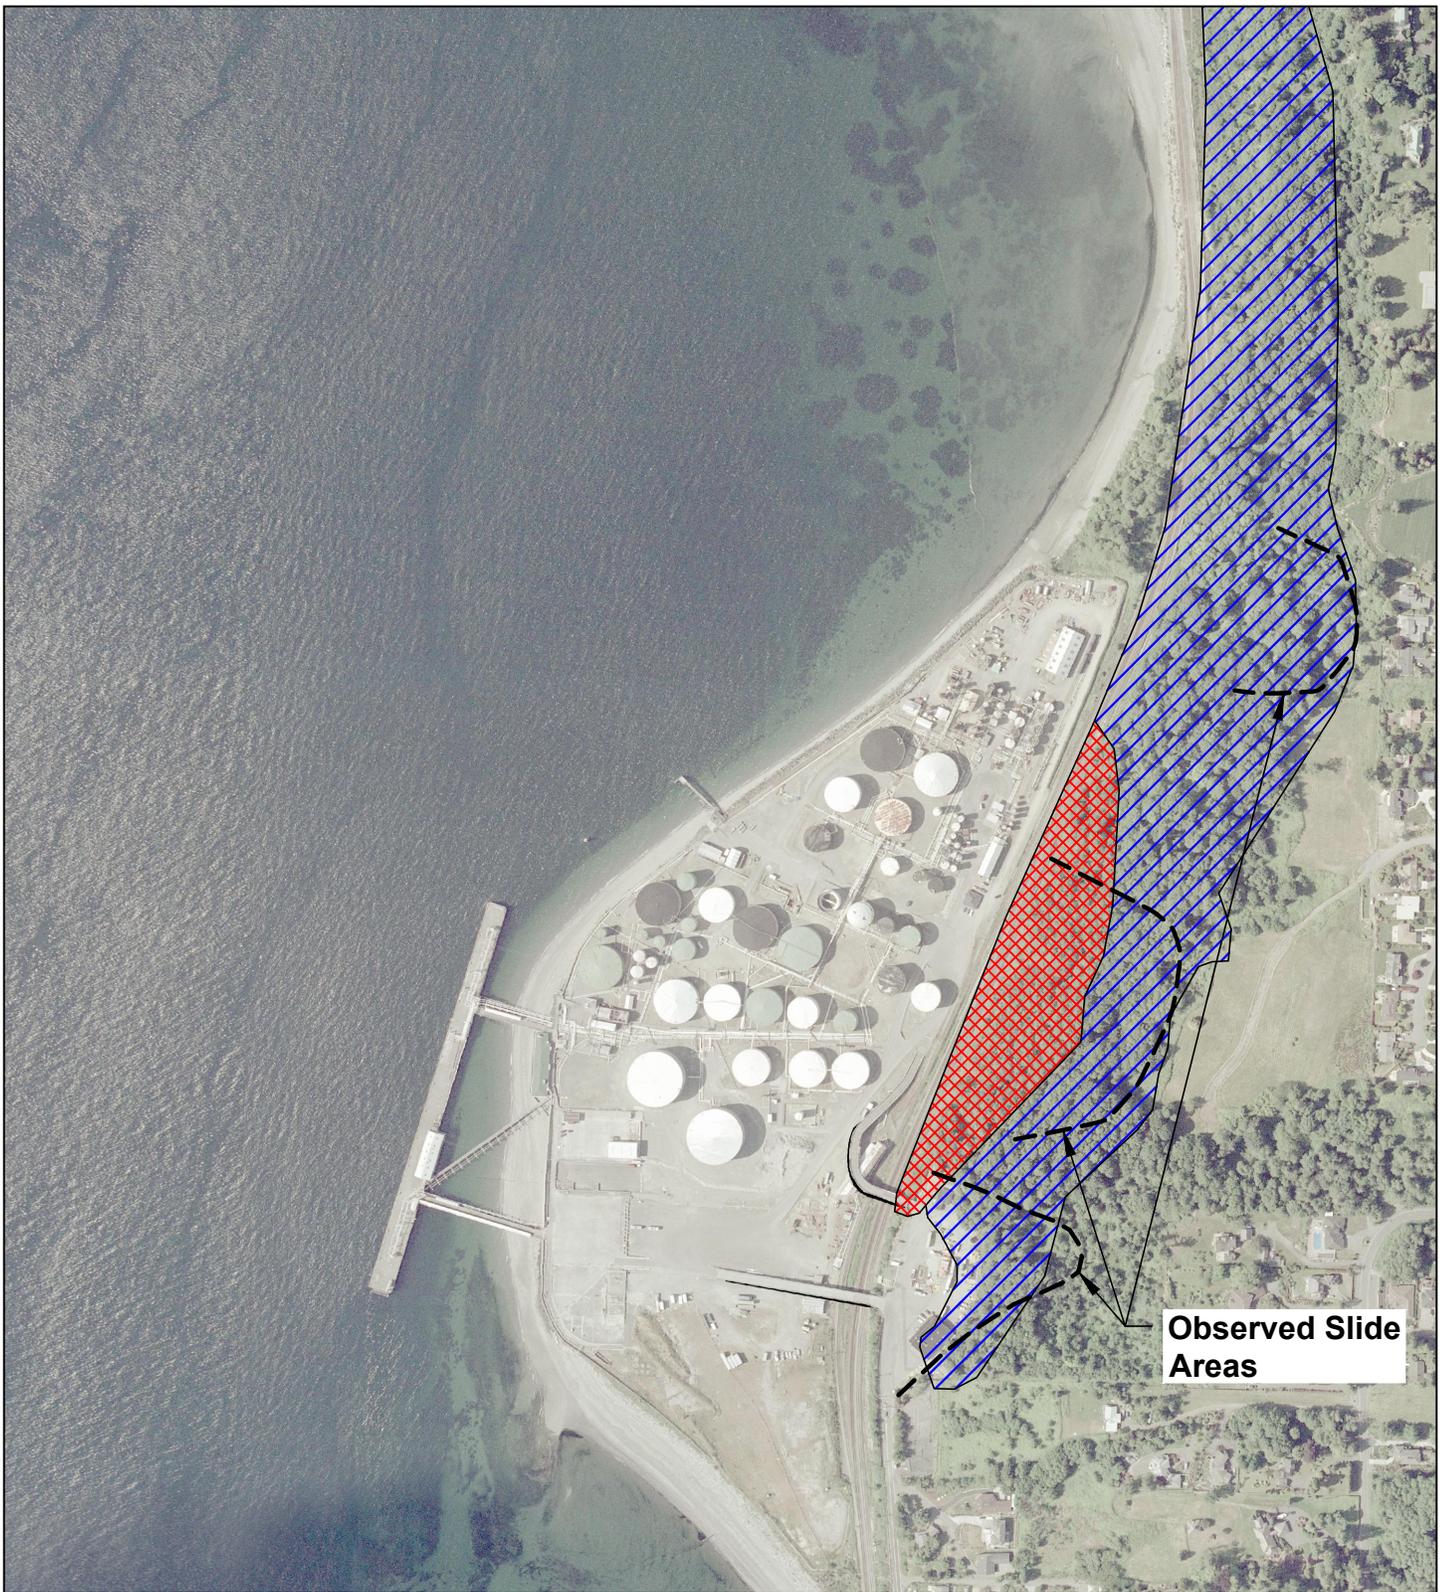
Figure
11

Coastal Atlas Mapped Unstable Areas
(Ecology 2004)

the 2007 SCC 30.62.340 vested for this project. However, the steepness of the slope varies considerably. LiDAR-derived slope calculations for the site and the east hillside are shown on Figure 11. Slope profiles through representative sections of the site and slopes to the east are shown on Figure 4. The overall slopes are less steep moving from north to south.

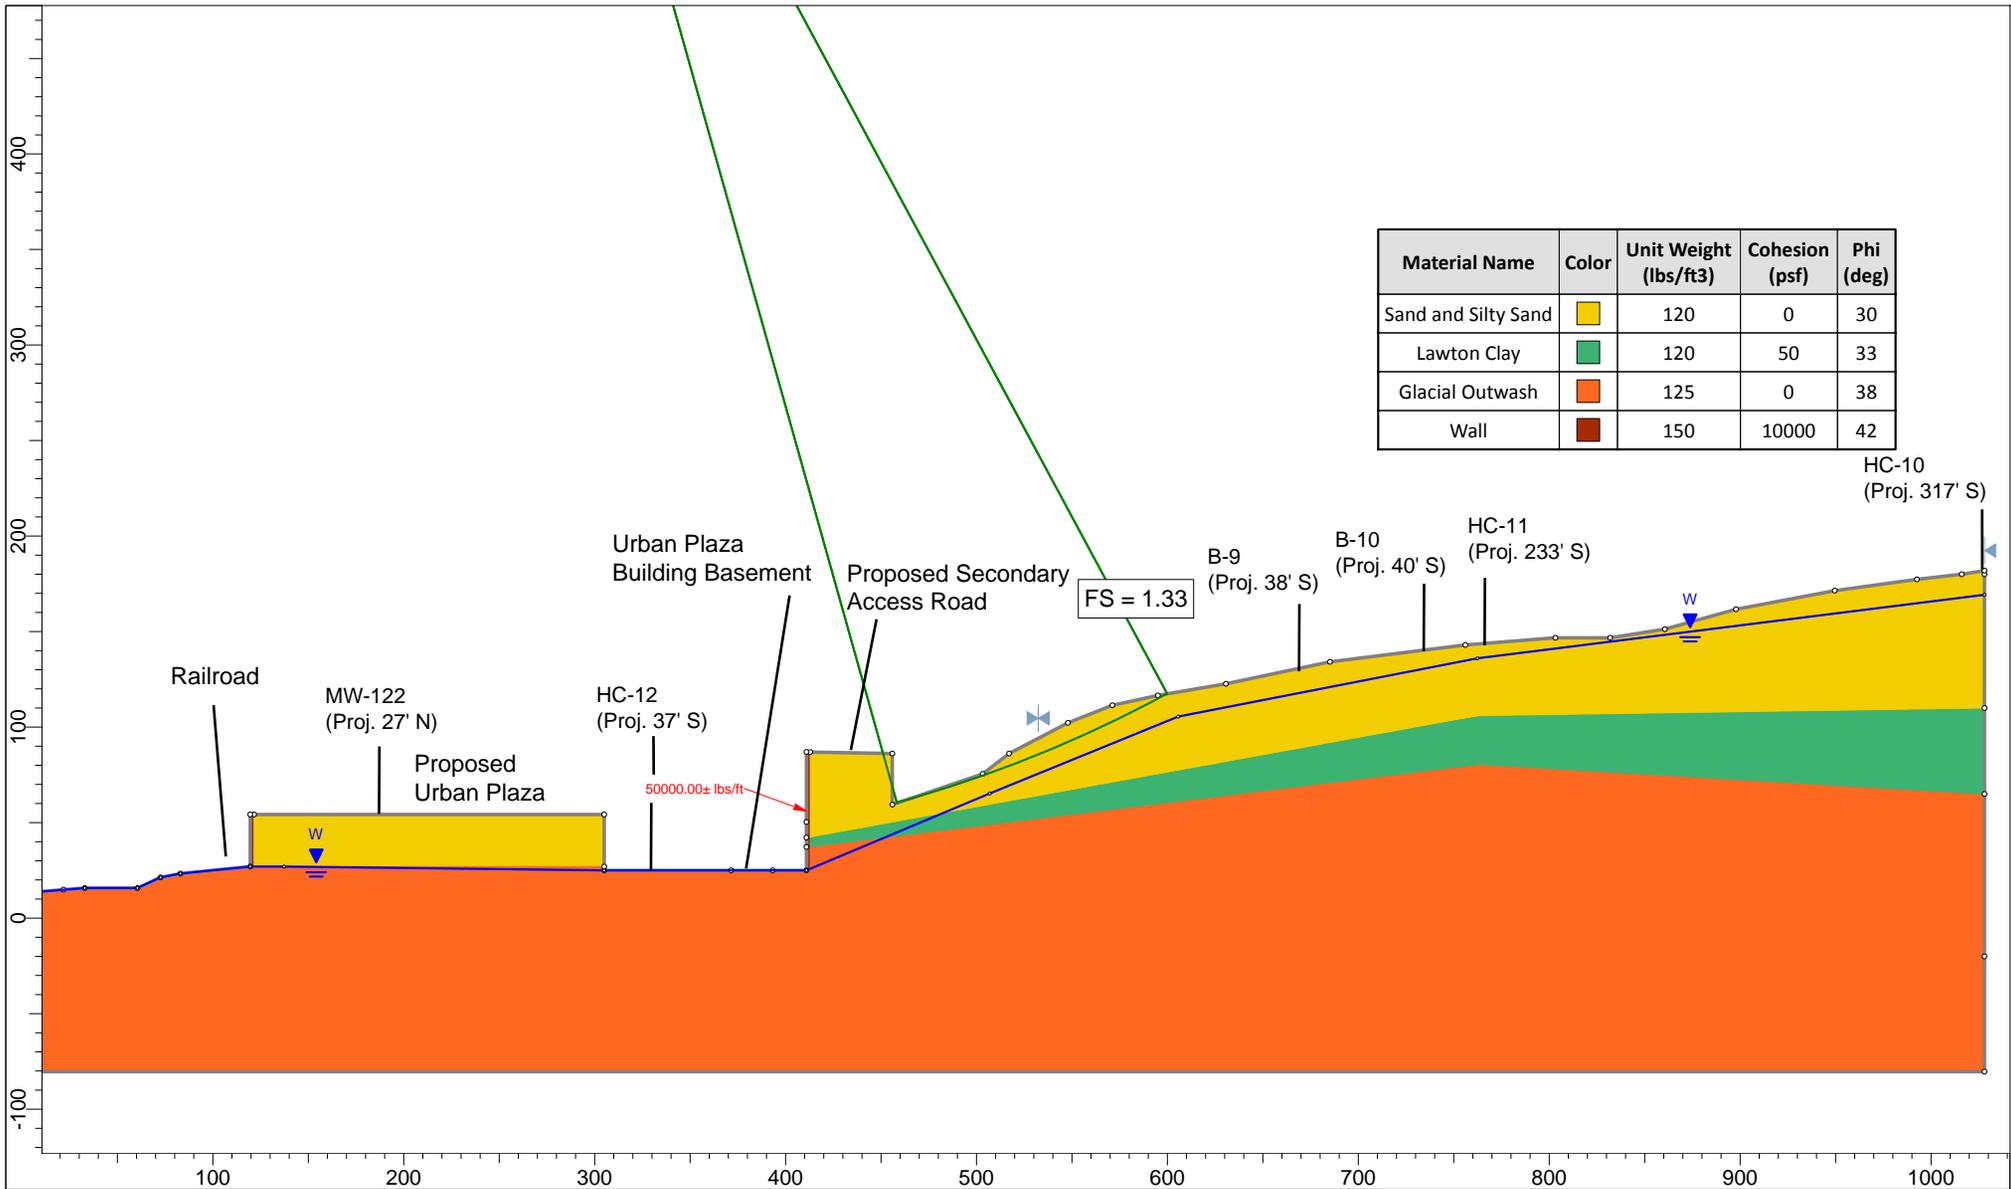
Point Wells Richmond Beach, Washington		
Section G-G' Proposed Two Walls - Static		
17203-54	Scale 1:1200	4/18
		Figure 20

Material Name	Color	Unit Weight (lbs/ft ³)	Cohesion (psf)	Phi (deg)
Sand and Silty Sand	Yellow	120	0	30
Lawton Clay	Green	120	50	33
Glacial Outwash	Orange	125	0	38
Wall	Brown	150	10000	42
