Subsurface Conditions Report

Point Wells Redevelopment Richmond Beach, Washington

Prepared for
BSRE Point Wells, LP

June 11, 2015
17203-54

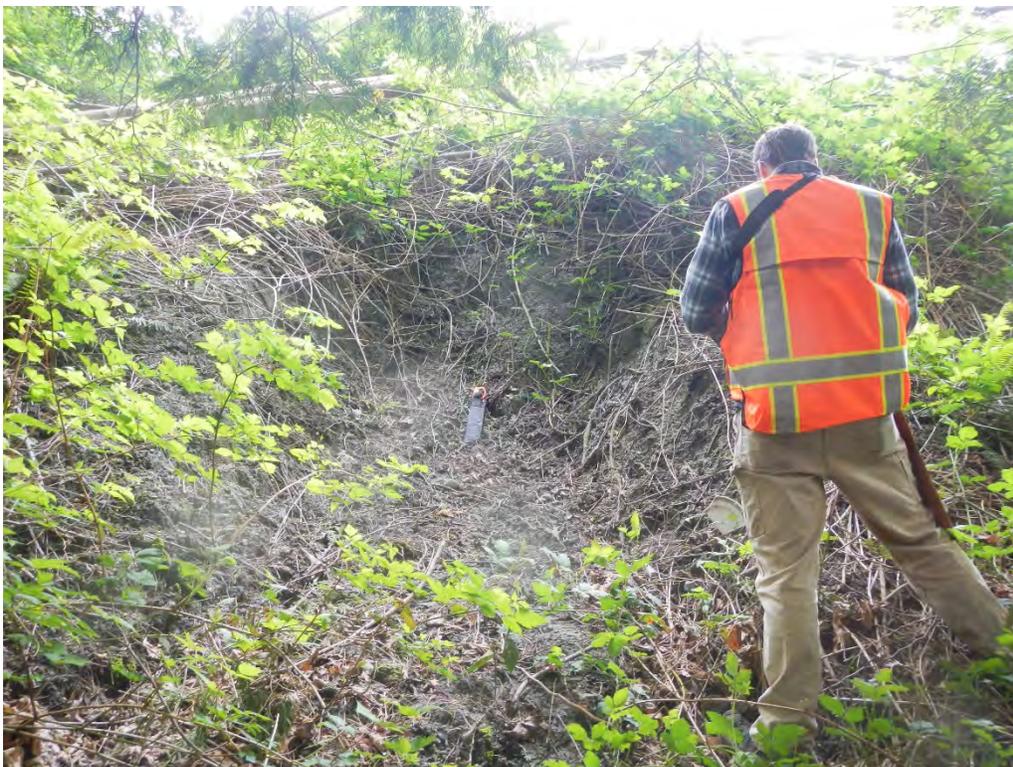
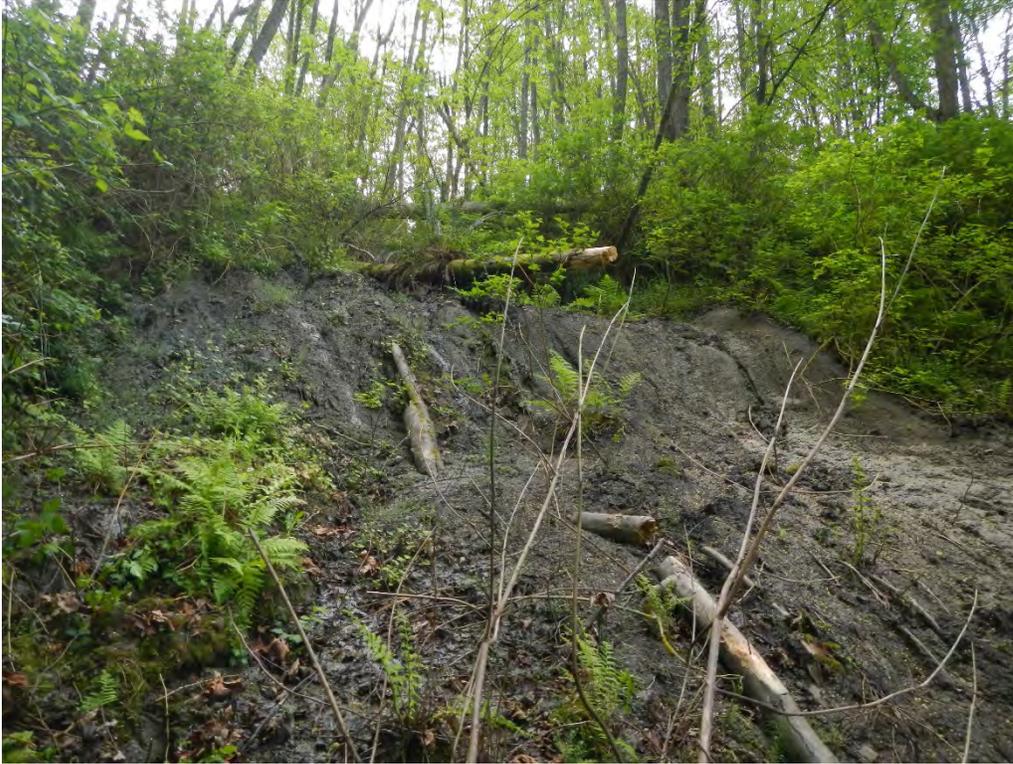
Photographs 1 (top) and 2 (bottom): Localized small landslides near Drainage 1.

Our observations found recent landslide activity to be primarily confined to the immediate vicinity of the drainages and likely the result of erosion at the toe of the slope and saturated soil conditions resulting from seeps and springs on the hillside. Examples of these slides are shown in Photographs 1 and 2.

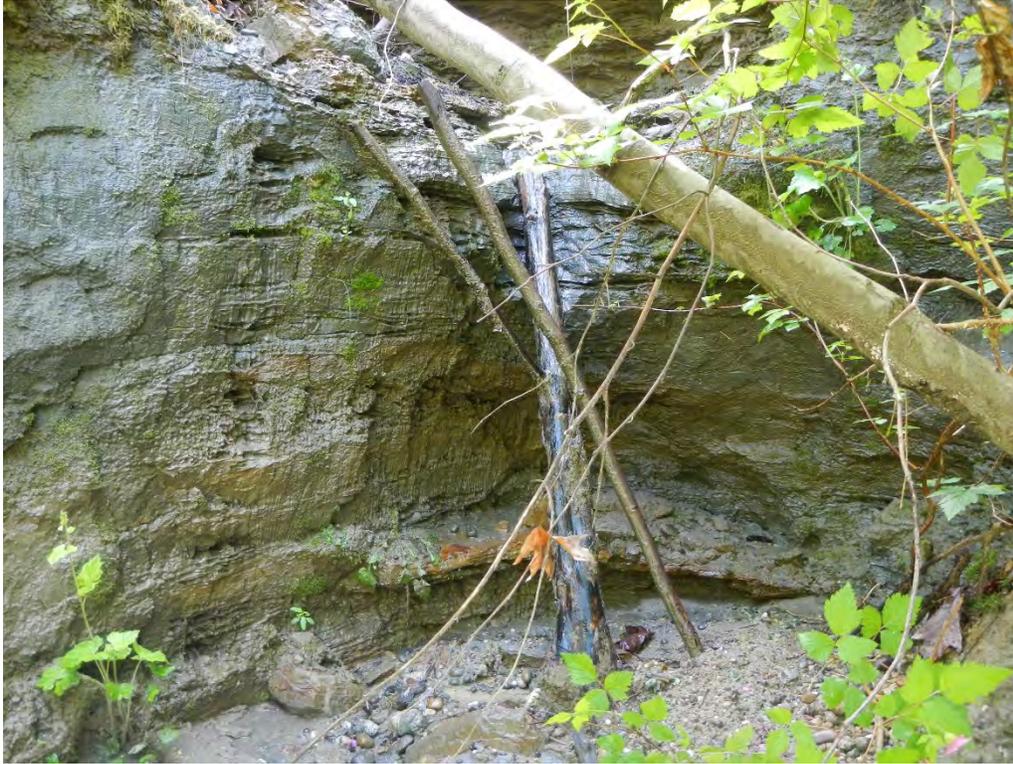
Photograph 3: Creek forming from seepage at the Advance Outwash-Lawton Clay contact.

Evidence of larger block slides and bluff erosion was observed along the northern portion of the upper bluff. At the base of the upper bluff, where the Advance Outwash-Lawton Clay contact could be observed, seeps within the Advance Outwash formed a small creek (Photograph 3).

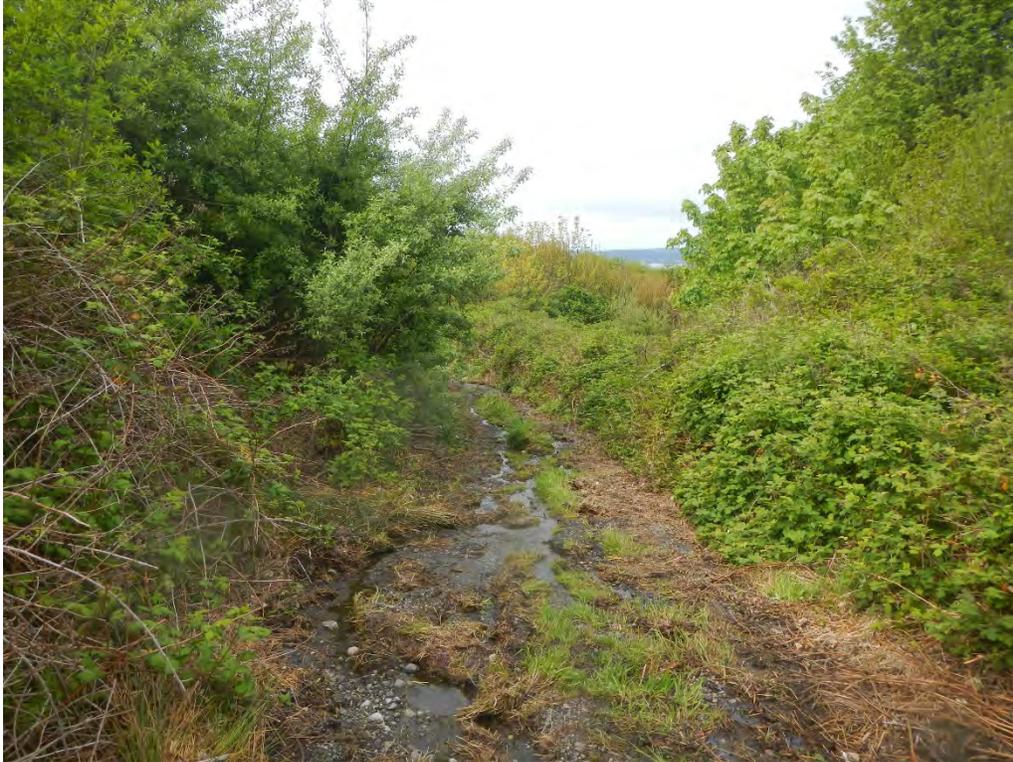
Photograph 4: Surface runoff at gate to the private property at the top of the slope, above Drainage 2.

Drainage 2 begins at approximately elevation 235 feet, where a storm drain discharges to the surface near the private property gate at the end of 238th Street Southeast, as shown in Photograph 4.

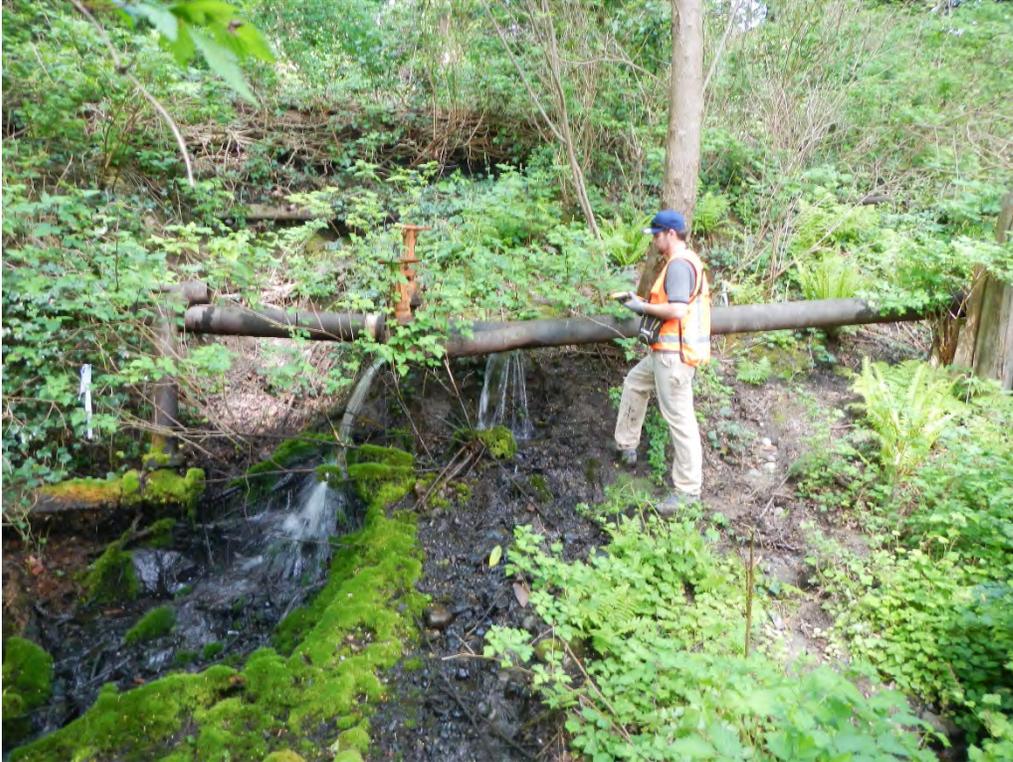
Photograph 5: Leaking pipes below retention pond in Drainage 1.

Numerous pipes that are mostly buried and likely related to historical Chevron activities at the top of the slope were observed near Drainage 1. As mentioned above, one of these was leaking near the upper retention pond, as shown in Photograph 5. It is unclear whether water is conveyed through the other pipes.

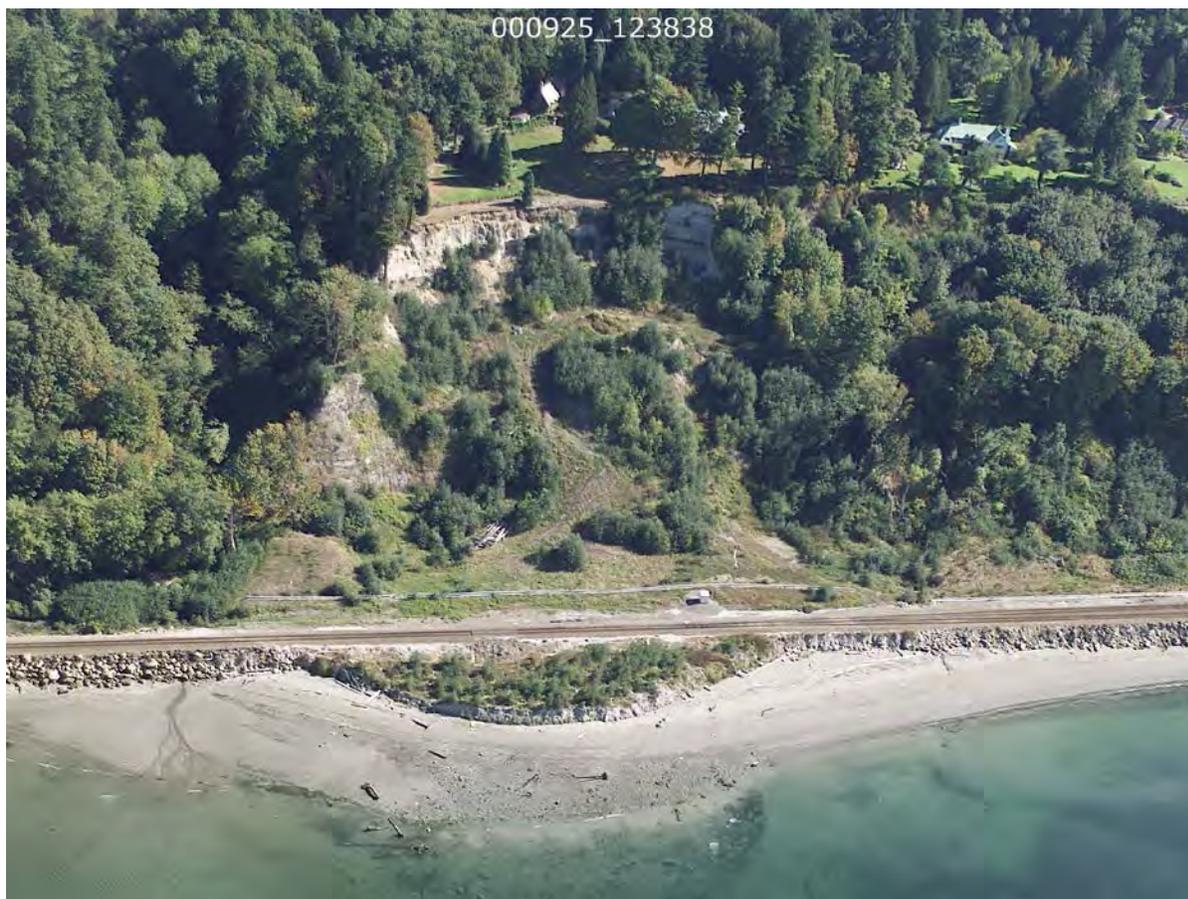
Photograph 6: 1997 Woodway Landslide in 2000 (Ecology 2002).

Large, deep-seated landslides have occurred in the vicinity of the site. The well-documented Woodway Landslide, approximately 1,500 feet north of the site and shown in Photograph 6, is an example of the type of large, deep-seated landslides that occur on Puget Sound coastal bluffs. The Woodway slide followed a prolonged period of heavy precipitation, which resulted in increased water infiltration into the subsurface, increased groundwater pore pressures, and reduced soil strength; these combined factors are believed to have triggered the landslide (Landau 1998 and Savage et al. 2000). Based on finite element slope stability modeling, Savage et al. estimated the slide was triggered when the accumulation of perched groundwater above the Lawton Clay increased to about 16.5 feet from its typical 8 feet measured over a period of 2.5 years after the slide occurred.

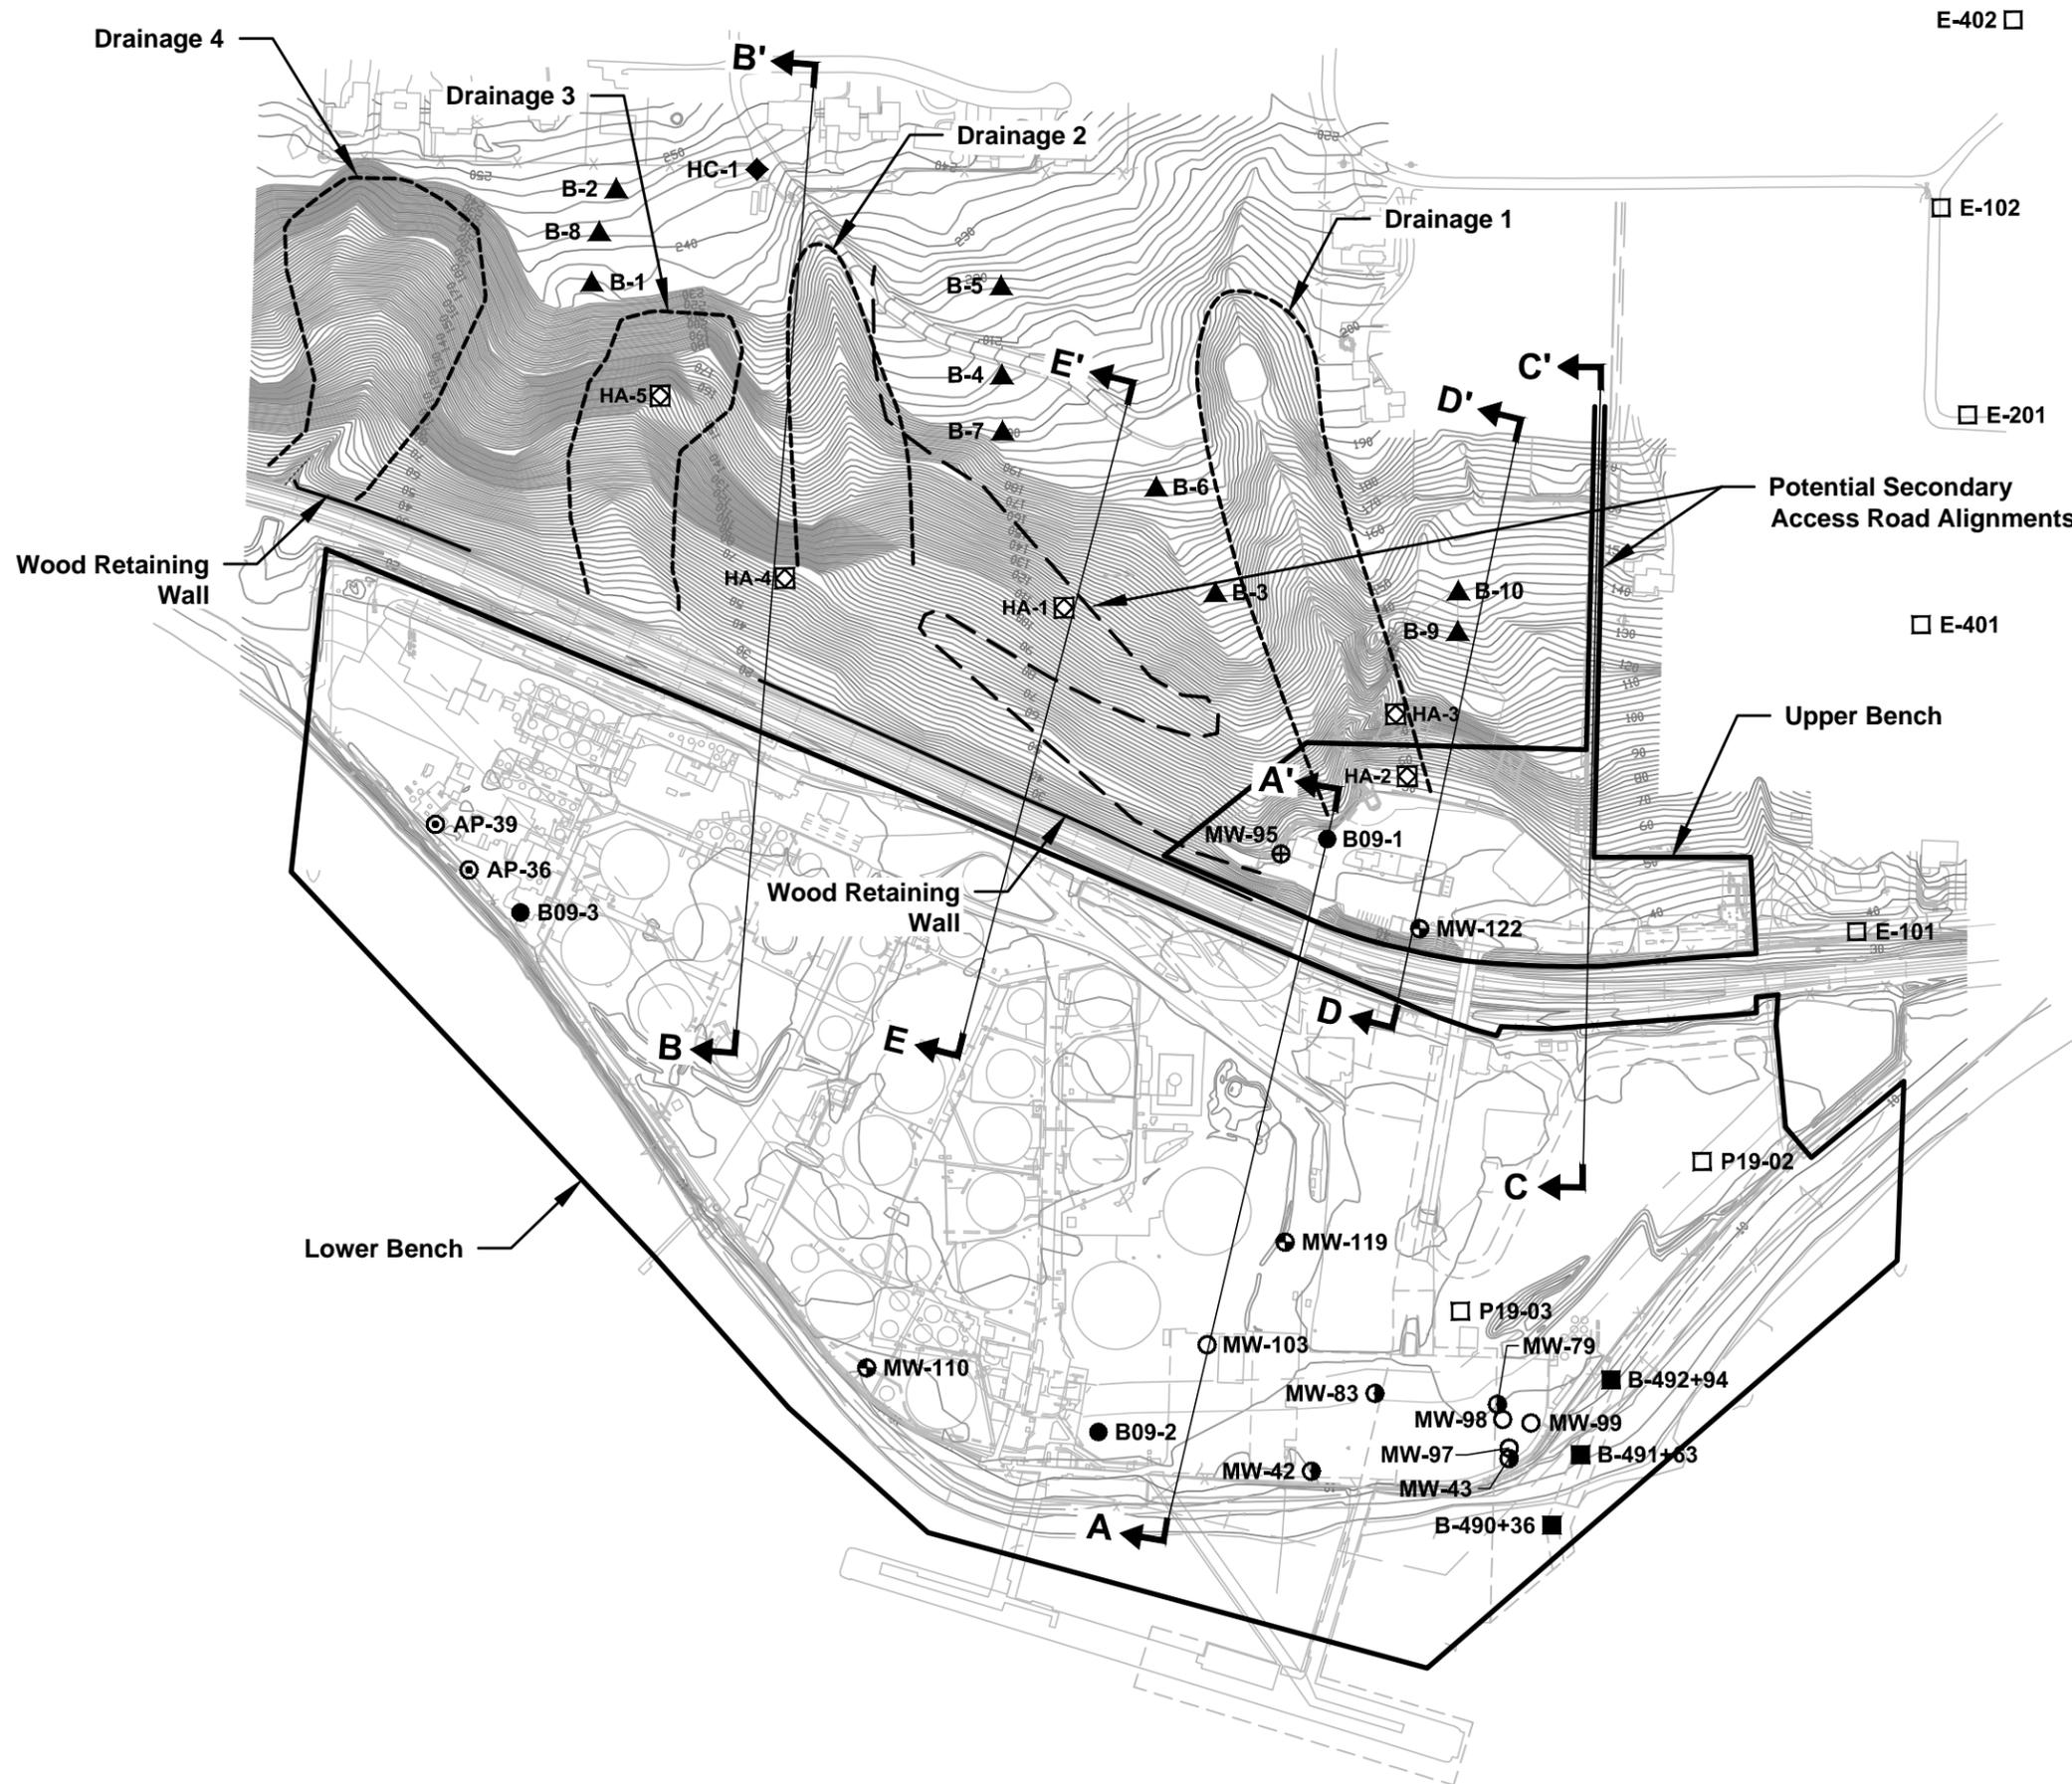
Point Wells Richmond Beach, Washington	
Site Topography	
17203-54	6/15
	Figure 2

To assess soil conditions and potential geologic hazards, we completed a 250-foot soil boring at the top of the eastern slope and installed VWP's to monitor groundwater levels in different stratigraphic units. Field reconnaissance was performed on the eastern slope to document slope conditions and evaluate potential landslide features identified on laser imaging, detection, and ranging (LiDAR) imagery of the site with respect to the proposed development alternatives. LiDAR imagery was collected in April 2013 and provided by the Washington State Department of Transportation (WSDOT 2013). As part of the reconnaissance, five hand-auger soil borings were advanced on the slope. Details of these activities are in the following section, and exploration locations are shown on Figures 2 and 3.

During the field reconnaissance, five hand auger borings were advanced to approximately 3 to 8.5 feet bgs. Soil conditions encountered in these shallow borings are shown in Table 1. Hand auger locations are on Figures 2 and 3.

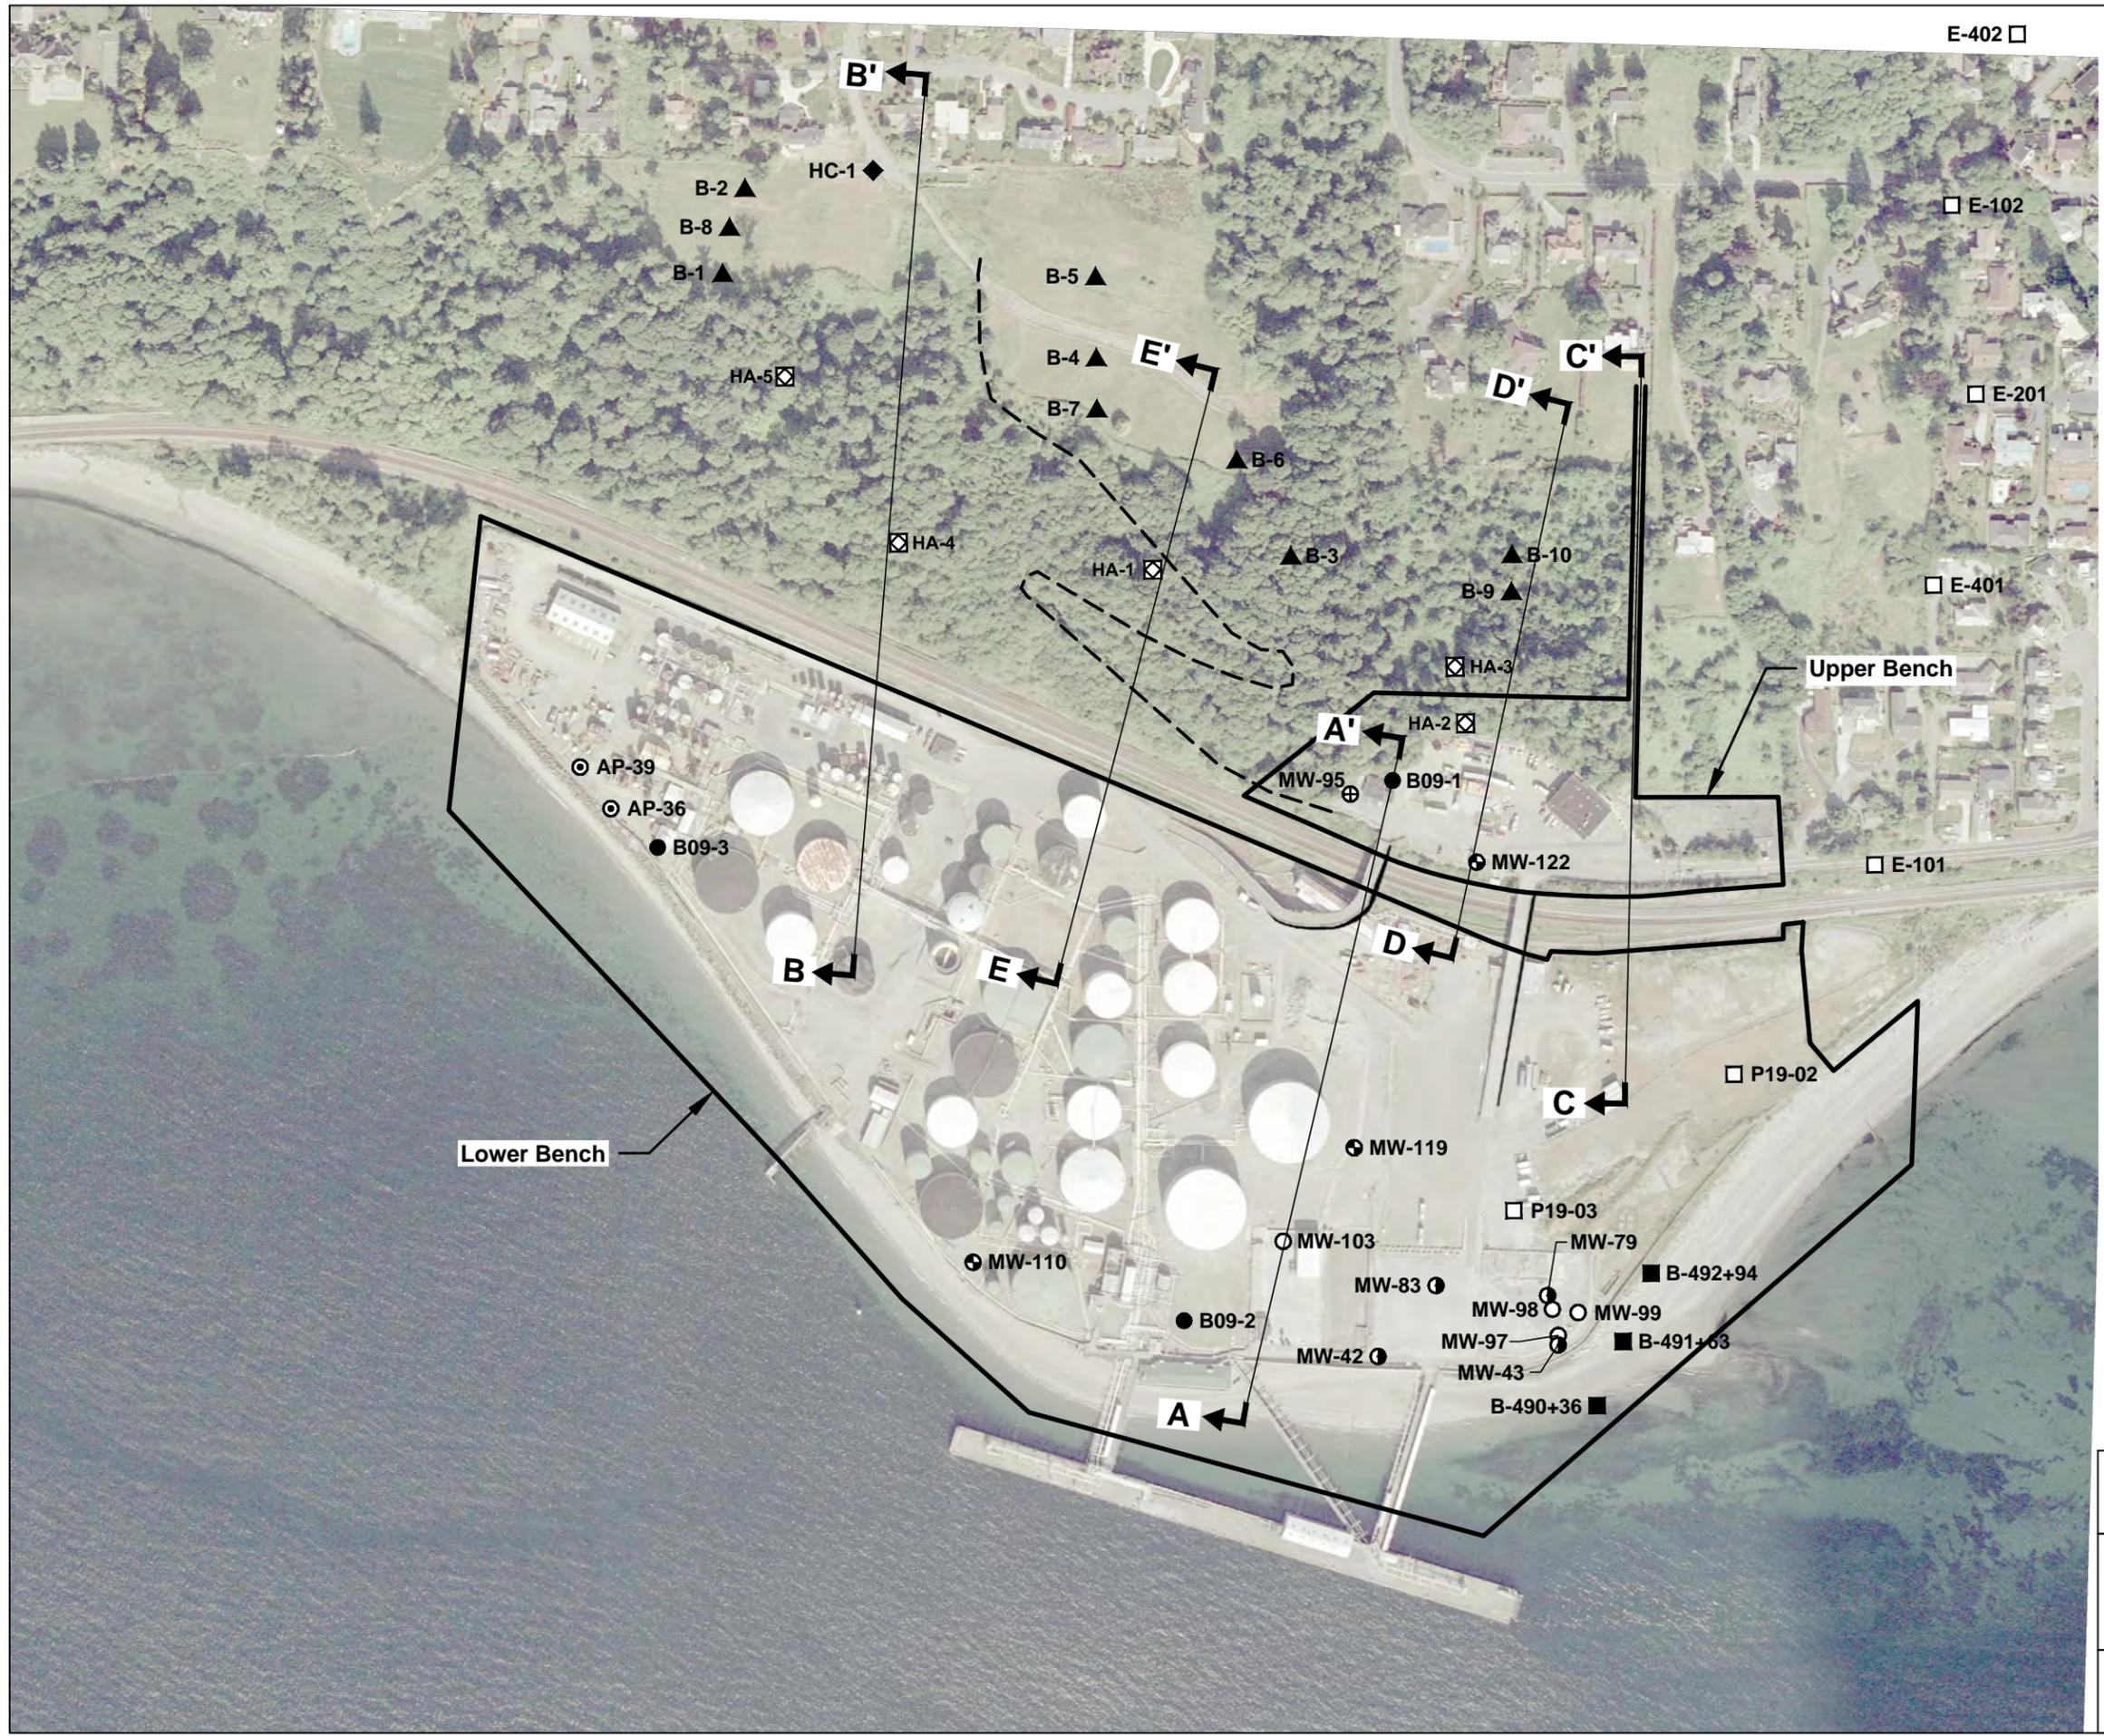
The Upper and Lower Benches are generally flat, but the slope east of the railway rises approximately 150 to 200 feet. Site topography is shown on Figure 2 and LiDAR imagery is shown on Figure 5. The majority of the slope is steeper than 33 percent (3H:1V), and is designated a landslide hazard area under the Snohomish County Code (SCC), as shown on Figure 9. However, the steepness of the slope varies considerably. LiDAR-derived slope calculations for the site and the east hillside are shown on Figure 10. Slope profiles through representative sections of the site and slopes to the east are shown on Figure 4. The overall slopes are less steep moving from north to south.

During our field reconnaissance, we identified two primary drainages (Drainages 1 and 2) extending from the top to the toe of the slope, as shown on Figure 2. Two additional drainages (Drainages 3 and 4) were located north of the primary drainages and did not appear to extend to the top of the slope, although this was not verified in the field because of dense vegetation and steep slopes. The estimated extent of the creeks is shown on Figure 10. Seeps and springs appear to account for a large portion of the water in all the drainages, particularly in the northern portion of the hillside.

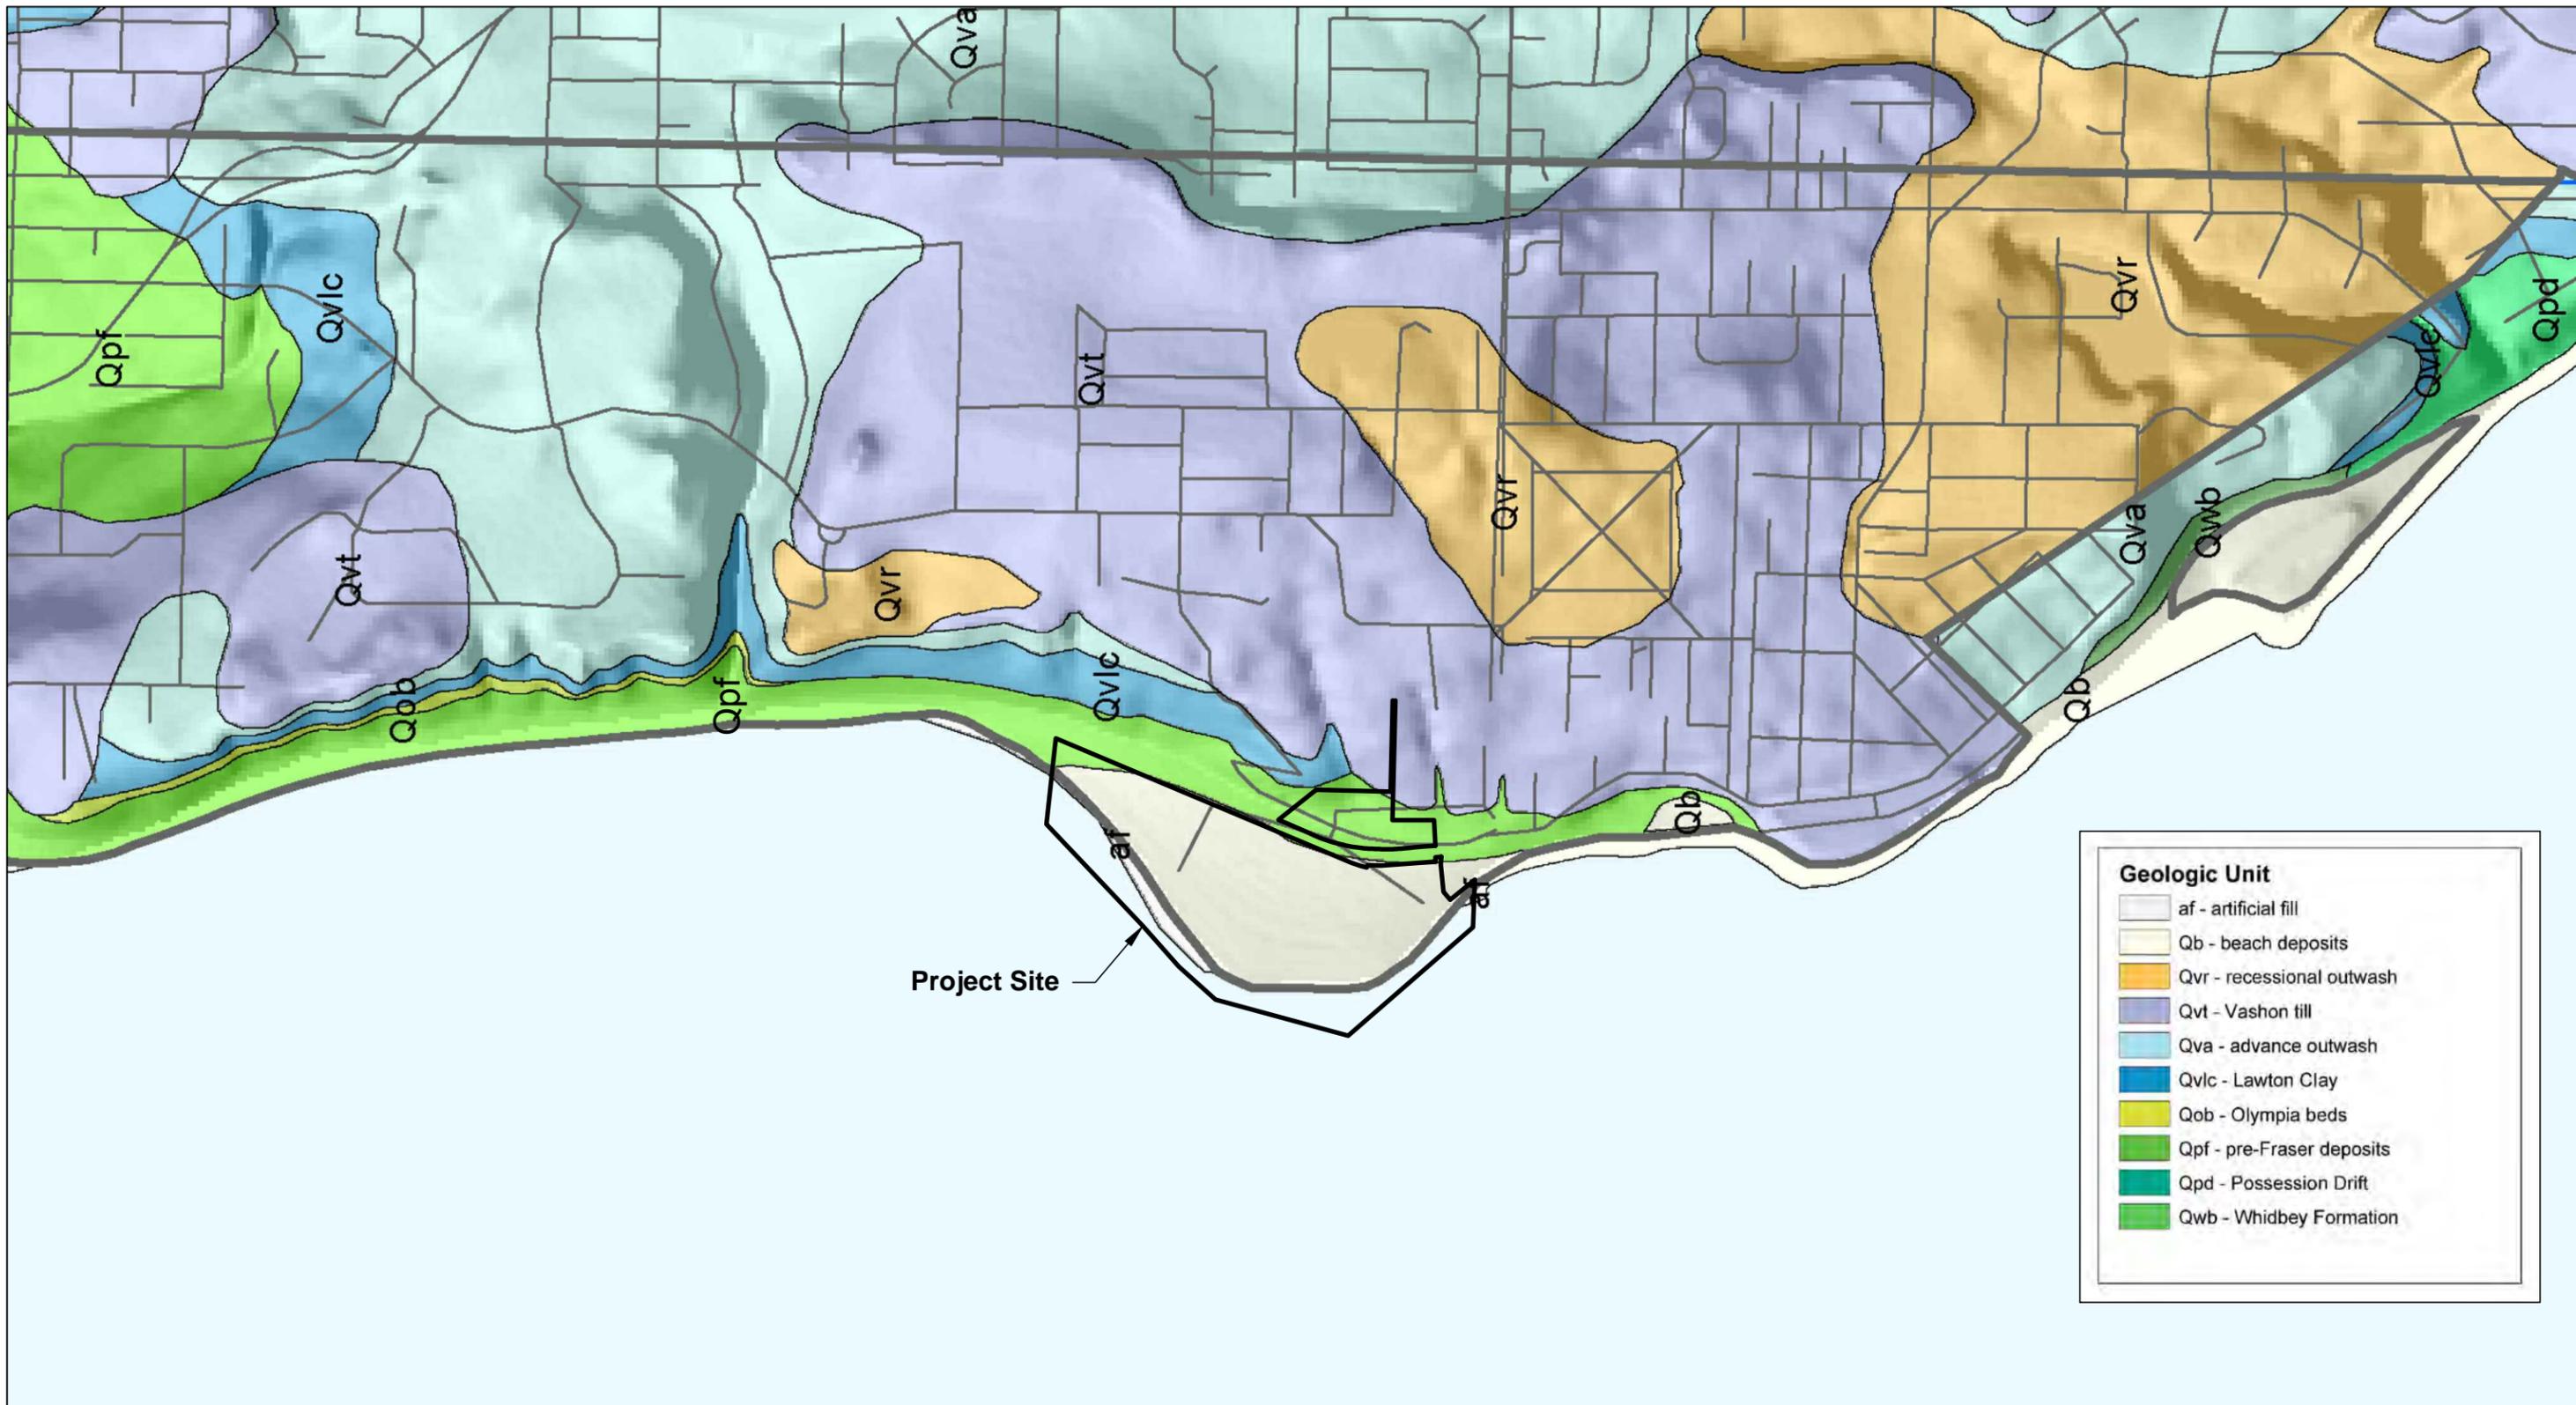
Point Wells Richmond Beach, Washington	
Geologic Map	
17203-54	6/15
	Figure 6

A geologic map of the site and surrounding vicinity based on the work by Booth et al. (2004) is shown on Figure 6. The surficial soils of the Lower and Upper Benches consist of artificial fill (af) and pre-Fraser deposits (Qpf), respectively. The pre-Fraser deposits are sedimentary deposits typically consisting of poorly to well-sorted gravel, sand, silt, and clay. The original ground surface of the Lower Bench was modified and fill was placed to raise grade for construction of the existing facility. The artificial fill consists of loose to dense, trace to silty, gravelly Sand.

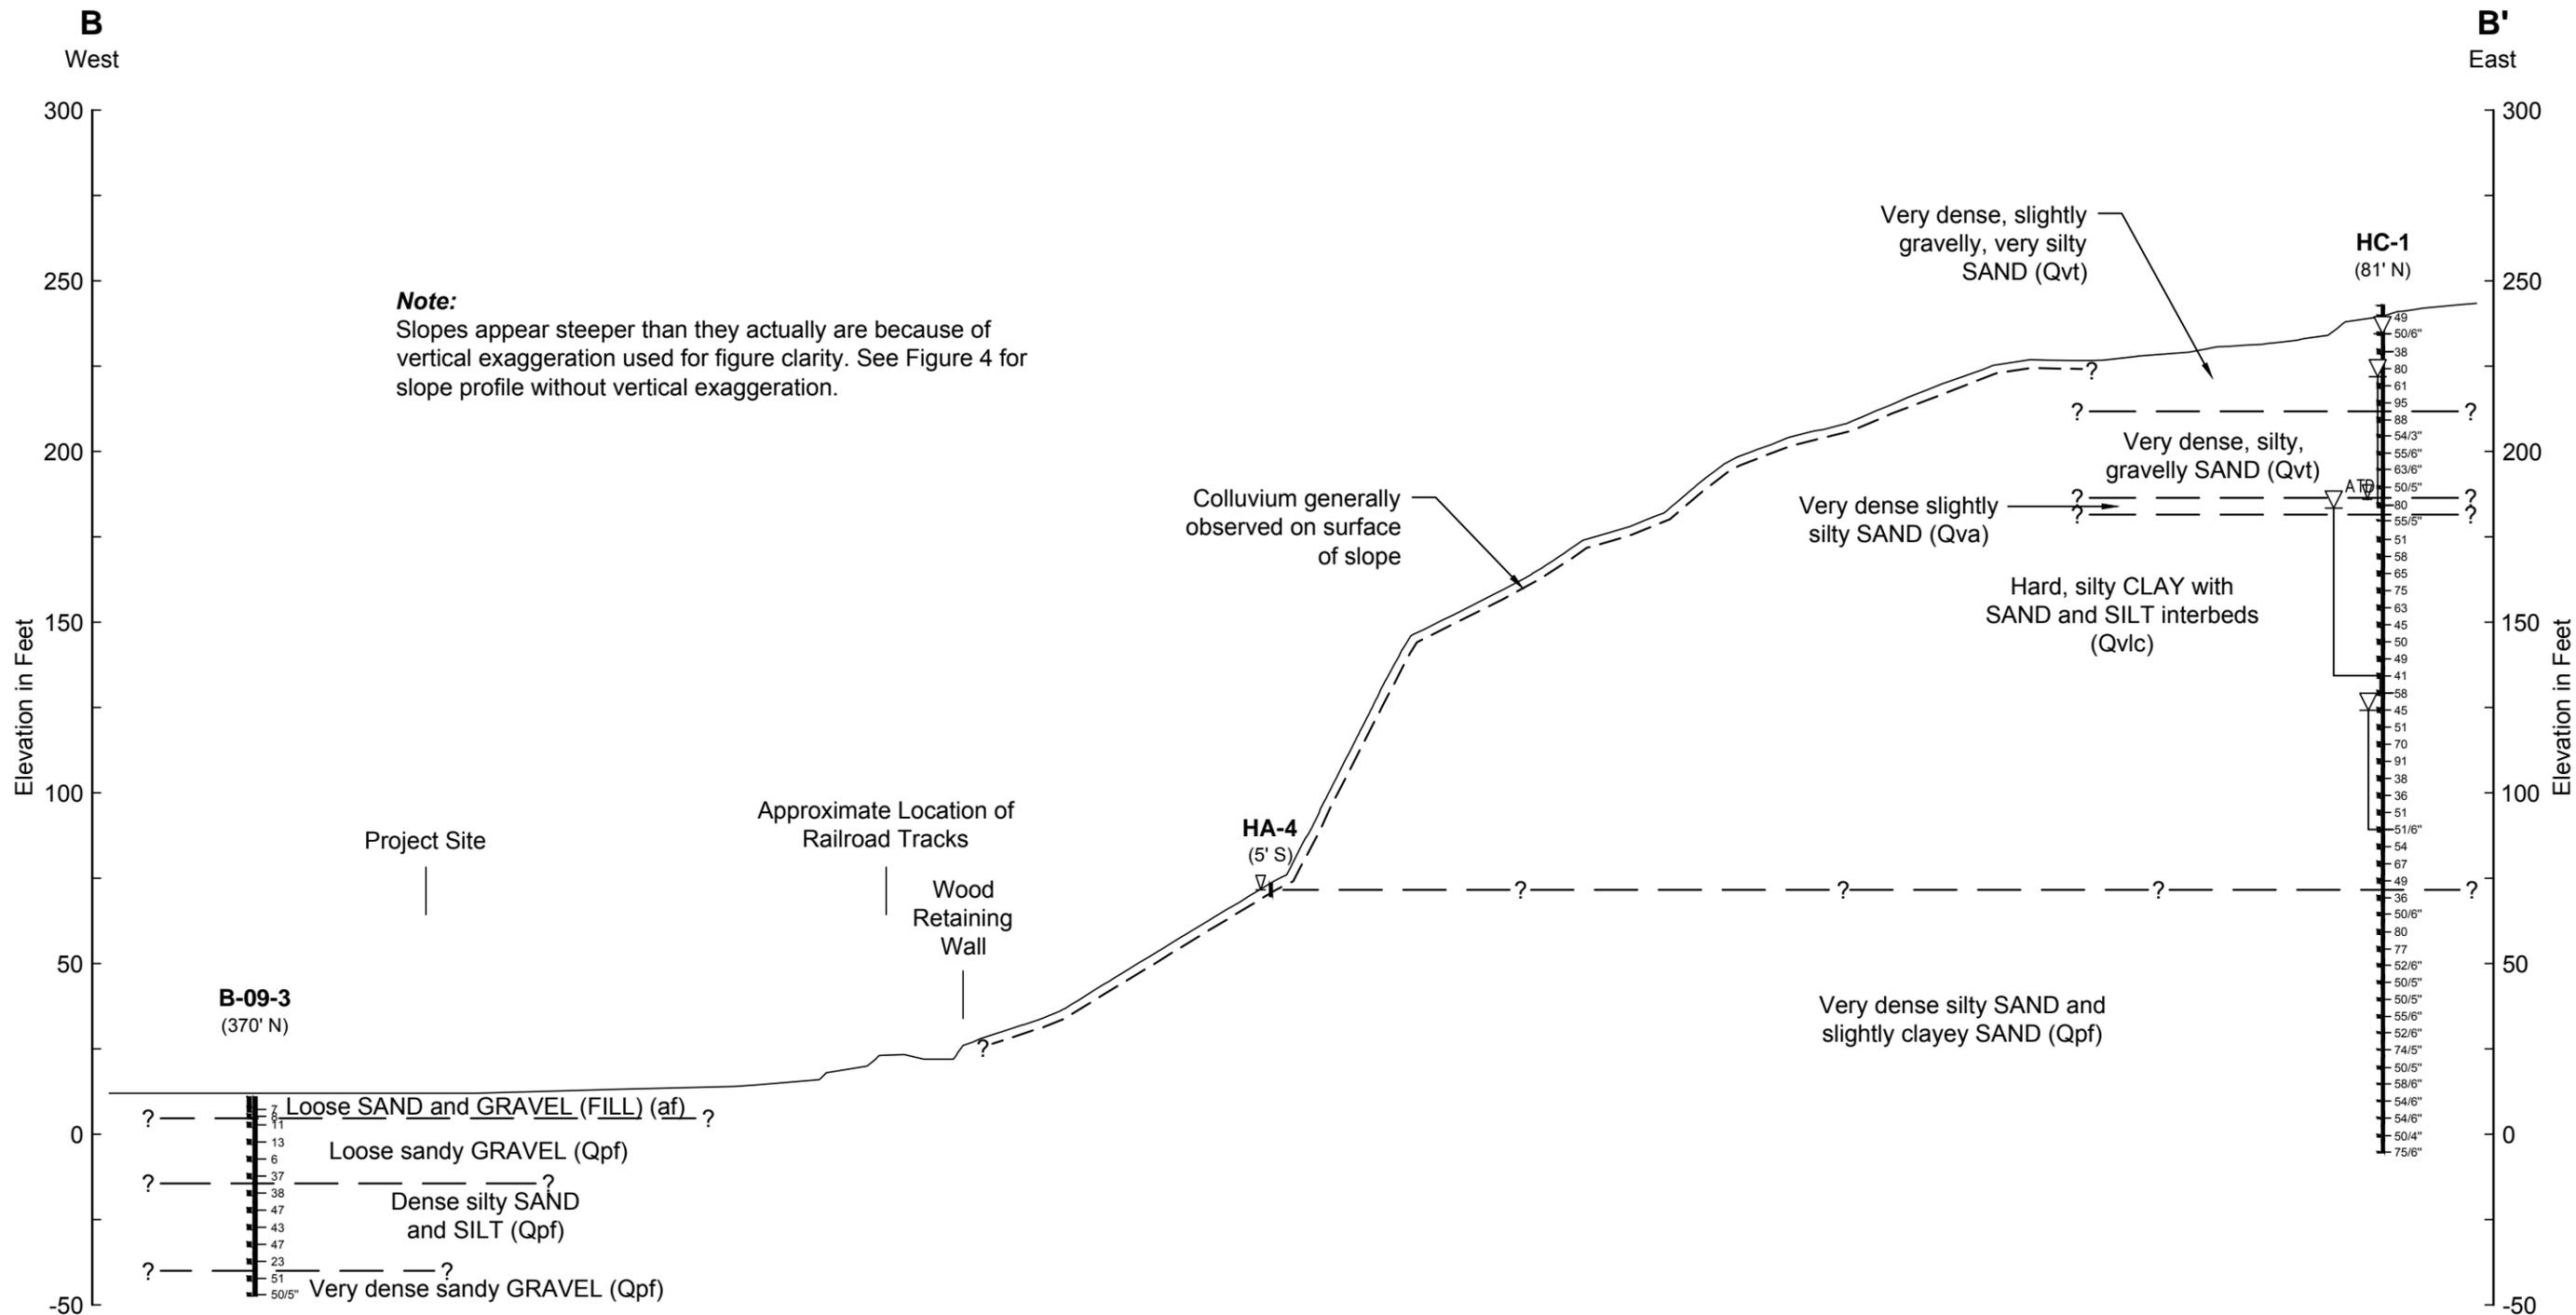
Point Wells Richmond Beach, Washington	
Generalized Subsurface Cross Section B-B'	
17203-54	6/15
	Figure 8

Note:
Slopes appear steeper than they actually are because of vertical exaggeration used for figure clarity. See Figure 4 for slope profile without vertical exaggeration.

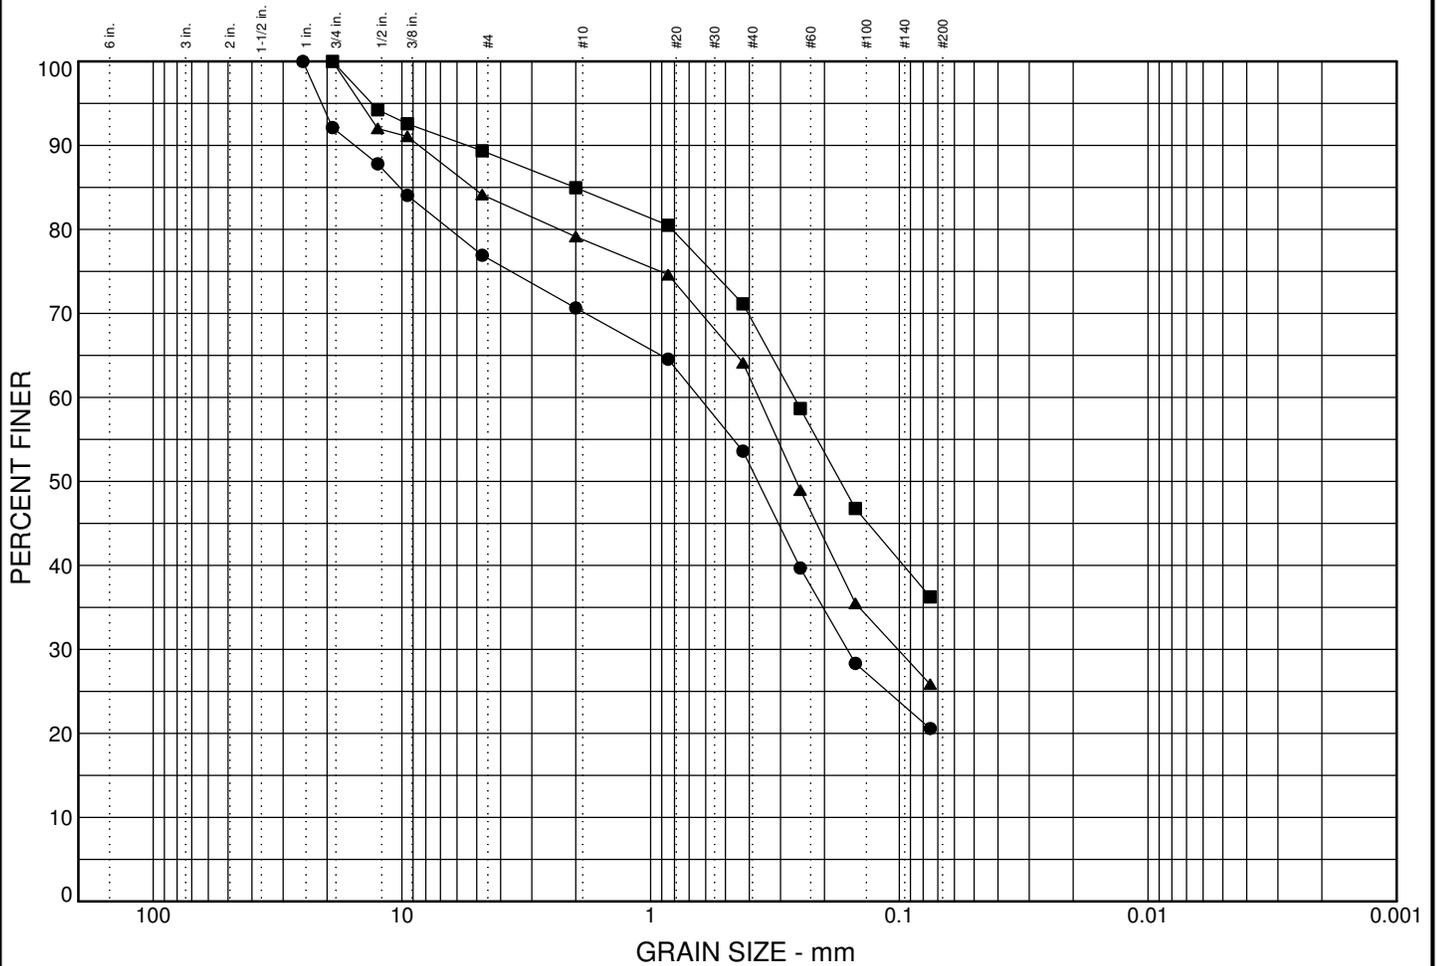
Particle Size Distribution Test Report

% COBBLES	% GRAVEL	% SAND	% SILT	% CLAY
●	0.0	23.1	56.3		20.6
■	0.0	10.6	53.1		36.3
▲	0.0	15.9	58.3		25.9
