Subsurface Conditions Report

Point Wells Redevelopment Richmond Beach, Washington

Prepared for
BSRE Point Wells, LP

June 11, 2015
17203-54

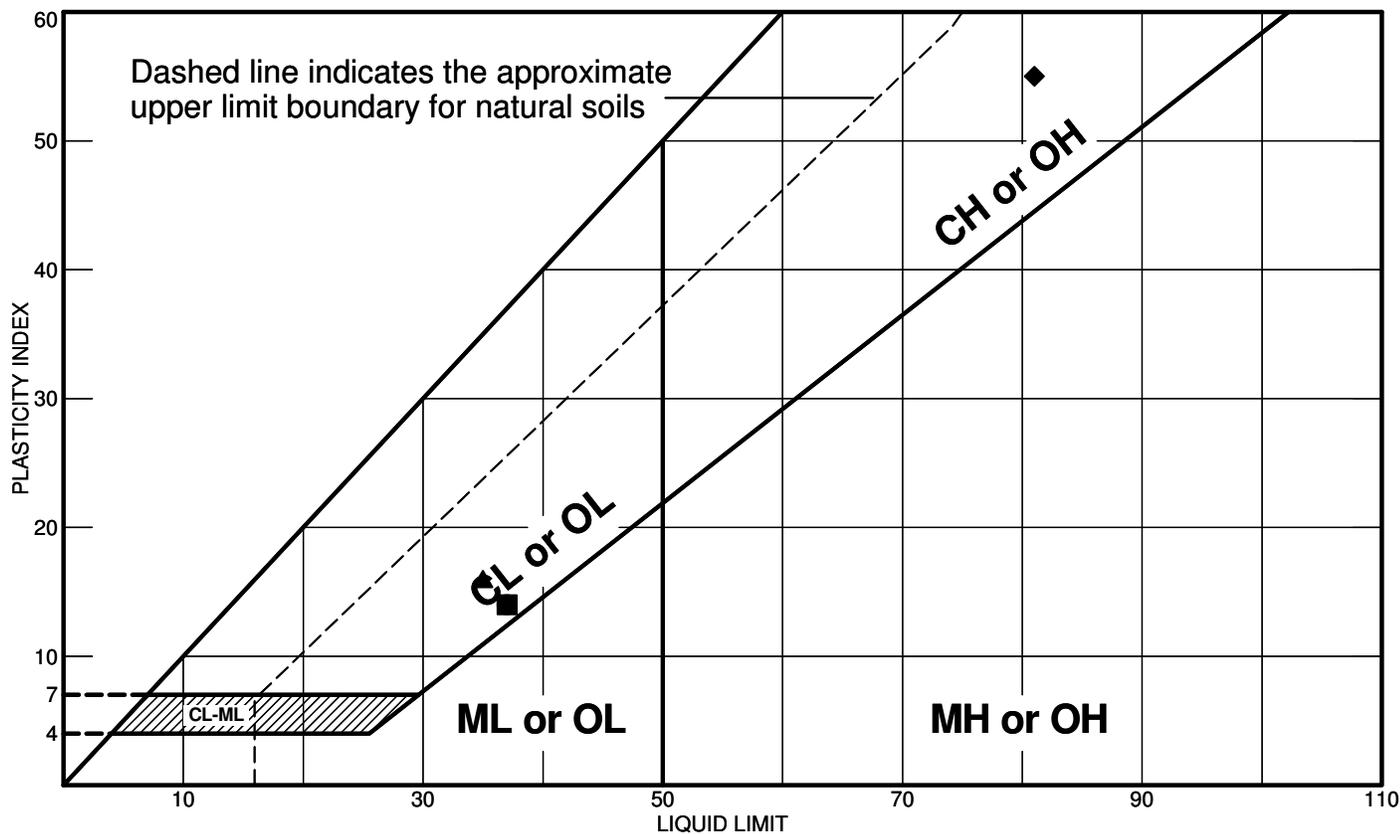
Liquid and Plastic Limits Test Report

Location + Description	LL	PL	PI	-200	USCS
● Source: HC-1 Sample No.: S-15 Depth: 68 CLAY	37	23	14		CL
■ Source: HC-1 Sample No.: S-16 Depth: 73 CLAY	37	23	14		CL
▲ Source: HC-1 Sample No.: S-25 Depth: 118 CLAY	35	19	16		CL
◆ Source: HC-1 Sample No.: S-35 Depth: 168 CLAY	81	26	55		CH
