Subsurface Conditions Report

# Point Wells Redevelopment Snohomish County, Washington

Prepared for  
**BSRE Point Wells, LP**

Prepared by  
**Hart Crowser, Inc.**

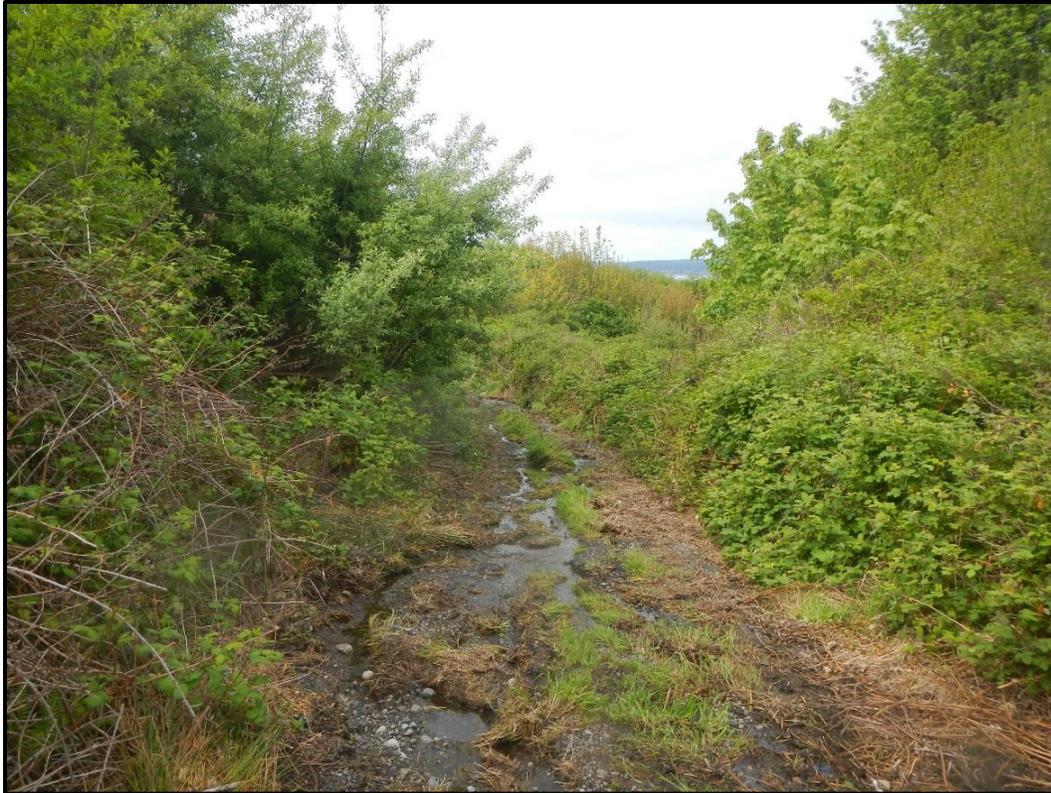
*Photograph 4: Surface runoff at gate to the private property at the top of the slope, above Drainage 2.*

Drainage 2 begins at approximately elevation 235 feet, where a storm drain discharges to the surface near the private property gate at the end of 238th Street Southeast, as shown in Photograph 4.

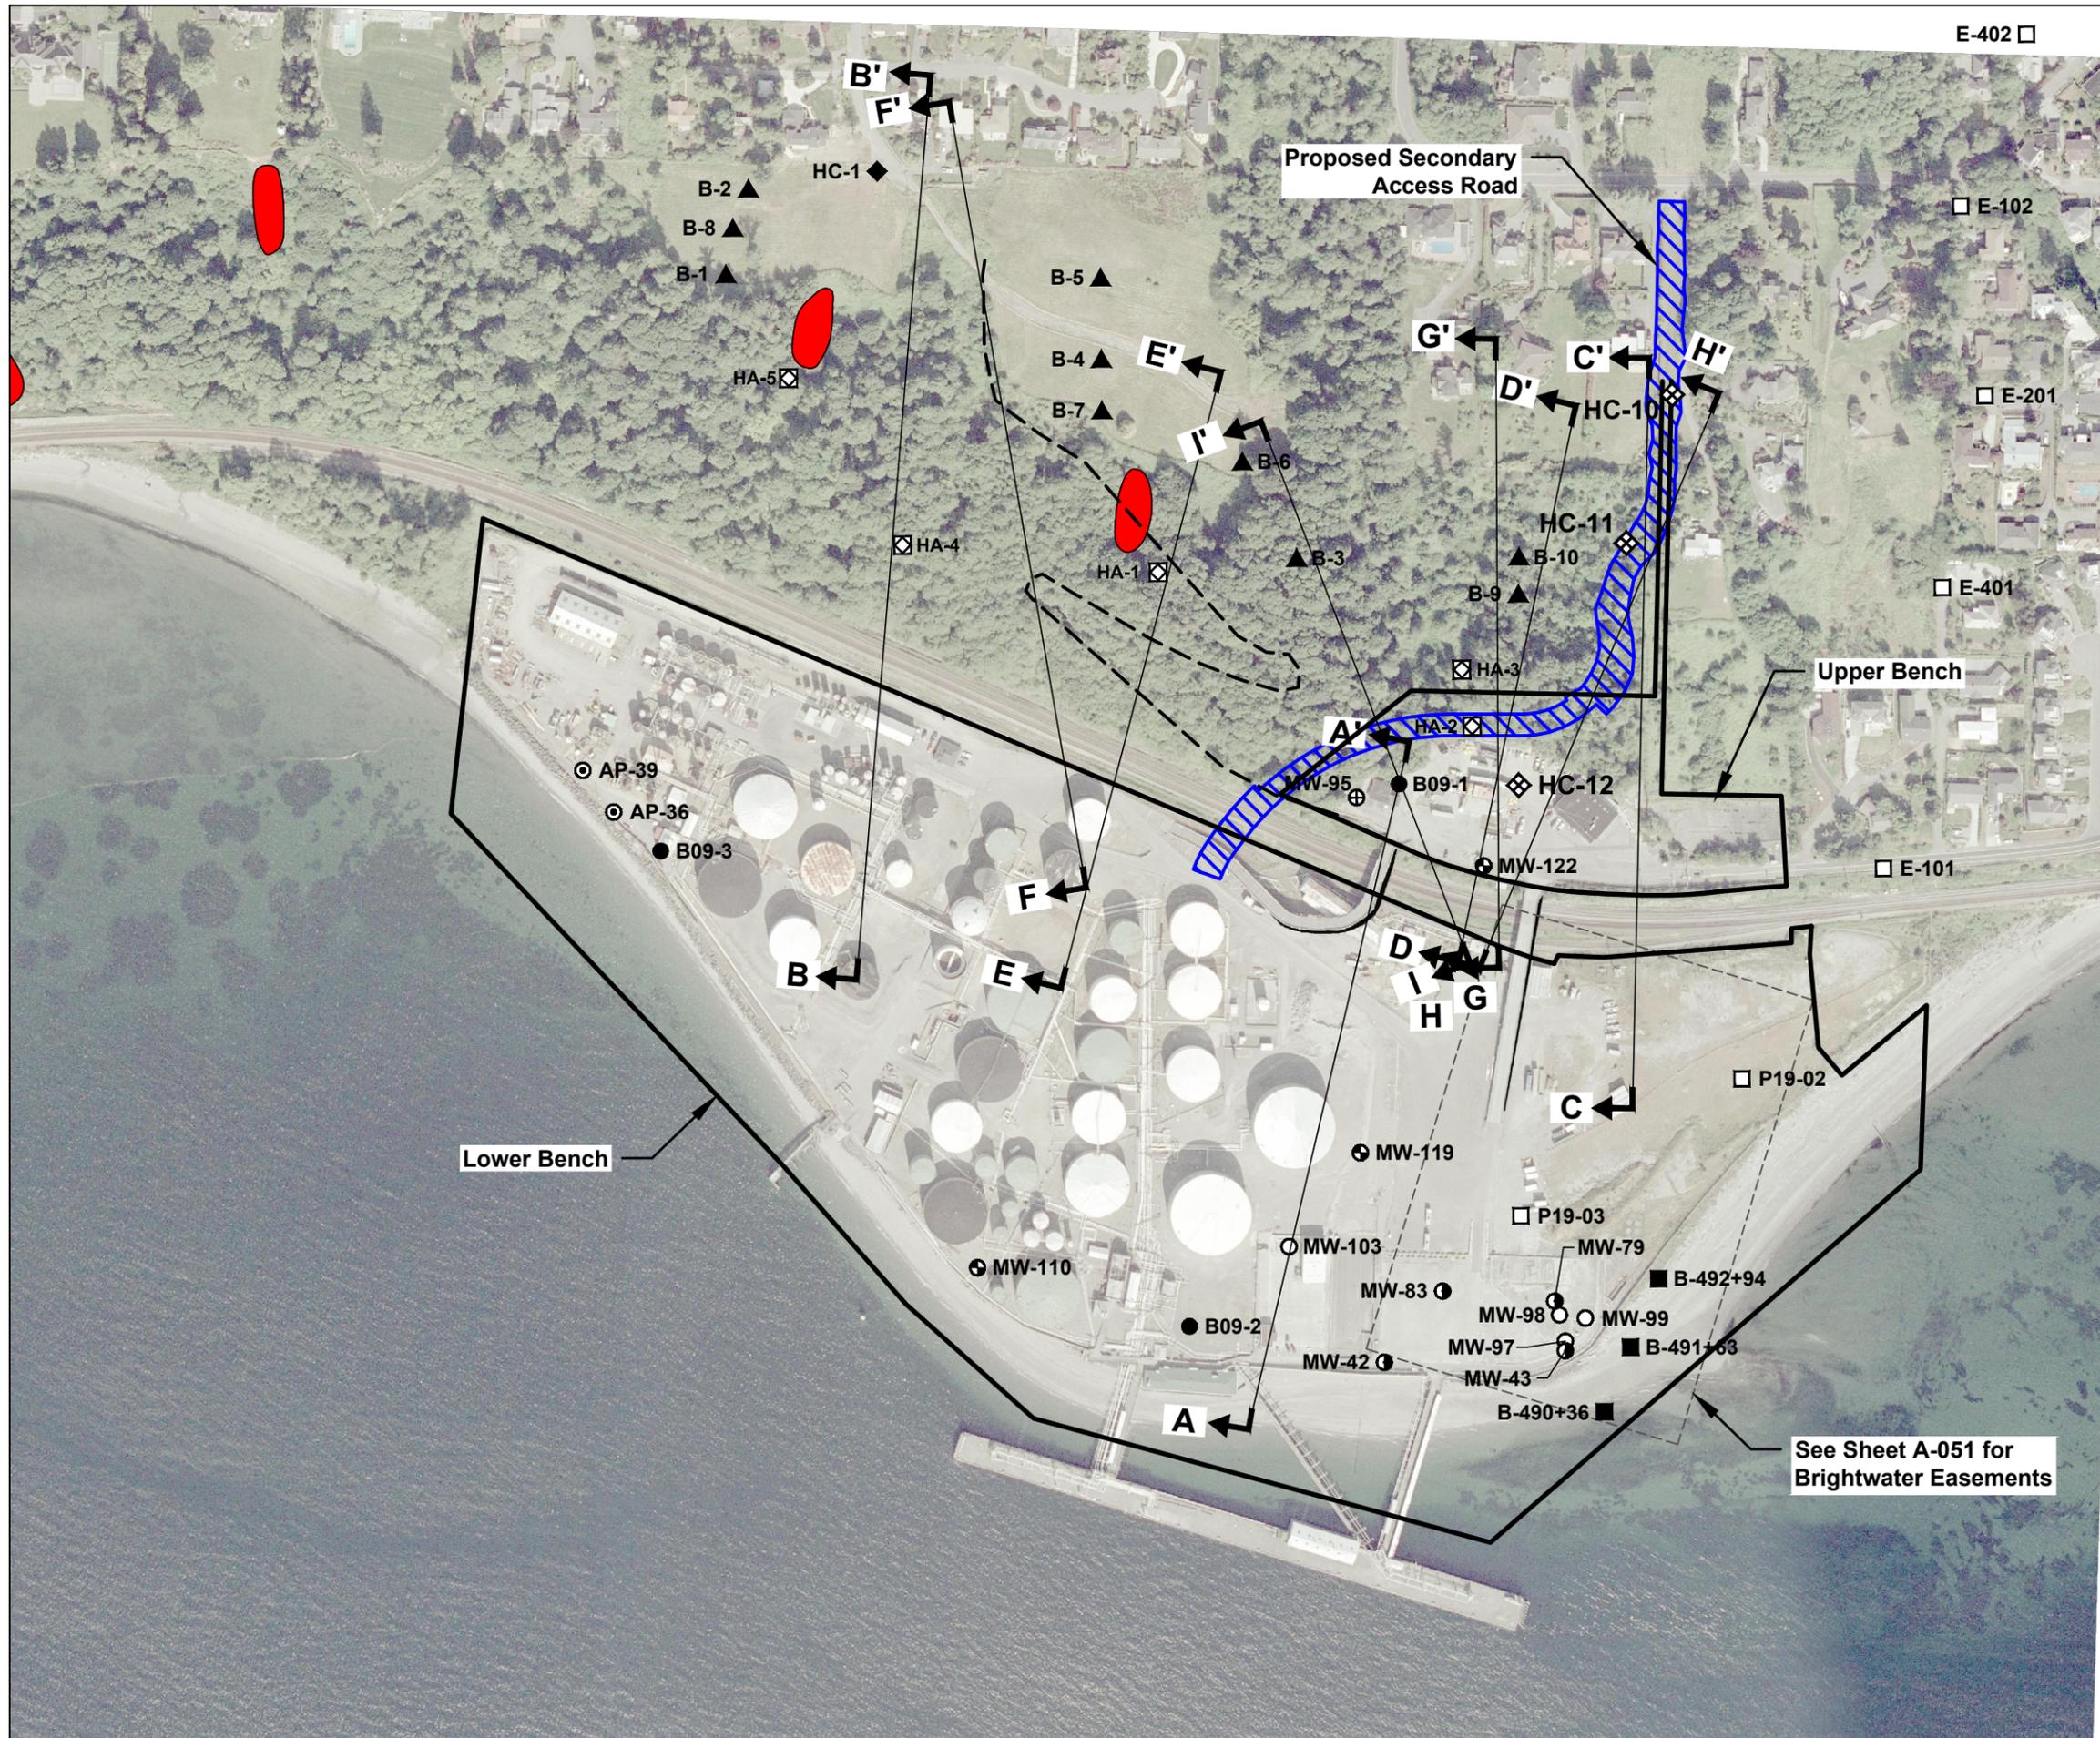
- Legend
- HC-10 ◆ Hart Crowser boring (2018)
  - HC-1 ◆ Hart Crowser boring (2015)
  - HA-1 ☒ Hart Crowser hand auger (2015)
  - B09-1 ● Hart Crowser boring (2009)
  - MW-110 ⊕ Hart Crowser monitoring well (2008)
  - B-483+00 ■ HWA boring (2007)
  - B-1 ▲ ECI boring (2004)
  - P19-03 □ CDM boring (2003)
  - AP-39 ⊙ KHM boring/well (2001)
  - MW-99 ○ KHM monitoring well (2001)
  - MW-95 ⊕ Pacific Environmental Group monitoring well (1998)
  - MW-79 ⊕ Converse NW monitoring well (1991-1992)
- A A' Cross section/slope profile designation  
 — — — Abandoned access road

To help assess soil conditions and potential geologic hazards, we completed a 250-foot soil boring at the top of the eastern slope, three deep borings along the Secondary Access Road (Figure 2), and installed vibrating wire piezometers (VWPs) to monitor groundwater levels in different stratigraphic units. Data from these additional deep borings supplement data from over 200 shallower borings previously completed on the eastern slope, Upper Bench, and Lower Bench at the site. Field reconnaissance was performed on the eastern slope to document slope conditions and evaluate potential landslide features identified on light detection and ranging (LiDAR) imagery of the site with respect to the proposed development alternatives. LiDAR imagery was collected in April 2013 and provided by the Washington State Department of Transportation (WSDOT 2013). As part of the reconnaissance, five hand-auger soil borings were advanced on the slope. Details of these activities are in the following section, and exploration locations are shown on Figures 2 and 3.

During the field reconnaissance, five hand auger borings were advanced to approximately 3 to 8.5 feet bgs. Soil conditions encountered in these shallow borings are shown in Table 1. Hand auger locations are on Figures 2 and 3.

As shown on Figure 3, several monitoring wells were previously advanced on the Upper Bench. The explorations shown on Figure 3 are 20 feet deep or greater. Water level was measured at the site on October 5, 2009, in monitoring wells MW-95 and MW-122. At that time, the groundwater in MW-95 was observed at an elevation of about 40 feet. Artesian flowing conditions were observed at MW-122, as indicated by water flowing from the top of the monitoring well. Artesian flowing conditions occur when groundwater is confined and groundwater pressures increase enough to cause groundwater to rise through the well and flow at ground surface. The ground surface elevation in MW-122 is approximately 48 feet.

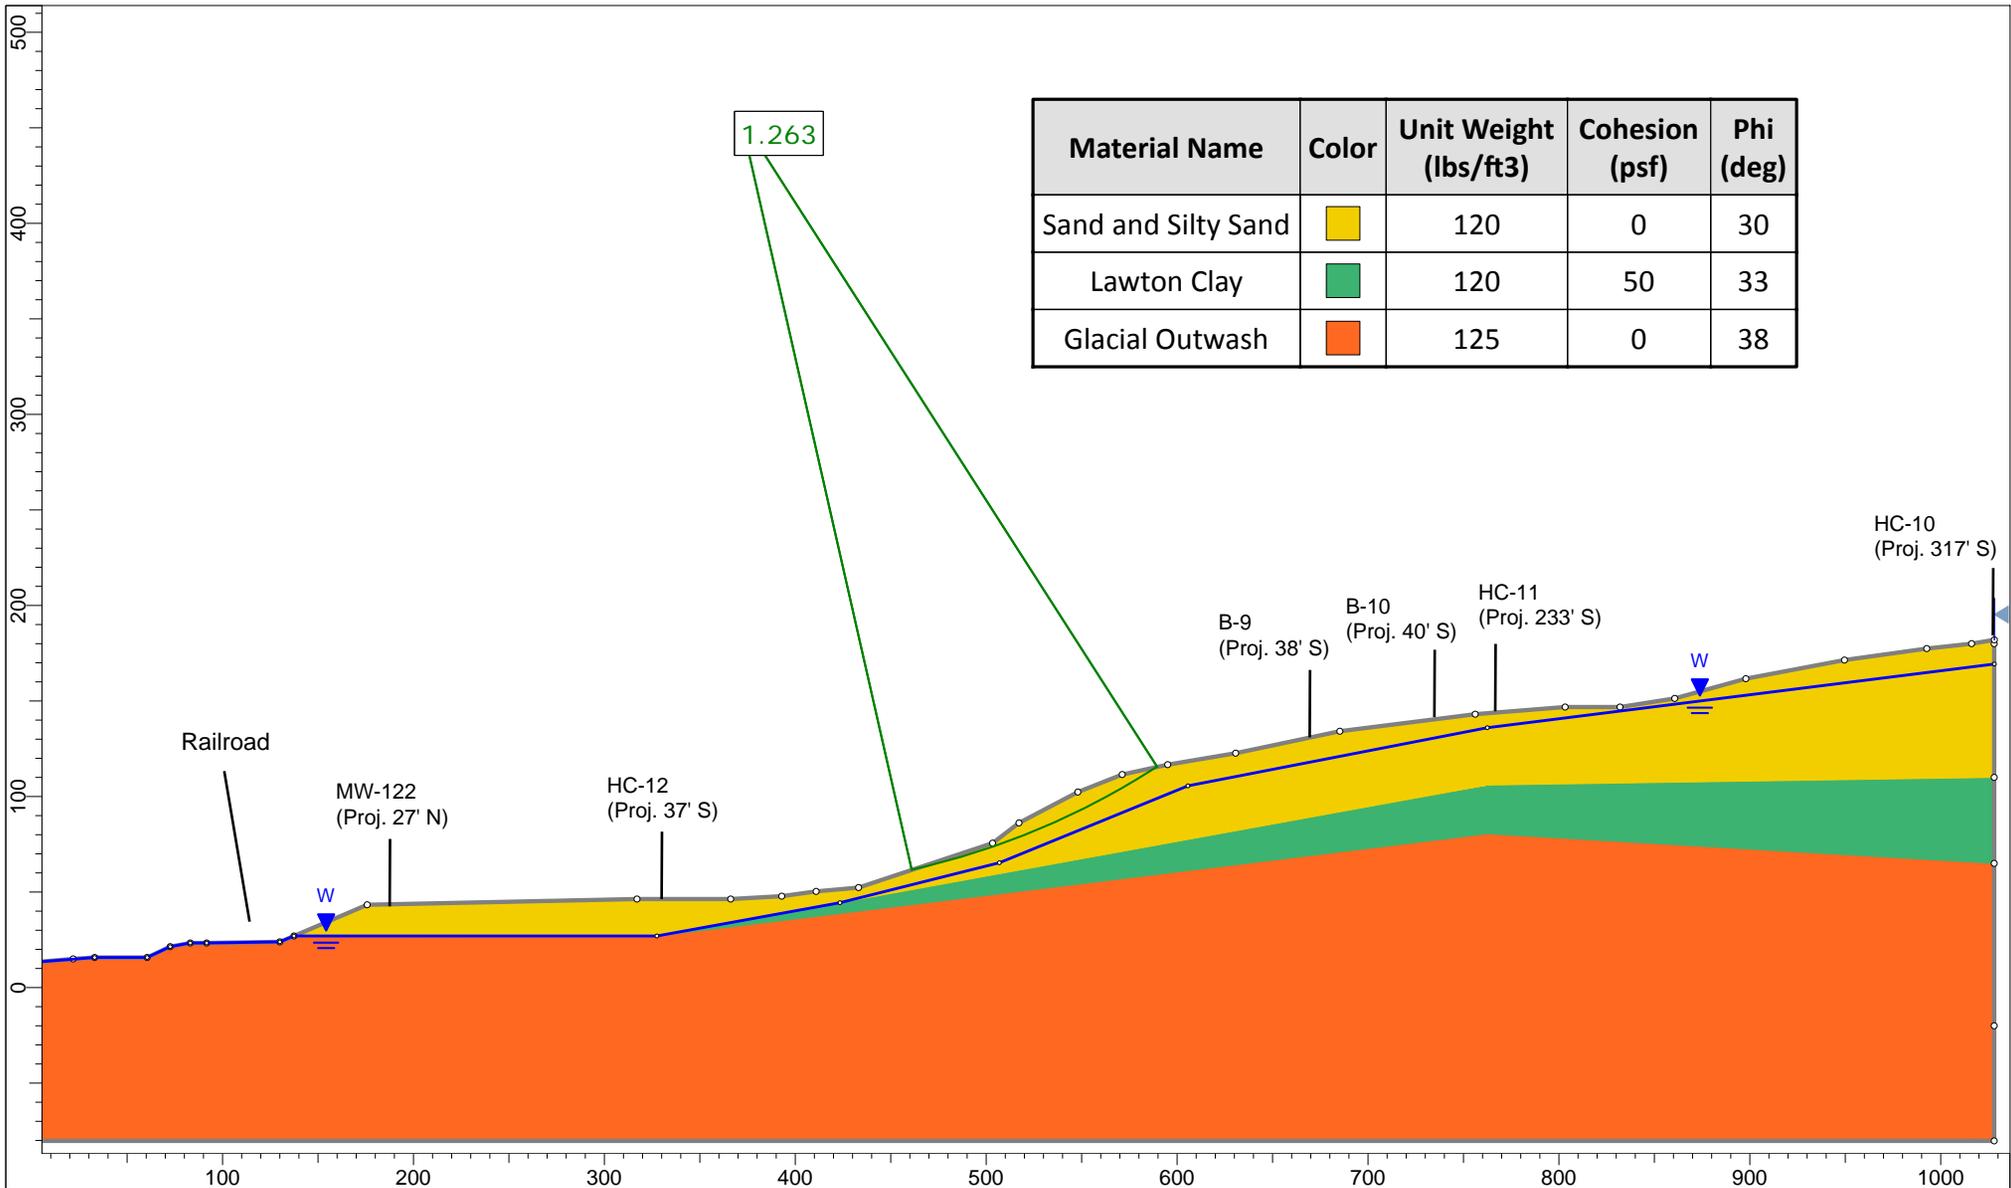
<b>HARTCROWSER</b>	Figure <b>18</b>

Material Name	Color	Unit Weight (lbs/ft <sup>3</sup> )	Cohesion (psf)	Phi (deg)
Sand and Silty Sand	Yellow	120	0	30
Lawton Clay	Green	120	50	33
Glacial Outwash	Orange	125	0	38

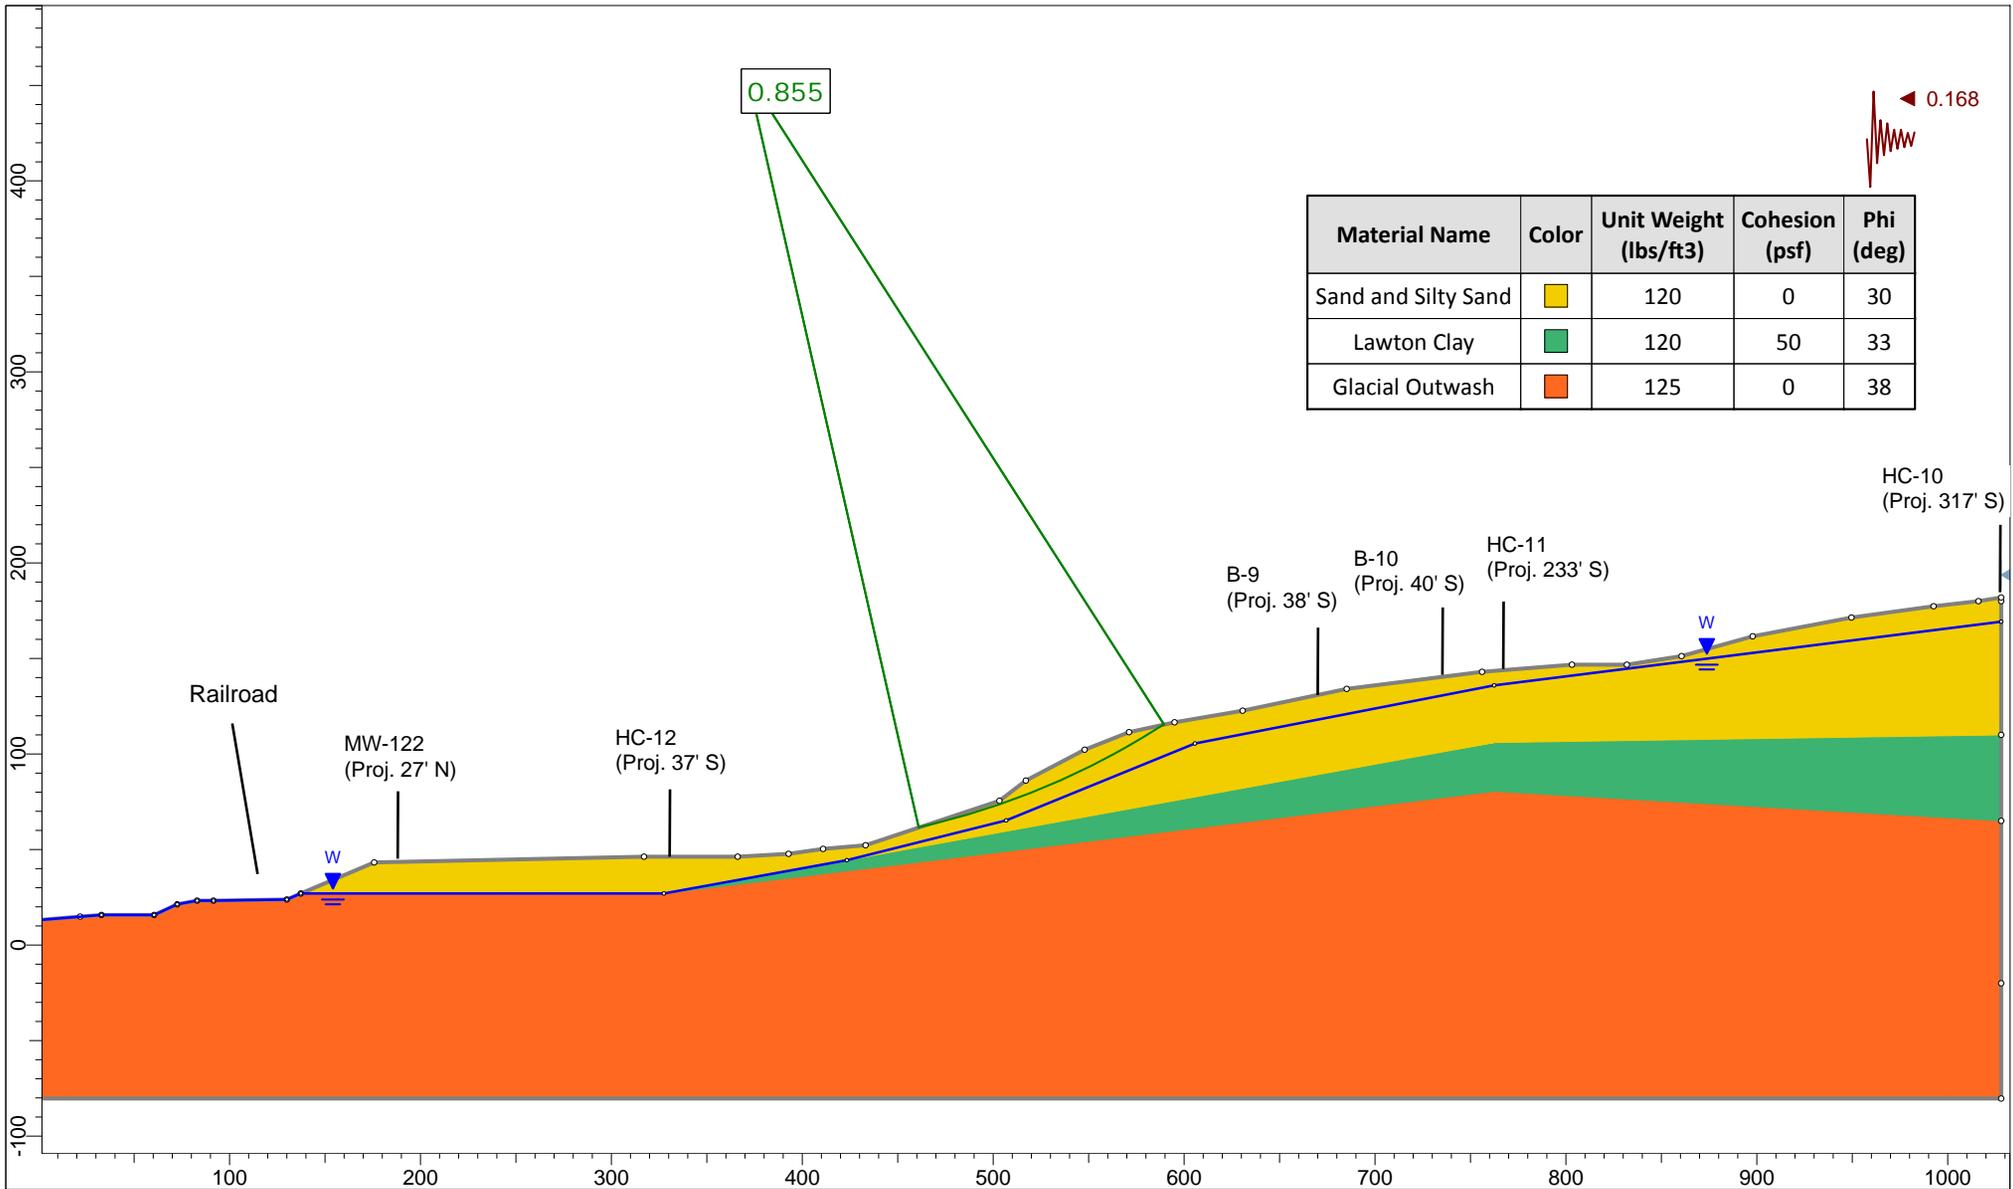
Point Wells Richmond Beach, Washington		
Section G-G' Existing Conditions - Pseudostatic		
17203-54	Scale 1:1200	4/18
		Figure <b>19</b>

Material Name	Color	Unit Weight (lbs/ft <sup>3</sup> )	Cohesion (psf)	Phi (deg)
Sand and Silty Sand	Yellow	120	0	30
Lawton Clay	Green	120	50	33
Glacial Outwash	Orange	125	0	38

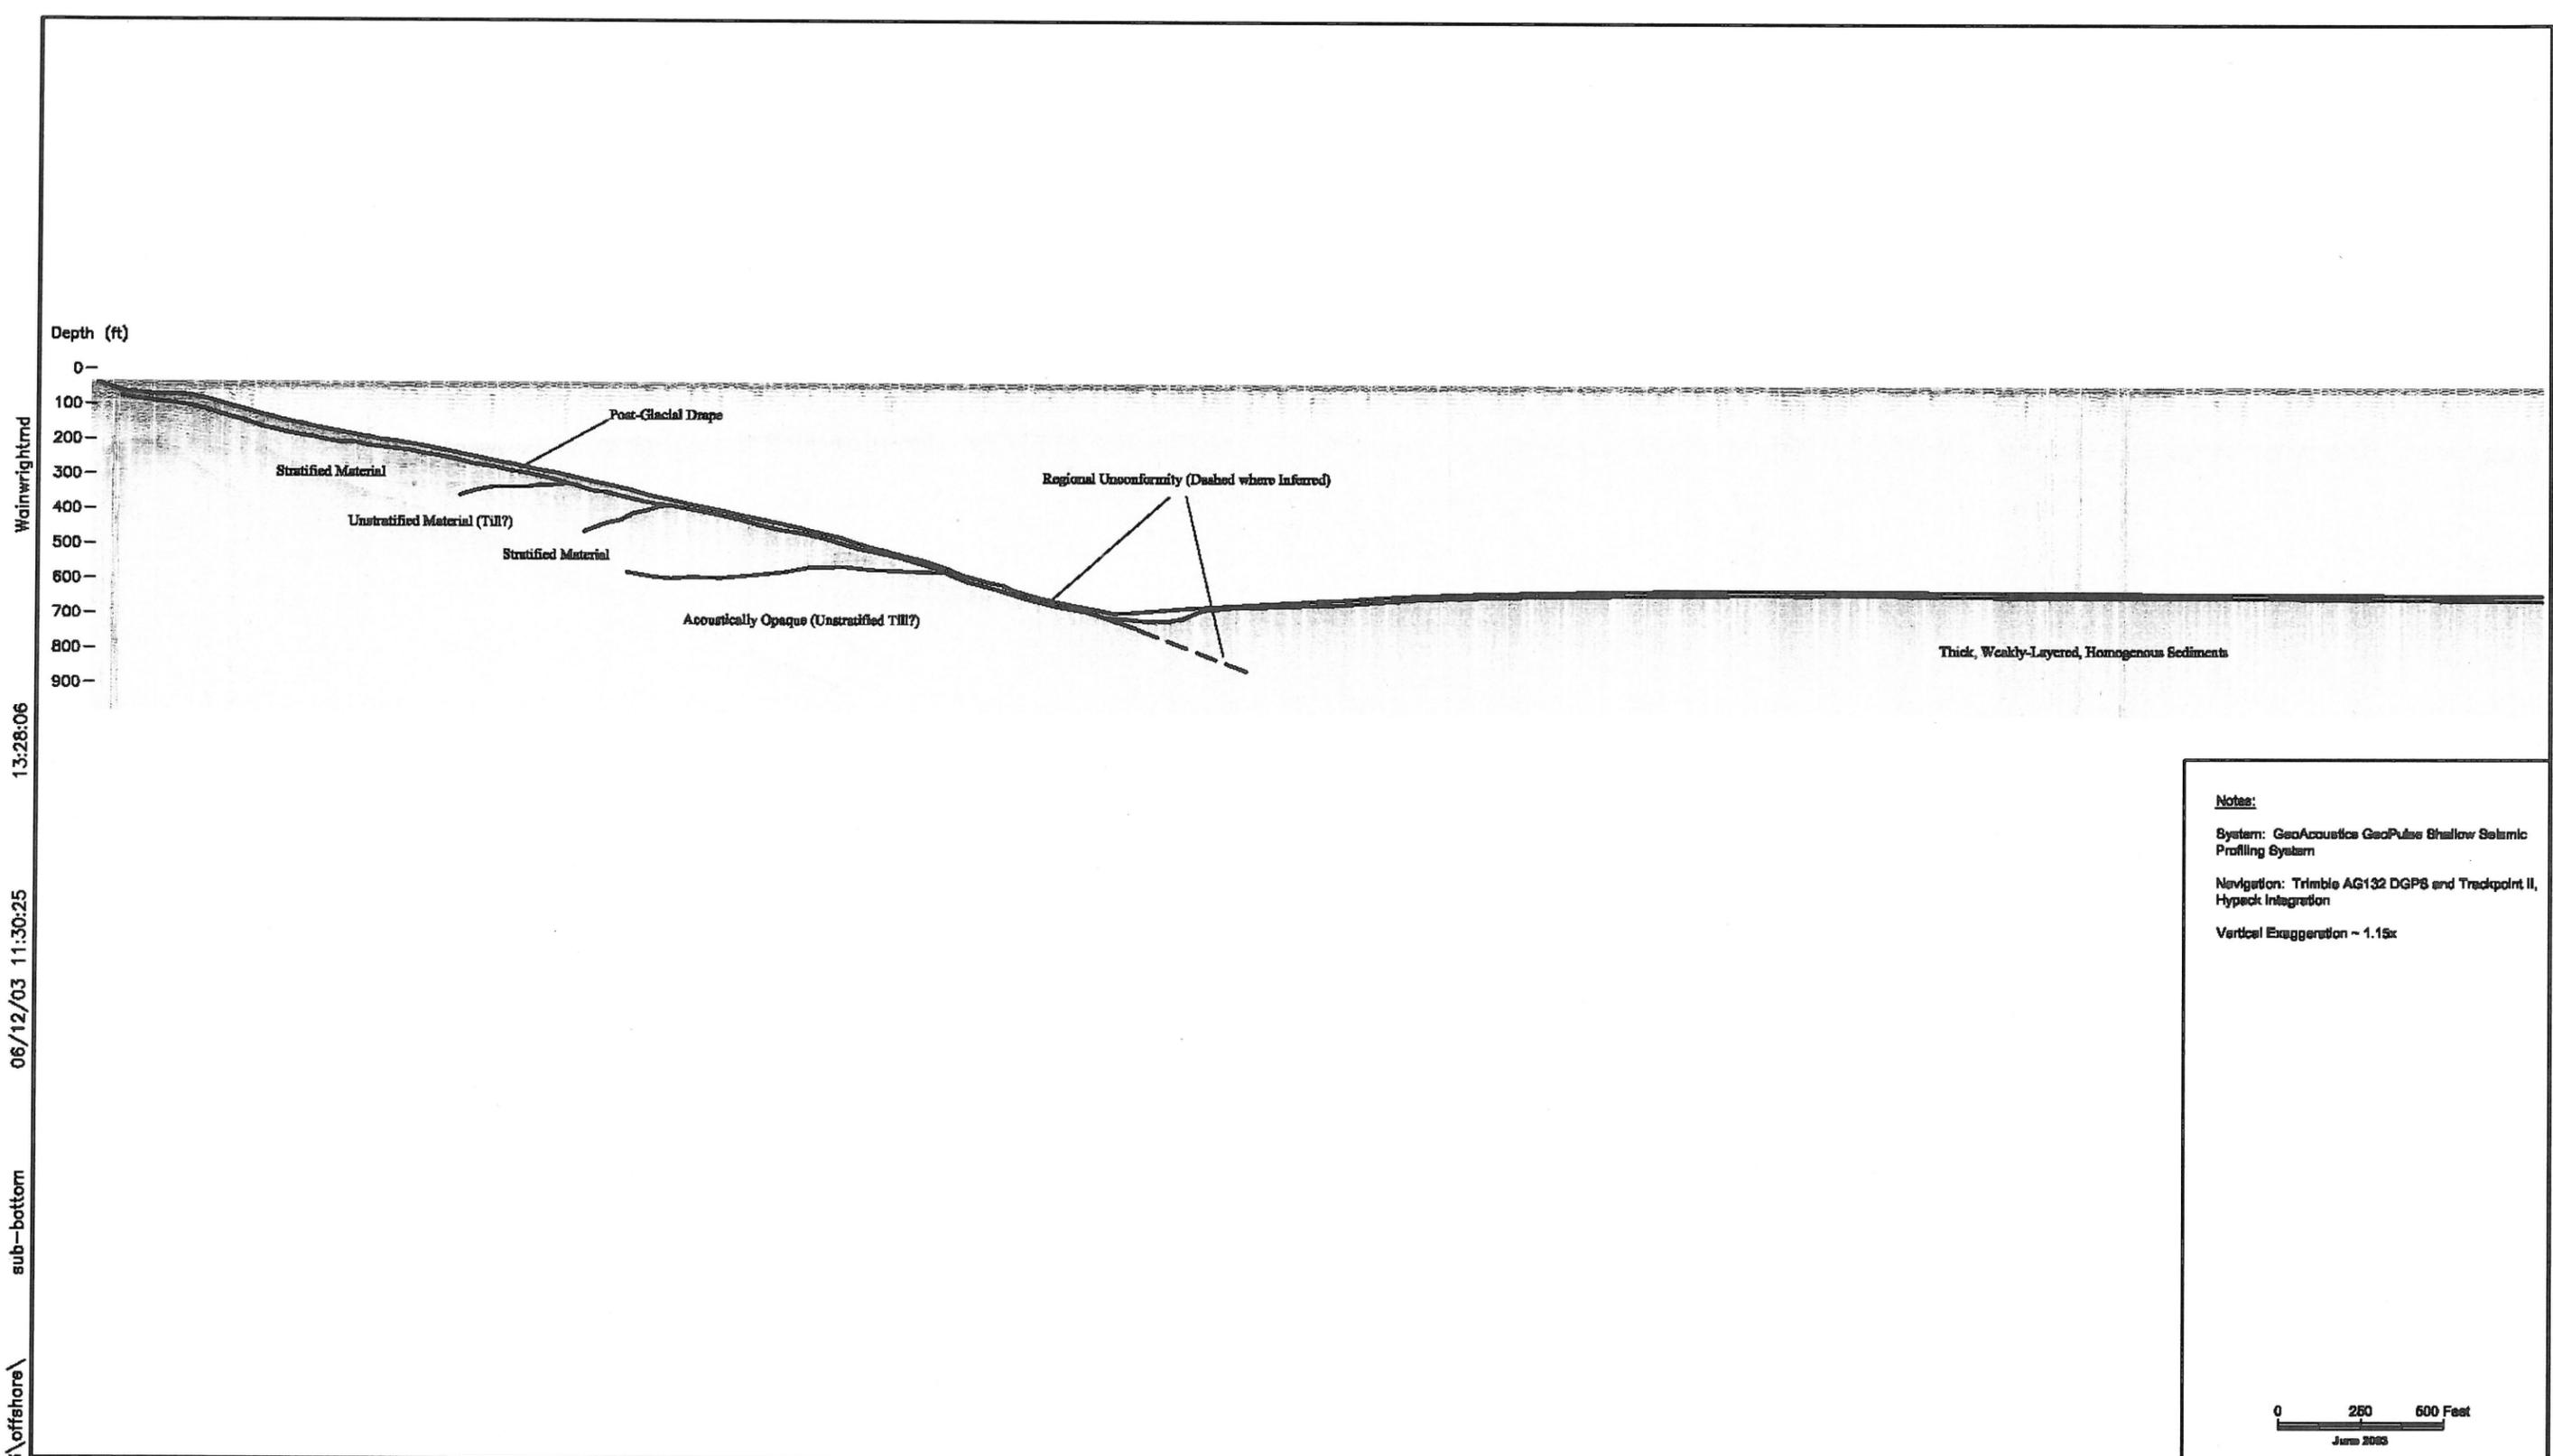
**Notes:**  
 System: GeoAcoustics GeoPulse Shallow Seismic Profiling System  
 Navigation: Trimble AG132 DGPS and Trackpoint II, Hypack Integration  
 Vertical Exaggeration ~ 1.15x
