PREPARED BY SNOHOMISH COUNTY  
DEPARTMENT OF PUBLIC WORKS

**GEOLOGIC INVESTIGATION  
AND  
GEOTECHNICAL ENGINEERING REPORT**

***Little Bear Creek Advance Mitigation Site***

RC1730-115-37

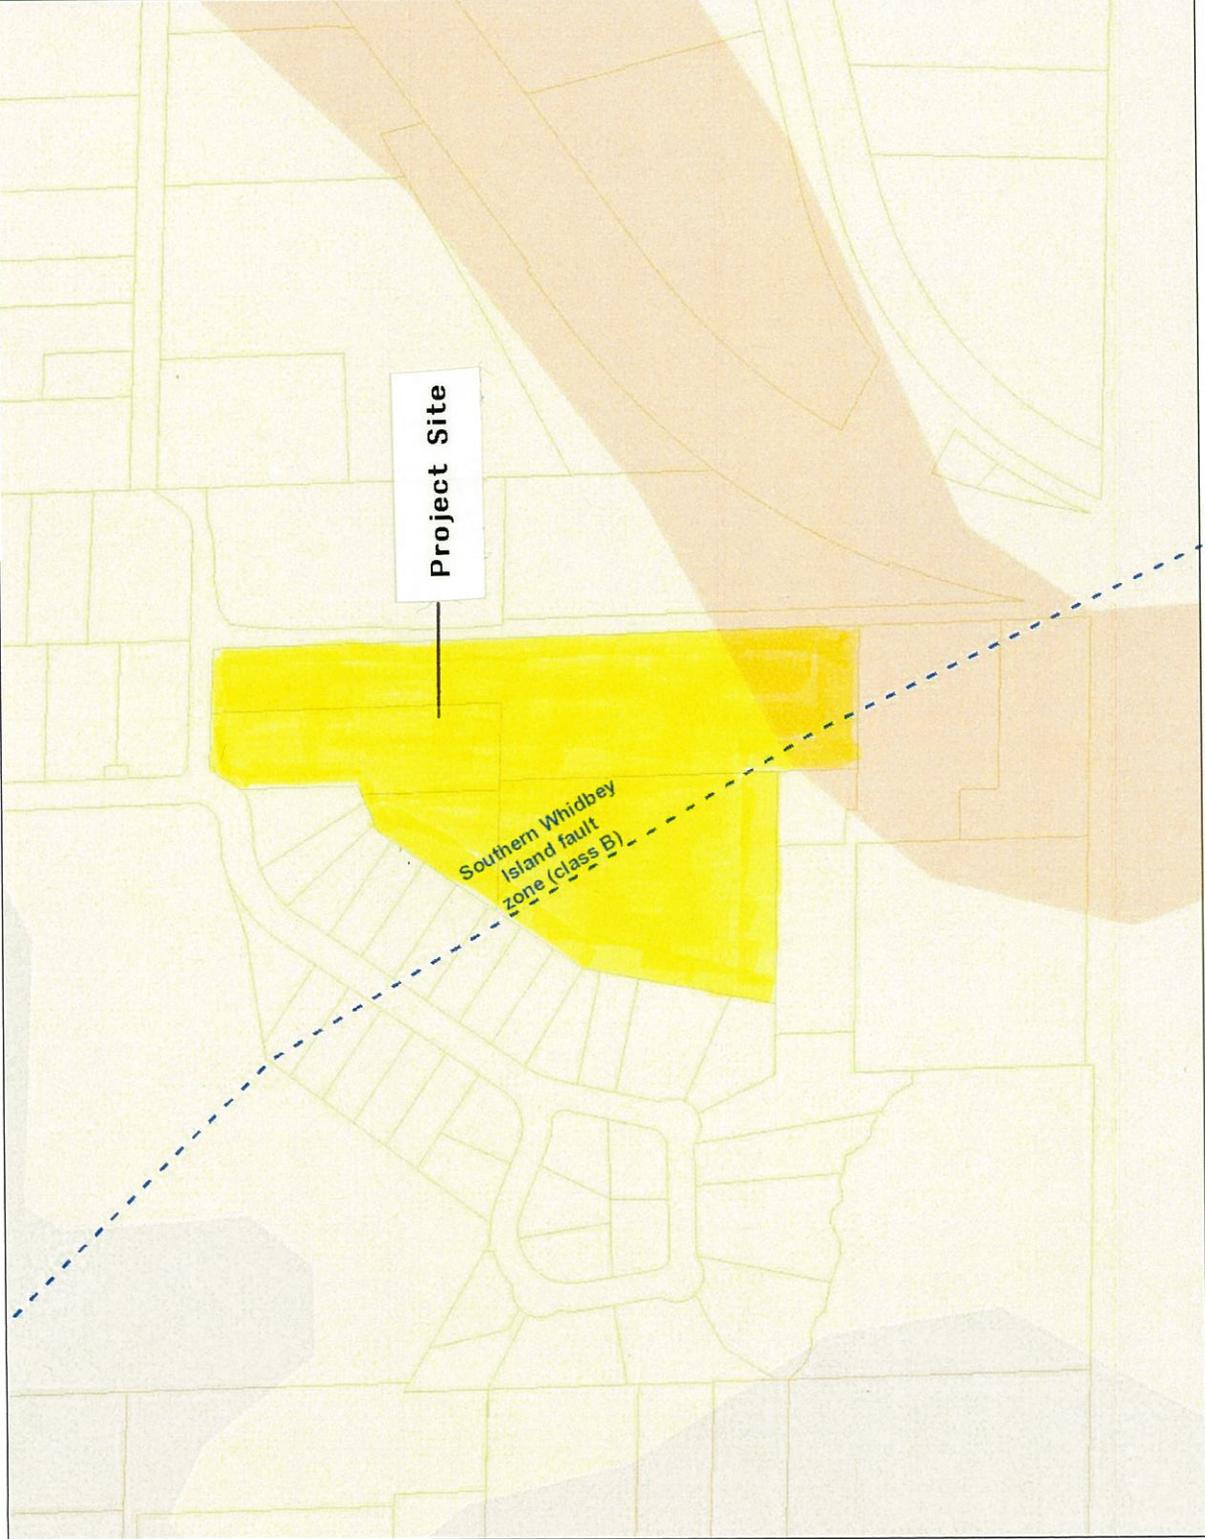
# SWIFZ Splay Map

Review of the **South Whidbey Island Fault Zone (SWIFZ) Maps** covering the project area indicates a mapped splay crossing the project site in the immediate vicinity of the slide scarps shown on the **Lidar Maps**. In many areas of the County the locations of the **SWIFZ** splays have been delineated based on surficial topographic features such as those seen on the projects **Lidar Maps**. Movement along the splay could account for the surficial topographic features along the western slope noted on the **Lidar Maps**. The actual presence of the splay has not been verified by any other site data.

A branch of a fault from the **SWIFZ**, commonly referred to as a splay, is mapped as crossing the project site. For reference purposes, the proposed location of the splay relative to the project site is shown on the **SWIFZ Splay Map** included in *Appendix K* of this report. While the exact location of the splay is unknown, its approximate location has been proposed based on subsurface geologic features and surficial topographic features observed in the vicinity of the project site. According to the USGS, the **SWIFZ** is an active fault zone. As such, it is possible that the project site could experience primary seismic hazards such as strong shaking and/or surface-fault rupture (*along the splay*) during its design lifespan. Based on the steep slopes along the western side of the site, the mapped geology of the site and the observed high ground water table and loose sandy
