2018 Goodwin & Shoecraft Milfoil Update

2018 Milfoil Locations

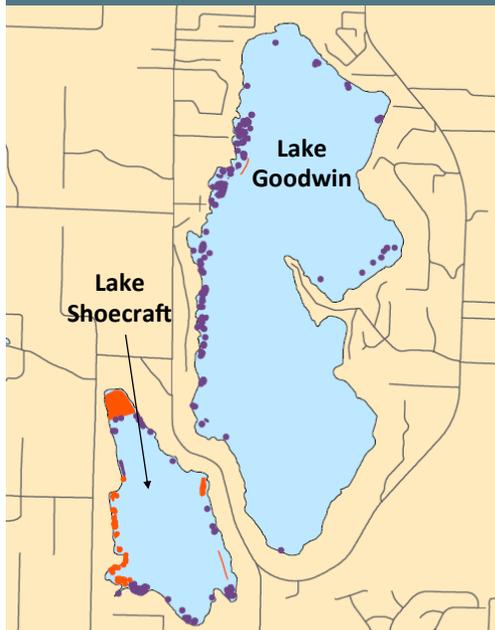
Milfoil Plants

- Not Pulled
- Pulled
- Area Not Surveyed

- Divers worked six days surveying and hand-pulled all milfoil found.
- A small shoreline area (5%) was not surveyed, but the worst areas were covered twice.

- Divers worked two days surveying and hand-pulling.
- Divers pulled small milfoil patches along 60% of the shore.
- Severe infestations were found along 35% of the lake and were too large for hand-pulling.
- A small shoreline area (5%) was not surveyed due to lack of time.

- Goodwin - continue successful diver hand-pulling (5-6 days).
- Shoecraft - conduct herbicide treatment in areas of severe infestation (10-11 acres) and conduct diver hand-pulling in the remaining areas.
